New Durham Town Hall
New Durham, New Hampshire

Historic Building Assessment
with
Preservation Guidelines

Prepared by
Elizabeth Durfee Hengen
Preservation Consultant

May 2012

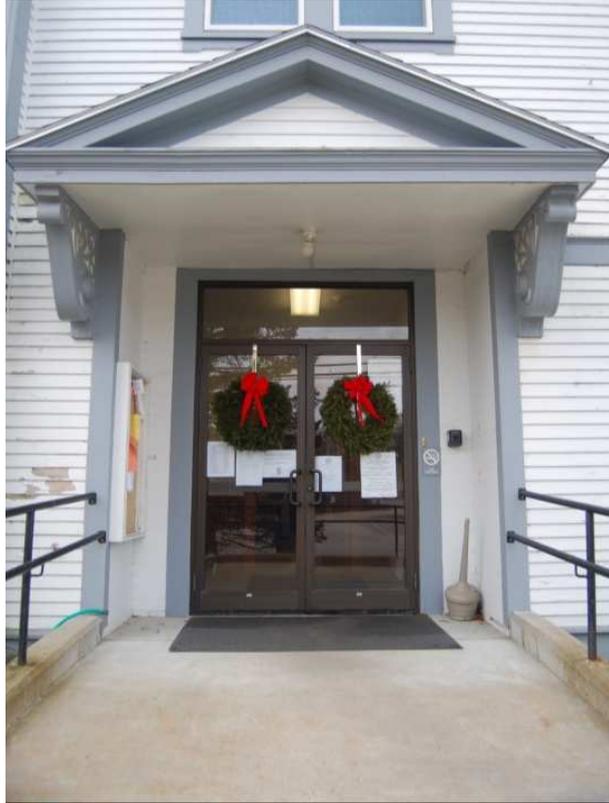
Replacement doors and transom window installed in mid-1980s; the loss of wooden panels and divided lights in the transom creates a starker, more reflective appearance than the original entry features did.

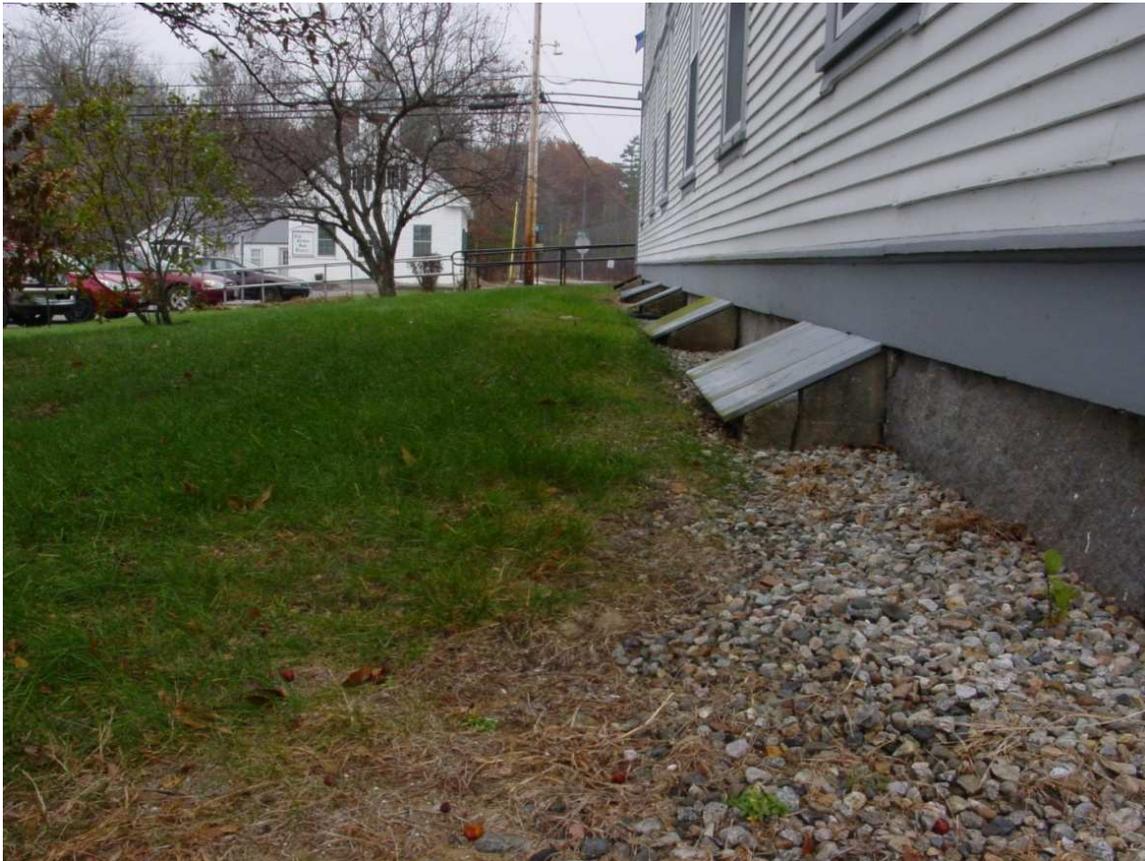
The area along the west side illustrates the build-up of soil and negative grade at the foundation.

Along the west side of the building, the problem is most severe. There is a build-up of soil at the foundation that creates a negative grade. Water enters and collects in the cellar and is then pumped outside by a sump pump. Yet, once on the surface, it is directed back towards the foundation a second time, rather than being diverted away.

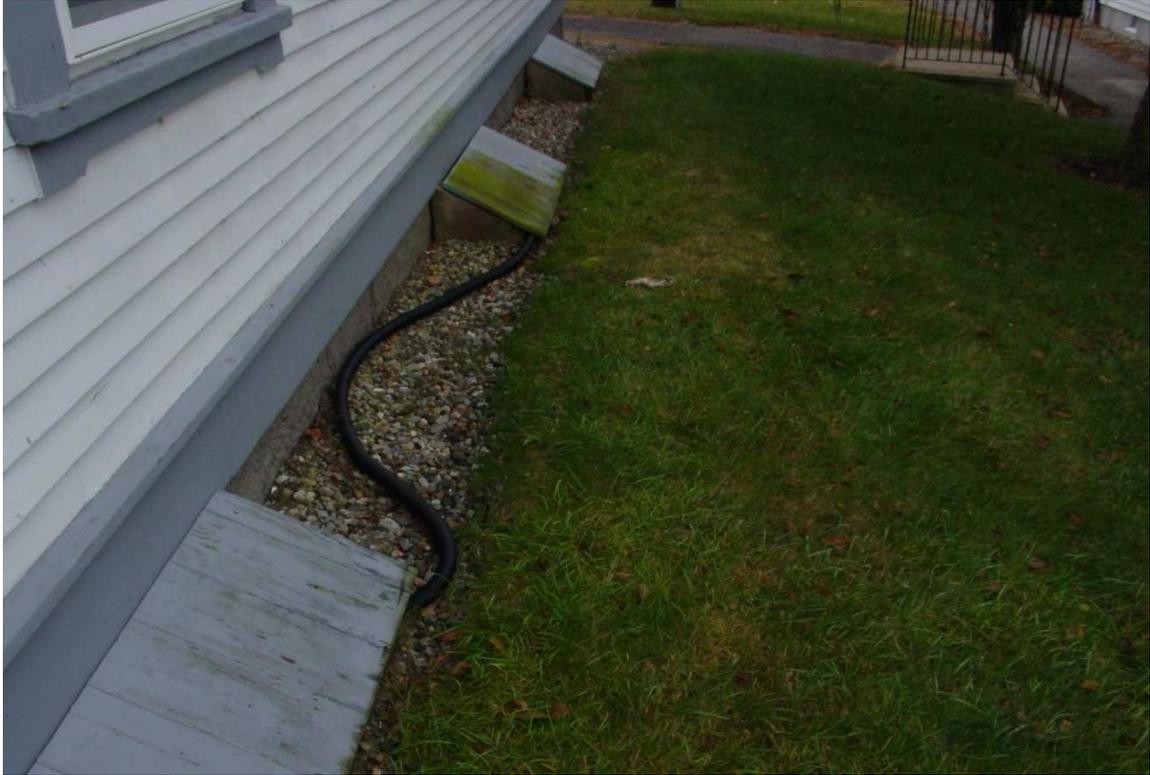
Note the exit piping from the sump pump lying along the west side foundation.

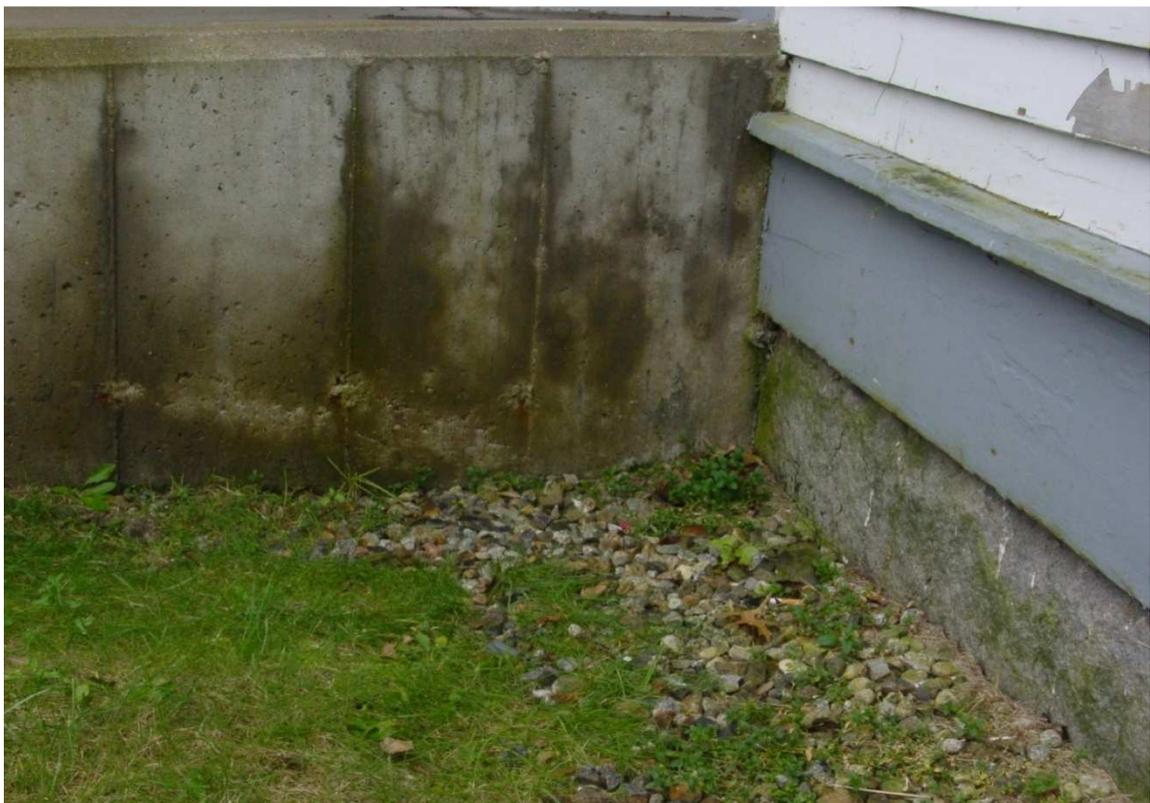
This view of the north side of the building, where the concrete ramp meets the front entrance, shows evidence of water collecting near the foundation and being diverted directly into the cellar.

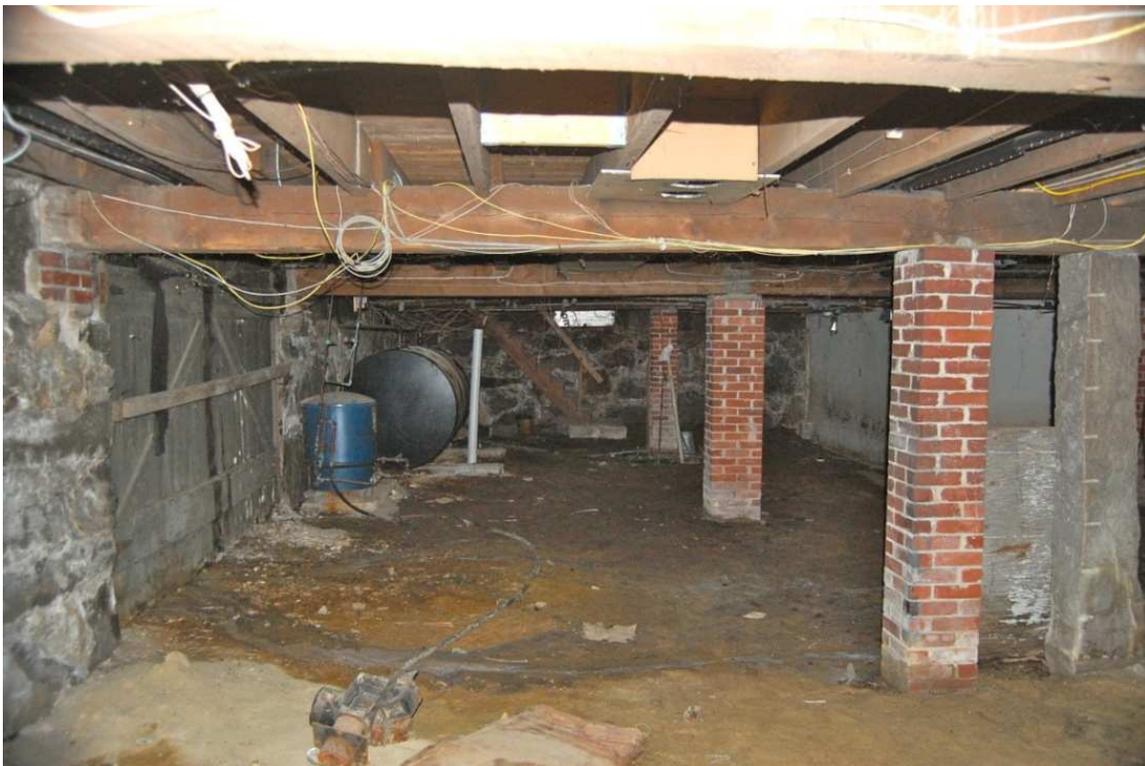
The major problem in the cellar, as already noted, is water infiltration from improper surface drainage, resulting in serious moisture and mold problems. This excessive moisture and deteriorated wood accumulated on the dirt floor have led to unhealthy conditions.

A view of the cellar showing the foundation, granite posts and brick piers, flooring system, and moist floor. The stairway to the second floor is at the far end.

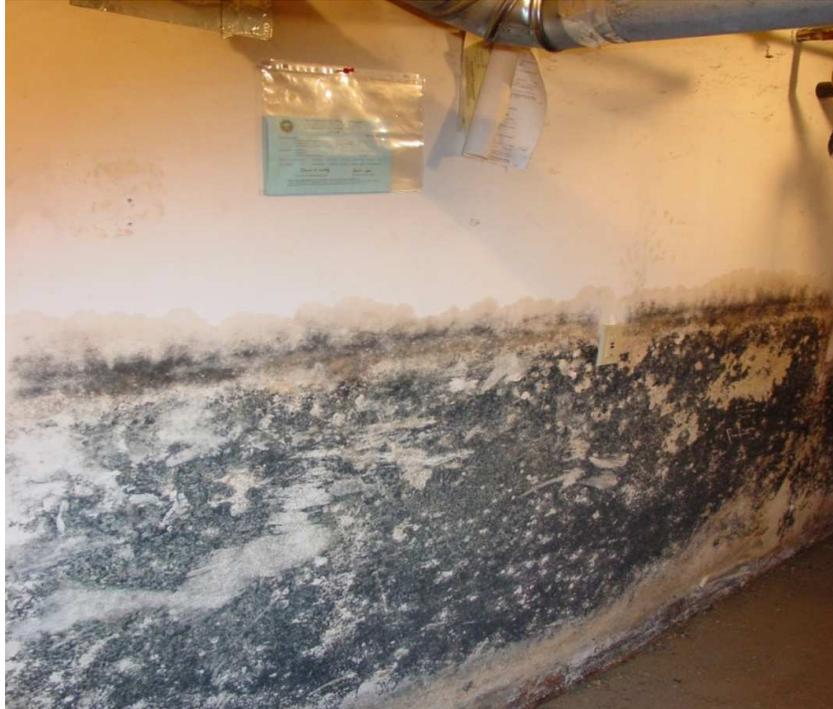
The furnace room has severe mold issues that need to be addressed immediately

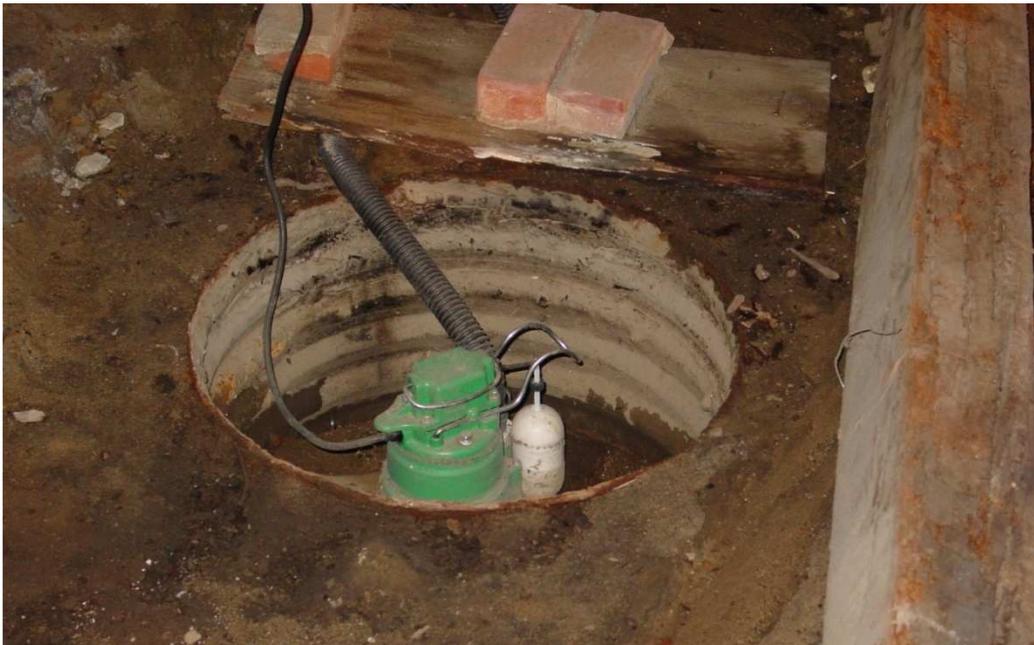
The sump pump is an area of concern relative to the water penetration issue mentioned above. The primary problems being inadequate pitch around the building and the sump pump exit pipe laying too close to and directed at the foundation. Thus, the sump pump is continually circulating the same water over and over again, wasting electricity as well as causing premature failure of the pump due to overuse.

As water comes in, it washes across the debris-filled floor and then dumps into the containment area for the sump pump, seen in the photograph. This could lead to clogging the pump.

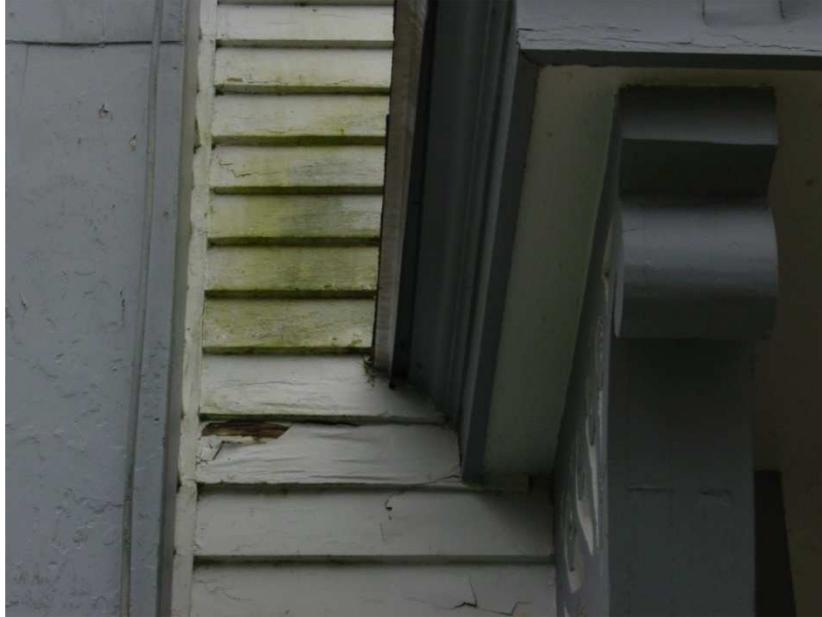
Along the front (north) wall, where the doorhood meets the clapboards, there is water damage.

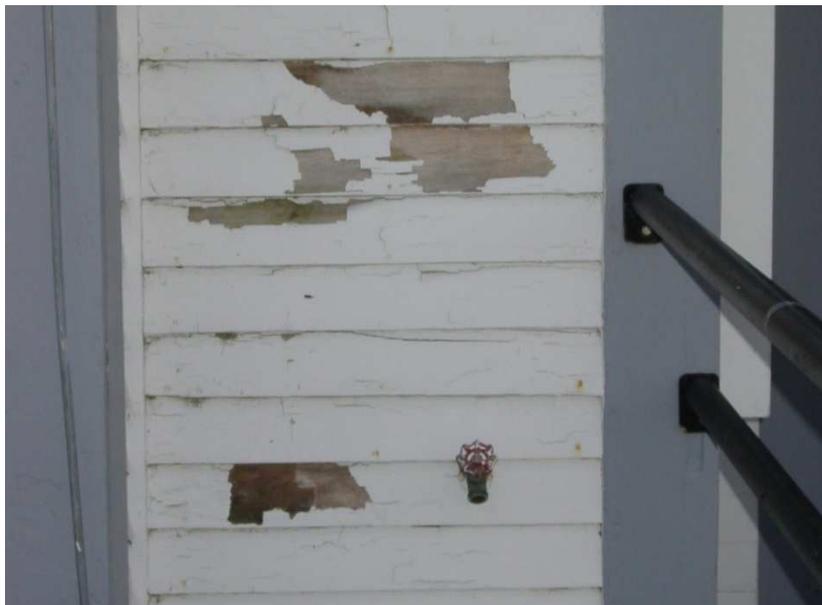
The water damage then proceeds down the wall to the left of the ramp.

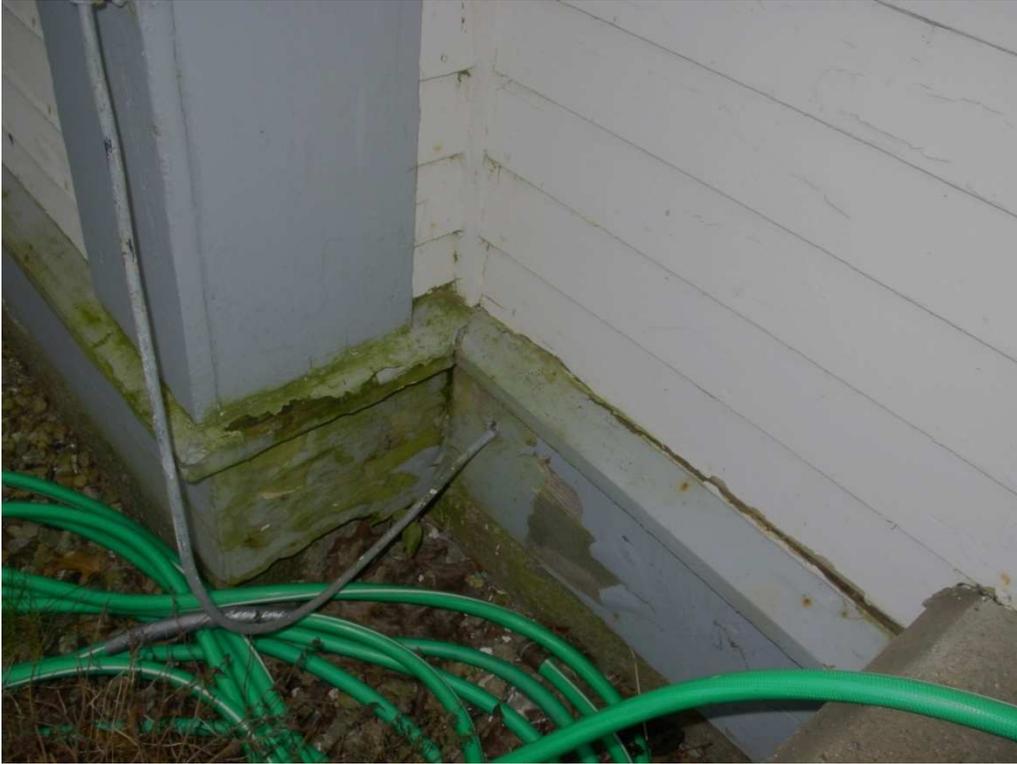
The damage continues all the way to the trim at the sill, left of the ramp.

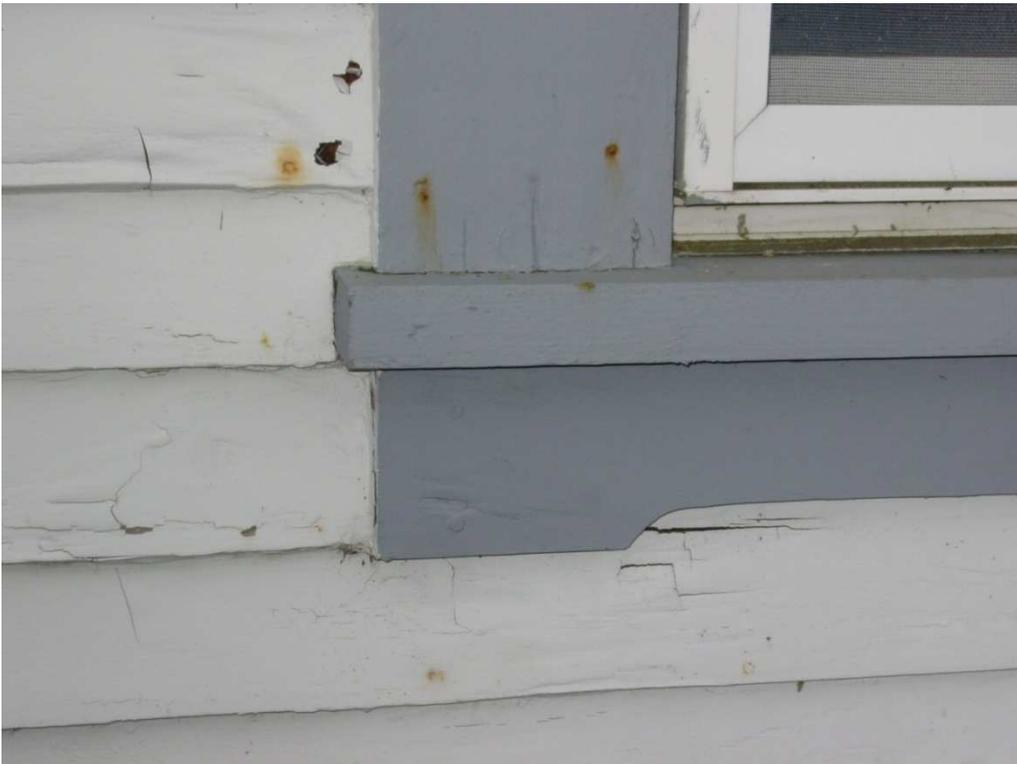
There is also damage/rot to the clapboards next to the first floor window, left of the front entrance, most likely from water infiltration at the window header. The damage surrounds the window trim and sill.

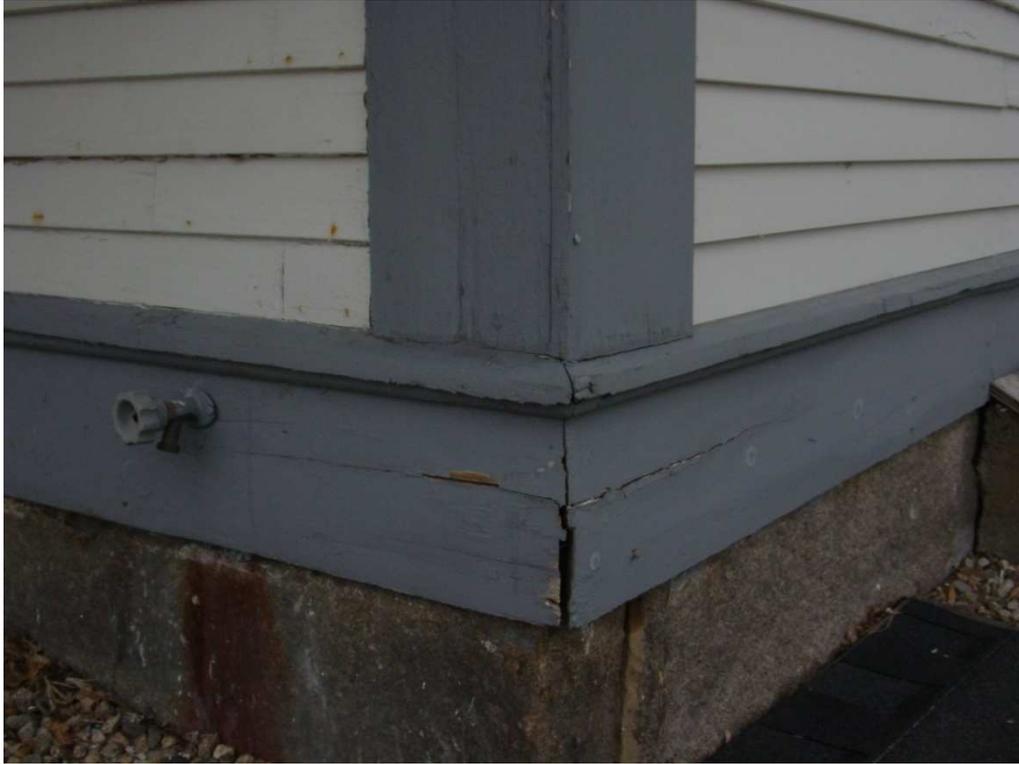
Where water has found its way behind the trim, the trim protecting the sheathing and sill has rotted. This image shows the southeast corner of the building, where such damage needs repair, especially at the water table. Because the trim is compromised, there may also be damage to the sill on this corner.

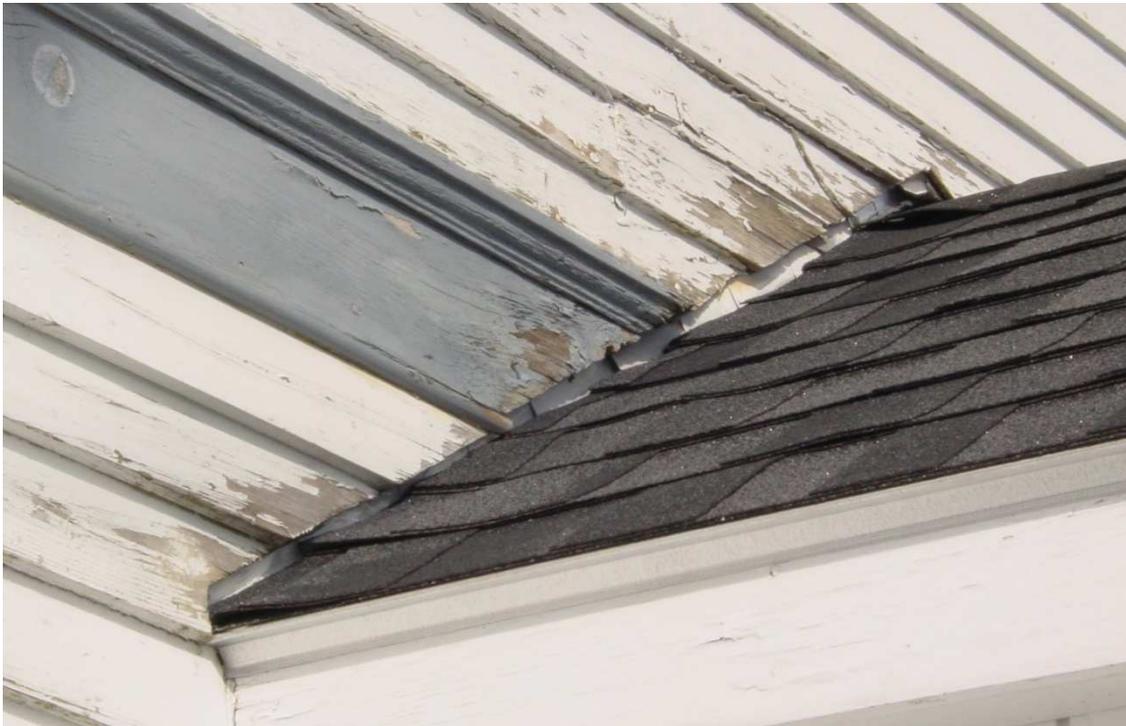
Clapboard and trim deterioration due to water infiltration can also be seen on the south wall, where the connector to the vault meets the main building.

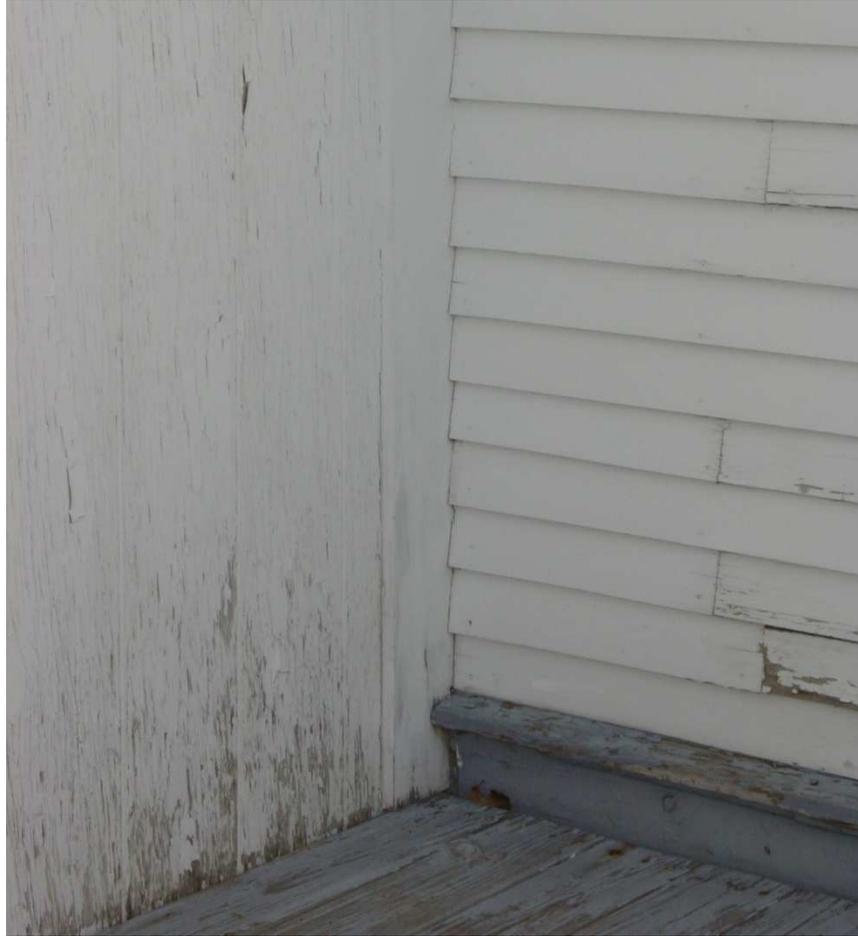
Walls on the east side of the connector and the south face of the main building are in need of repair and paint. This is likely due to a combination of water getting in and poor paint preparation.

Where there are problems with peeling paint, and after any repairs/addition of new wood siding, it is very important that the new paint application follow careful preparation of the surface. After that, a good quality paint should be applied. It is possible some of the current paint issues were caused by substandard preparation work and/or paint product.

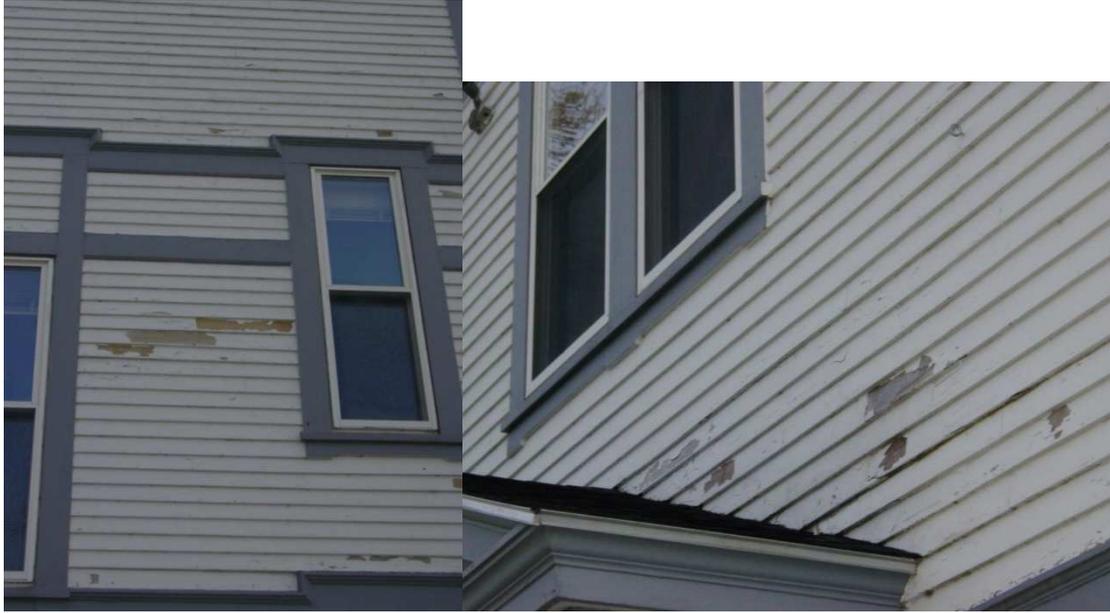
Areas of concern regarding paint on the north elevation.

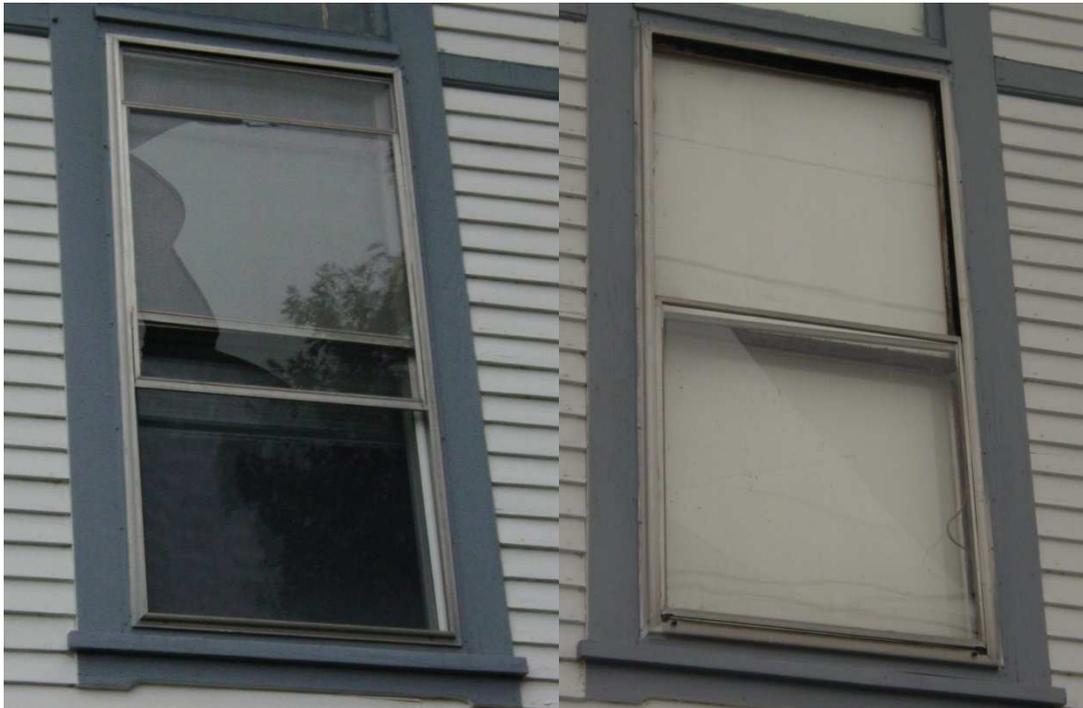
While most of the storm windows appear to close properly, there are some that are not (left) or are broken (right). The storm windows along the second floor, while still functioning, are of an older style and are not nearly as energy efficient as the newer models on the first floor.

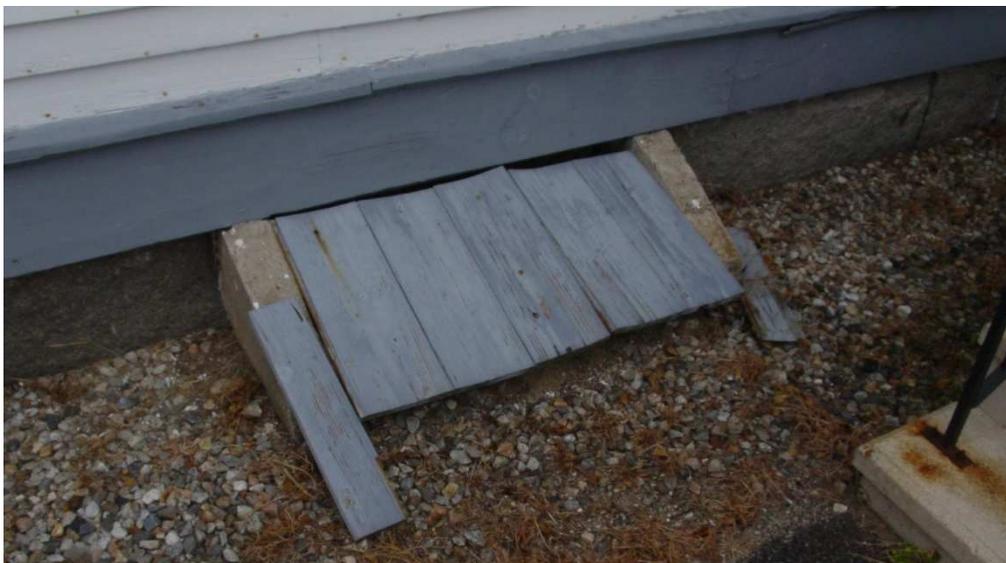
The three-light cellar sash are not functional at this time and most have been blocked-off. The covers over the window-wells (seen in this photo) are in need of attention so that they will continue to keep water out of the window-wells, and thereby keep the cellar drier.

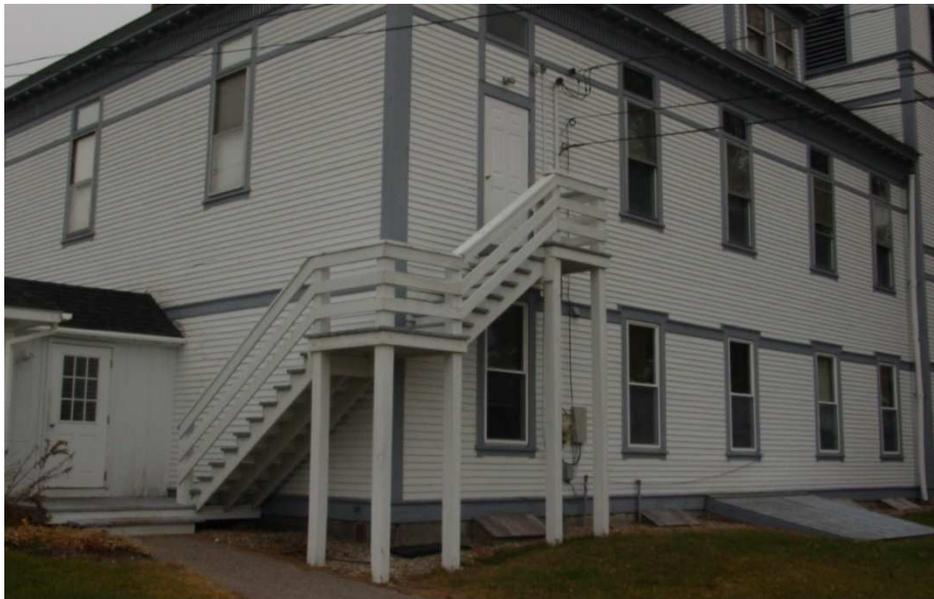
The fire escape on the southeast corner of the building.

The wooden fire escape at the southeast corner of the building shows signs of deterioration due to exposure to inclement weather. Although this fire escape has been “grandfathered,” it does not meet current life-safety code requirements. Current code requirements would require the fire escape be built out of fireproof materials and also be covered and or enclosed. Also, the glass in the first-story window underneath the landing needs to be changed to prevent exploding glass from a fire in that area. Expanded public use on the second floor would require these upgrades to the fire escape.

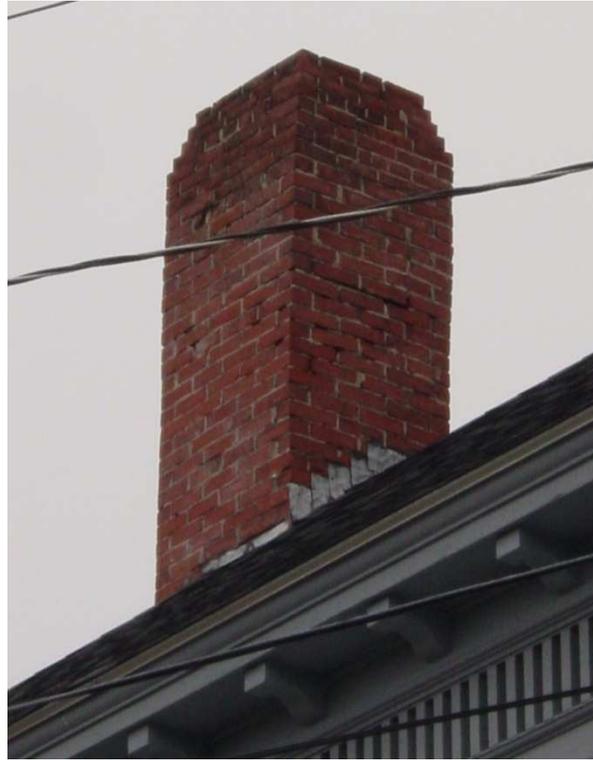
The chimney is used by the furnace in the furnace room. Overall, the chimney appears to be in good condition, with the exception of the chimney area above the roofline. The cap (on the top of the chimney) has failed and the bricks and mortar of the chimney itself have been patched several times. The chimney should be rebuilt from the roofline up.

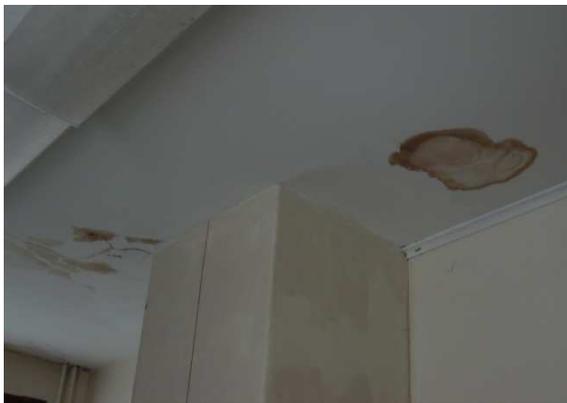
There is some staining in the ceiling around the chimney stack on the first and second floors, caused by improper flashing and/or moisture penetration in the mortar joints or through the brick itself. This damage may be old and has been since resolved with the new roofing and flashing, but given the condition of the chimney cap as noted above, additional damage could occur at any time.

Damage to the ceiling near the chimney.

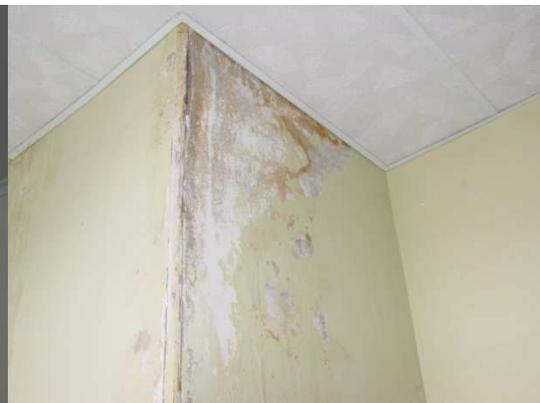
Water stains on the plastered chimney face.

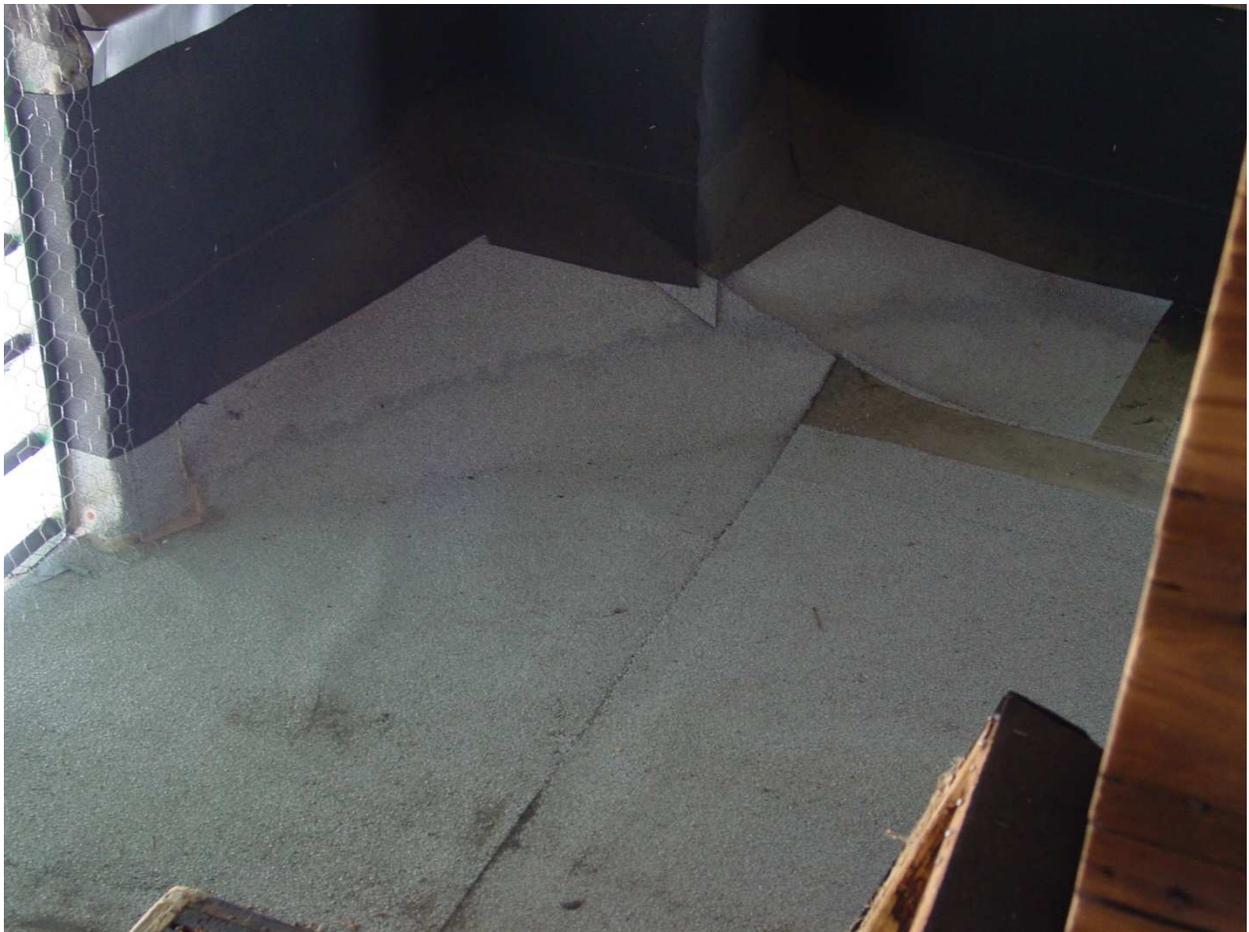
View of the deck inside the tower. At left is one of the vents where water can escape. The light-colored material on the deck floor is asphalt roofing. The piece in the top right of the image has shifted out of place.

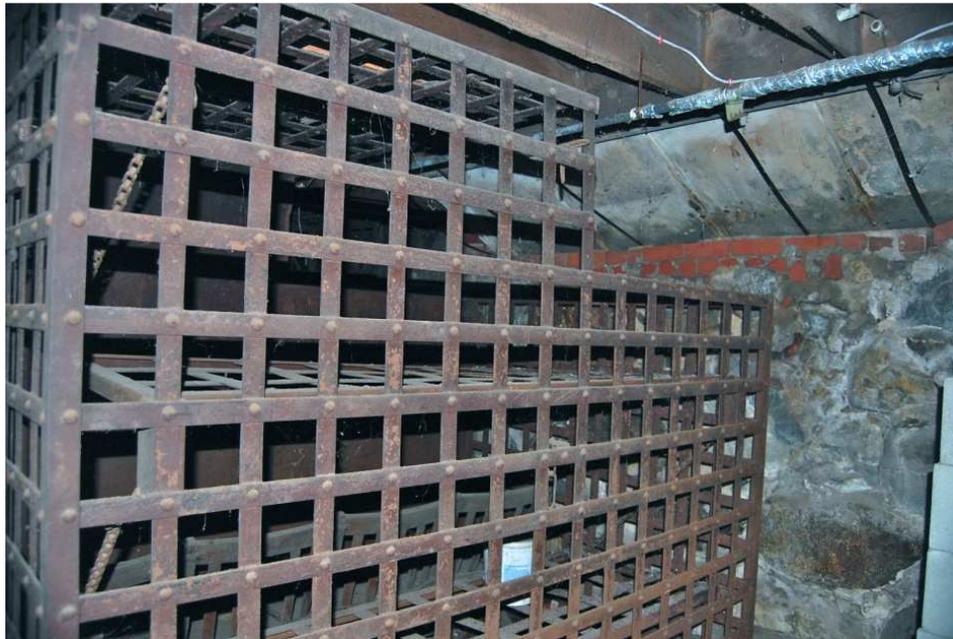
When the front entry ramp was installed in 1987, the rear sections of the cell walls were cut away.

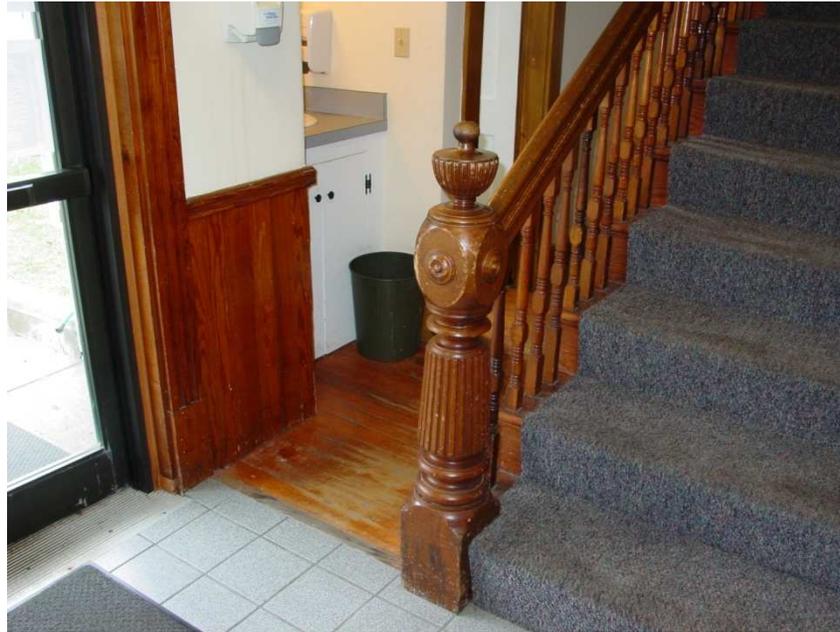
The hallway leading to the sink and two bathrooms at the front of the building is not ADA compliant.

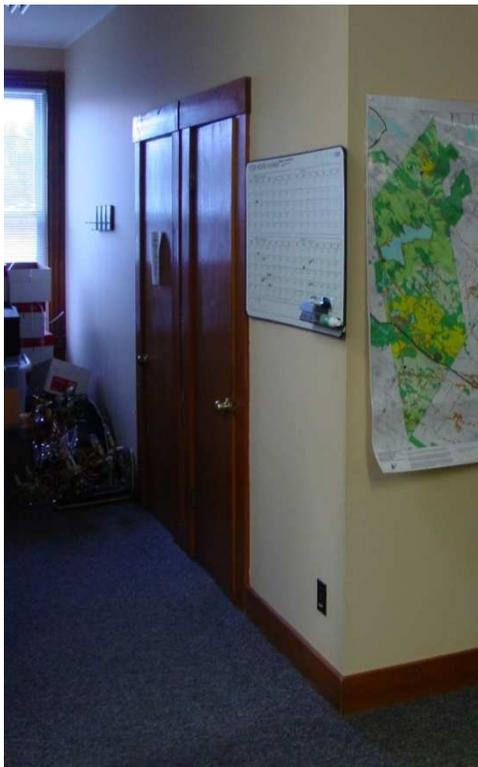
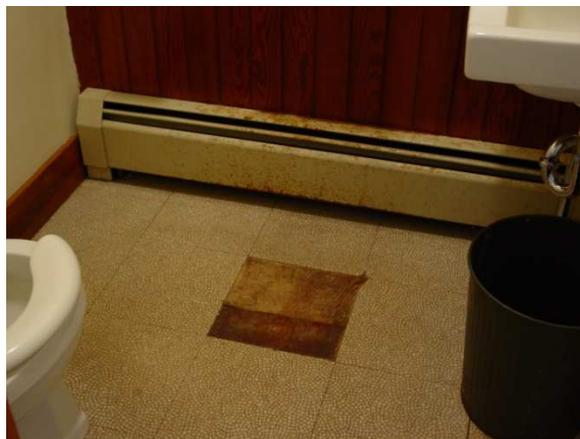
The photograph at left shows the hallway and entrances to the two bathrooms near the meeting room. The photograph below shows some of the repairs needed to these bathrooms, such as the deteriorated floor with missing tile and rusted baseboard heating. The location of these bathrooms is not ideal, as they open up directly into the meeting space.

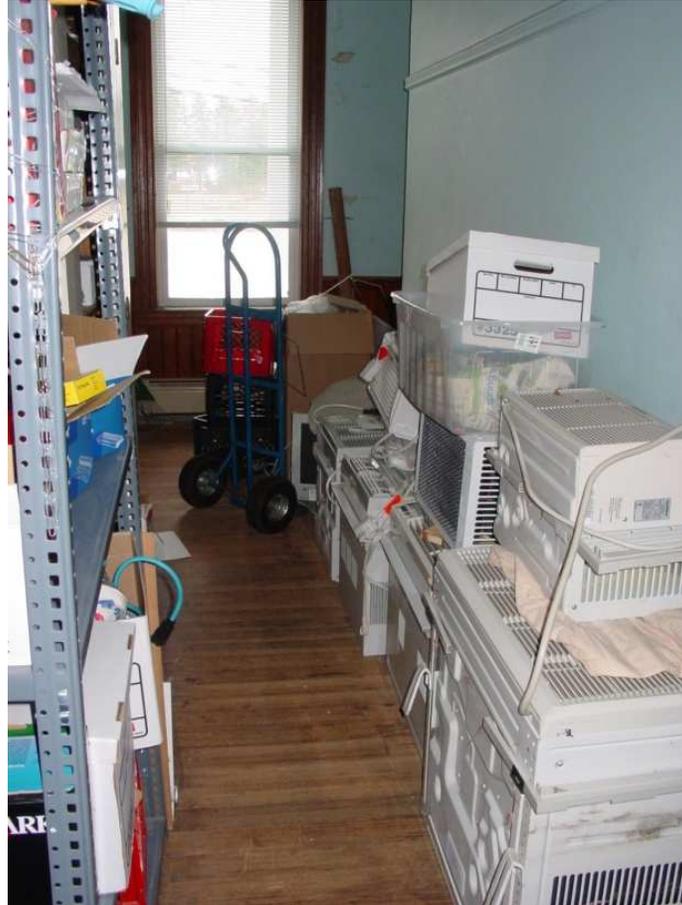
When the air conditioning units are removed during the fall and stored in the building, they are stored in hallways and other spaces that should be kept clear for safety reasons.
