Town Facilities Plan

Town of New Durham New Durham, New Hampshire

AGA Project No. 19-761
30 March 2021

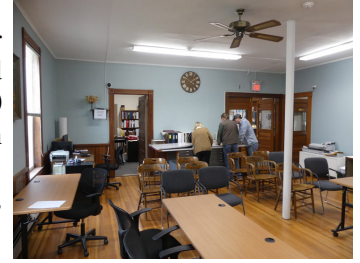
- Selectmen Meeting Room (First Floor): Desired capacity for Selectmen’s meetings, Planning Board, Zoning Board and other committees and commissions is approximately 70 persons, compared to the approximate 20 persons now with tables and chairs. Additionally the room has work space and files around the perimeter, due to the lack of space elsewhere, and includes a column in the center of the room.

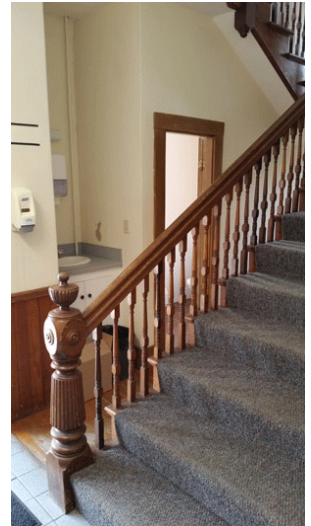
- The existing front stair railings are low in height and do not provide proper handrails. Both the height and shape for the stair handrails should be changed to improve life safety.

It is recommended that upgrades for life safety be identified and incorporated into any renovations planned for the Town Hall.

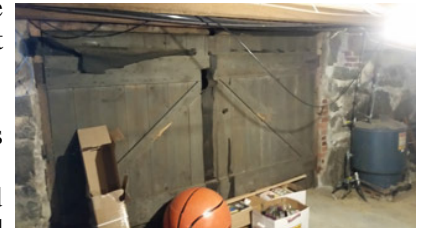
- The Records Room behind the Town Hall was noted to be lacking insulation at the roof.

The improvements necessary to properly insulate the Town Hall could be accomplished during a renovation of the building or as an independent project in order to improve energy efficiency.

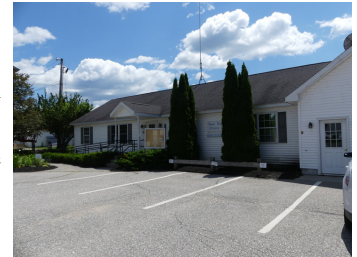
- The Police Station does have a ramp with railings leading to the front entrance as required.
- The second exit to the rear should also be accessible with proper clearances at the door.
- There should be an accessible route from the secure garage to the booking area that does not require traversing stairs.
- The interior corridor is too narrow to provide proper clearance and access to doors along the corridor.
- Door hardware throughout the facility should be lever hardware in lieu of knobs.
- The front entrance is required to have an automatic door operator by State Building Code.
- The Men and Women's bathrooms do not appear to be fully accessible with required clearances and fixtures.

It is recommended that the Town either prepare a study to address accessibility issues in the short term and establish a time line for compliance, or that these issues be incorporated into any renovation or other use planned for the existing Police Station.

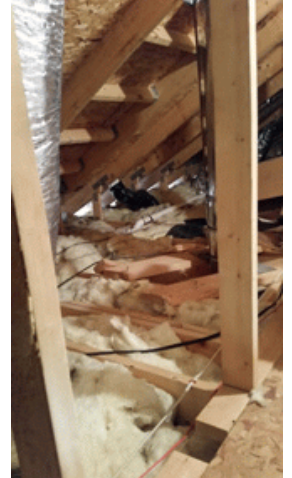
- There are ridge and soffit vents on the Police Station building. This indicates that the attic is ventilated and is what is called a "cold attic". The concern with energy performance is that the air handler and ducts for air conditioning are located in the attic space, which can be very hot in the summertime. This affects the overall performance, especially with the impact on the air temperature in the ducts and flexducts running through the attic.

- The attic insulation is poorly fitted between the truss bottom chords, which are 2 x 8 members. The insulation appears to be 6 inches thick; the R-value for this thickness insulation is not very high, probably in the R-15 to R-19 range, compared to current code requirements of R-38. The loose fitting attic insulation also likely results in significant energy loss.

- There is no insulation in the crawl space, either at the floor or at the foundation wall. There is bound to be a fair amount of energy loss through this space, and it likely affects the comfort at the first floor.

- The boiler is located in the uninsulated crawl space, and the hot water pipes are not insulated. Again, this will have an impact on energy performance.

The improvements necessary to upgrade the insulation in the Police Station could be accomplished during a renovation/expansion of the building or as an independent project in order to improve energy efficiency.

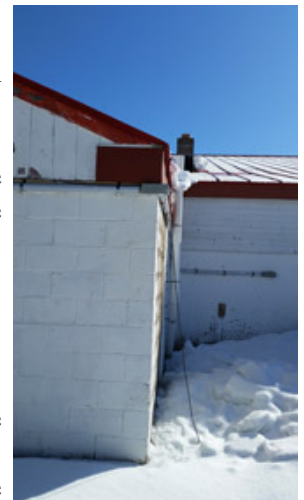
- The structural report completed in May 2003 notes that a majority of the walls are cast-in-place concrete to a height of six feet, with concrete masonry units above to a height of fourteen feet. There is concern that the

CMU walls are not sufficiently reinforced, which is a major concern when evaluating risk for a Class IV essential facility.

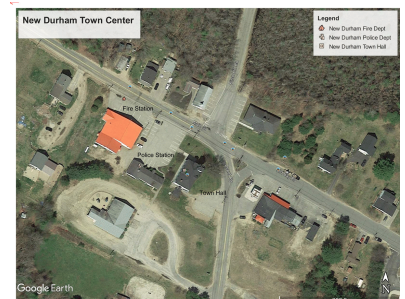
The Fire Station shares a 1.5 acre site with the Town Hall and Police Station, and the site issues described for the Town Hall apply to the Fire Station. Parking for all three facilities is maxed out at 24 spaces plus two handicapped accessible spaces. On-call and volunteer firefighters responding to a call drive to the Fire Station and may find a lack of available parking on site when they arrive because spaces may be taken by other user, especially for Town meetings and use of the Community Room by other Town groups. This is a serious concern when time is lost finding space to park, which is especially critical in responding to an emergency.

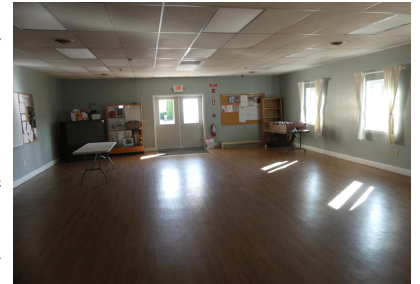
- The Community Room rear corridor is too narrow to provide proper clearances at door in the corridor, and the two bathrooms do not meet accessibility requirements.

It is recommended that the Town consider whether improvements to the Fire Station are warranted, including resolving accessibility issues, or if it is more appropriate to construct a new facility that incorporates current standards.

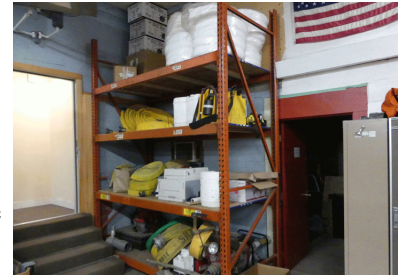
- There is a definite lack of an adequate number of toilet facilities for the Community Room and Fire Station.
- The stair to the second floor needs to be evaluated in terms of fire rating, only one stair, and egress through the apparatus bay.

It is recommended that upgrades for meeting life safety requirements be identified and incorporated into the fire station if it is not replaced in the near future.

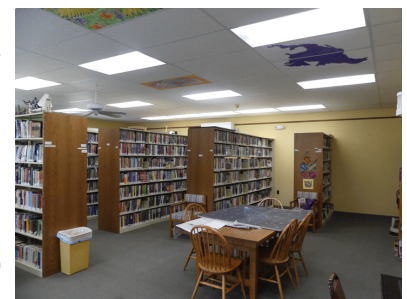
- The Stack/Reading Room needs additional space to accommodate more DVD's, an additional 1,000 - 2,000 young adult and adult volumes, additional reading tables, and more public computer stations.

- The DVD collection is very active and can expand, except that additional space for shelving is needed.
- Supplies and equipment are currently kept throughout the Library, including in a corner of the Stack/Reading Room. A storage room is required.

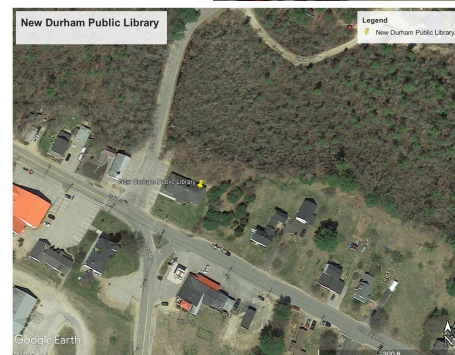
The current Library site is approximately 1/3 of an acre, with the Library located in the center, a well on the Northeast corner, and piping to a septic tank on the Southeast corner. The site is clear of trees in the center and is slightly raised in the center, then drops off several feet on all sides. There are woods behind the building to the North and East. Parking for a total of nine parking spaces, including one handicapped accessible space, is provided on the West side of the building via perpendicular street parking on Birch Hill Road. Refer to the site plan below.

The Library site is not designated as wetlands, but the existing building is positioned mostly within the current Town zoning vegetative buffer strip required adjacent to wetlands.

Expanding the building on the current site in accordance with Town zoning and setback requirements is only possible in the front of the building. Expanding to the East might be feasible with the purchase of land to that side, but that location practically benefits only the Children's Room and could affect well and septic systems. There are wetlands on the adjacent Russell Weldon property to the rear (North), approximately 70 feet from the rear of the building. The preferred expansion direction is to the rear of the building (North), which would require land from the adjacent property owner Russell Weldon, and a waiver or variance to build into the vegetative buffer strip. It should be noted that the Town has approved moving ahead with a land swap with this property owner in order to provide additional land for possible expansion to the rear of the Library. Expansion to the rear would benefit all areas of the Library, including the Stack/Reading Room, Children's Room and staff support spaces.

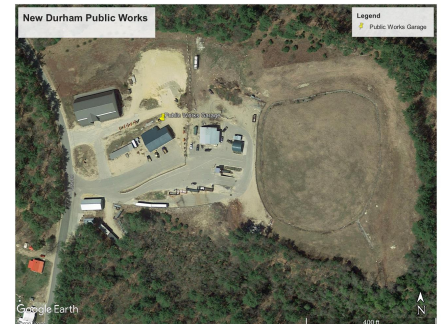
The Public Works site is a 27 acre site located on Tash Road. The site includes the previous landfill, now capped, and now serves as the Town’s transfer and recycling center. The site functions fairly well with garage vehicular traffic separated by a fence from the recycling center used by the public. The site is relatively flat with minor grade variations. As mentioned previously, the site contains other structures including the recycling garage, salt shed, spreader storage shed, several recycling storage canopies, two small general storage sheds, truck storage, a fuel tank enclosure with fuel tanks and pumps, and an outdoor sand storage area. There are several small parts of the site towards the South that contain wetlands, but the majority of the site is useable land. There is a drilled well adjacent to the garage, and a septic tank on site.

There is capacity on the site for expansion of facilities.

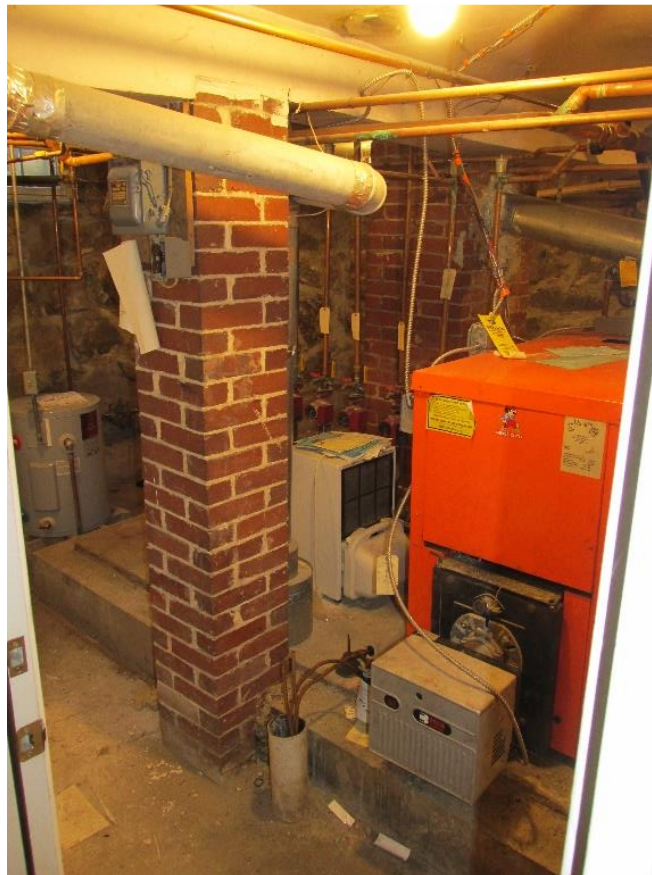
Town Hall Boiler Room

Building heat is sourced from an oil-fired cast iron sectional boiler of 420 MBH input manufactured by Pensotti of Italy. The burner is a Riello rated for a nominal 3.0 gallons per hour. Net output rating of the boiler is 311 MBH. Combustion air is provided by a dedicated fan ducted into the basement space.

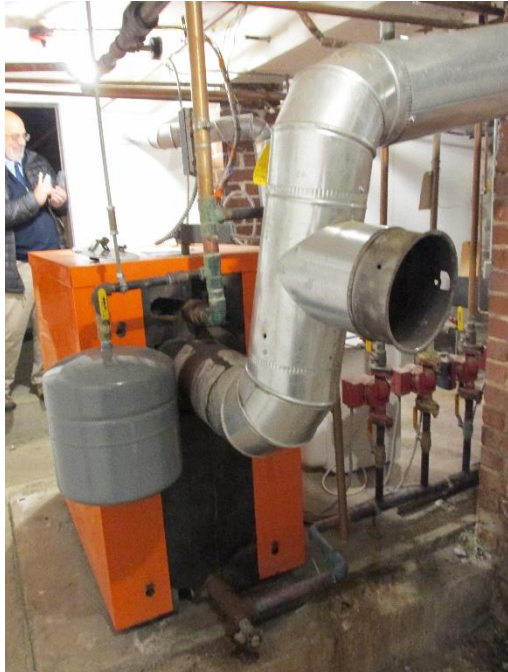
Town Hall Boiler Room - Connections

The boiler P&T relief valve is not installed on the boiler proper, but on the outlet pipe. The hydronic expansion tank is not installed at the air scoop, but at the boiler outlet. The make-up water connection is connected to the return manifold but should be connected at the air scoop/expansion tank location.

| 5. Re-pipe boiler in accordance with manufacturers recommendations and code requirements..... | Code |

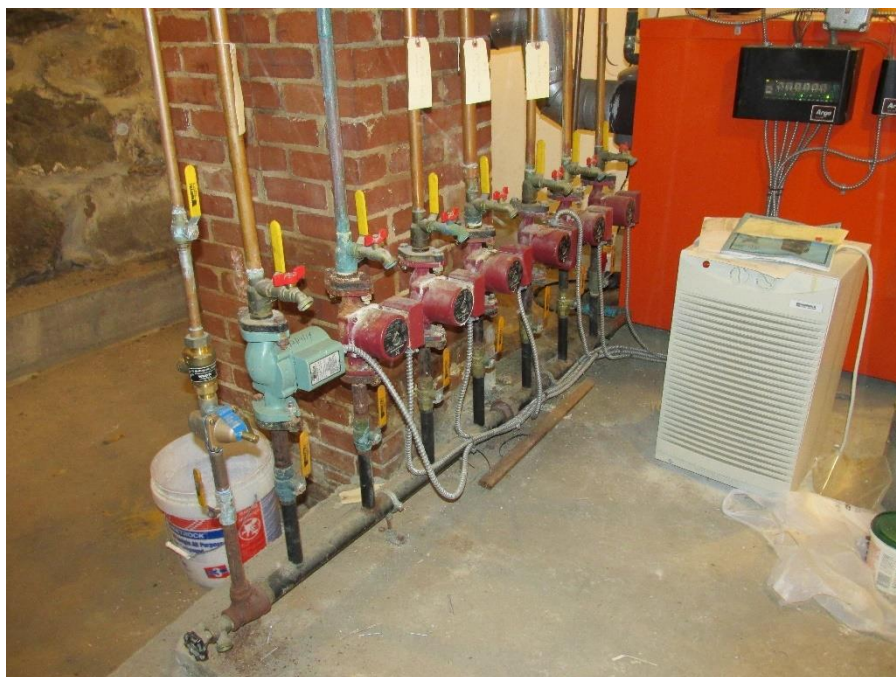
Town Hall Boiler Room - Zone Pumps and Make Up Feed

Seven zone pumps mounted to the return manifold serve the base board heat system throughout the building.

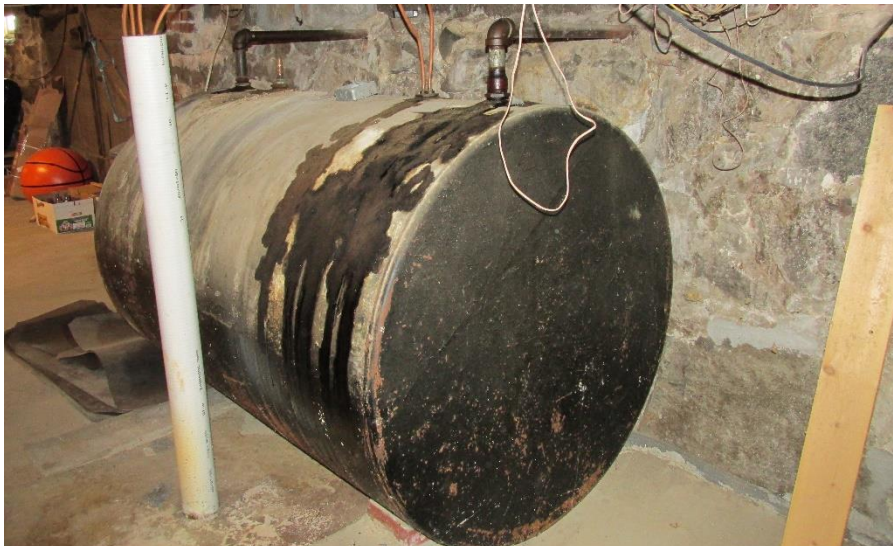
Town Hall - Fuel Oil Tank

Fuel oil storage tank does not appear to be UL Listed & Labeled in accordance with code requirements. Tank vent pipe connection shows evidence of leaking when tank is filled. Leak appears to be coming from vent whistle fitting. Fuel oil supply and return tubing appears kinked and are not “continuous” runs from tank to burner. Fuel oil tubing is not supported at tank and is not a corrosion resistant coated copper product as required by code. Two abandoned in place copper tubes run through the underground conduit to the boiler room along with the in-service lines.

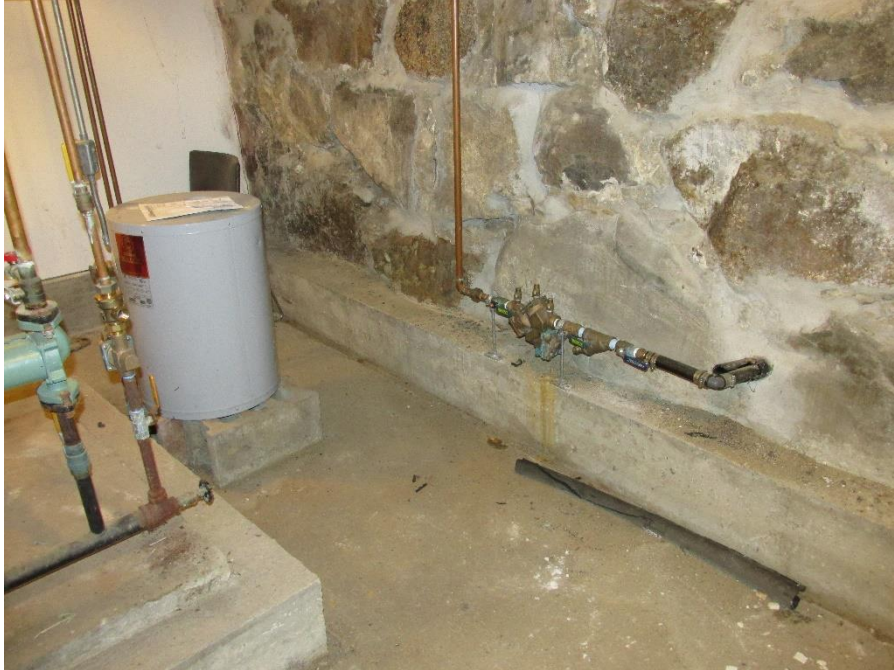
Town Hall Boiler Room - Domestic Water Entrance

The Town Hall domestic water entrance is located in the boiler room against the rear foundation wall. A 1" polyethylene (PE) pipe connects to the strainer/back flow assembly and then to a 3/4" copper pipe. This is the only backflow preventer fitted to the three buildings which share the well.

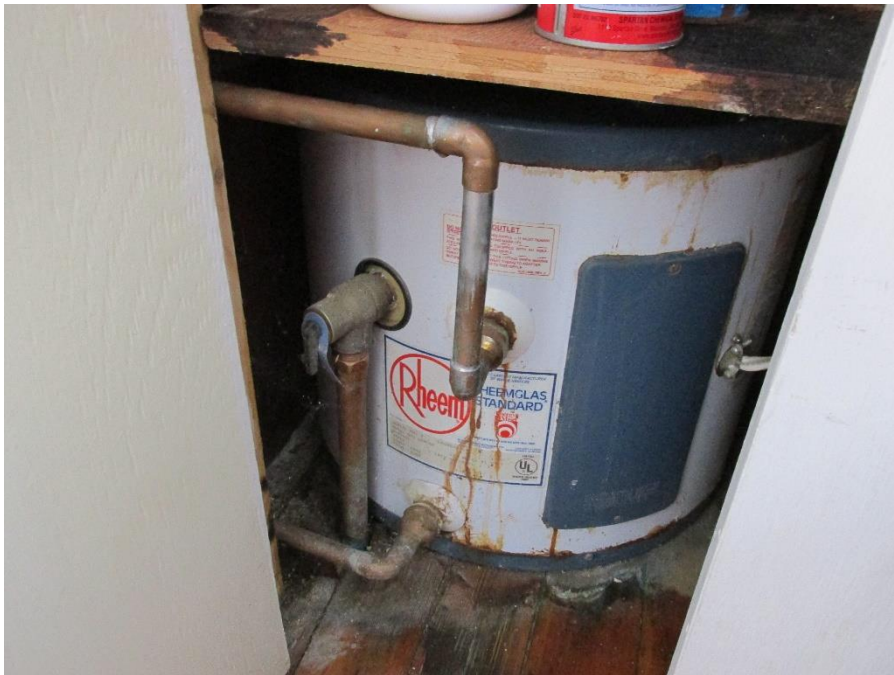
Town Hall Main Floor - Entry Lavatory Water Heater

Domestic hot water for the main entrance toilet room is sourced from a 6 gallon electric water heater located in the cabinet under the sink.

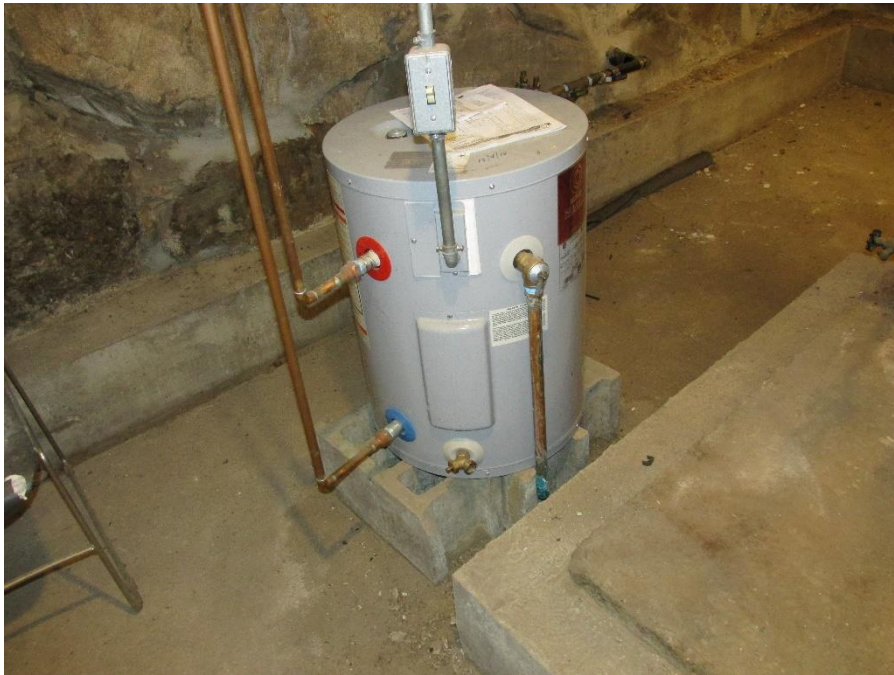
Town Hall Boiler Room - Water Heater in Boiler Room

Domestic hot water for the meeting room toilet, kitchenette, and laundry tub is sourced from a 19-gallon electric water heater located in the boiler room.

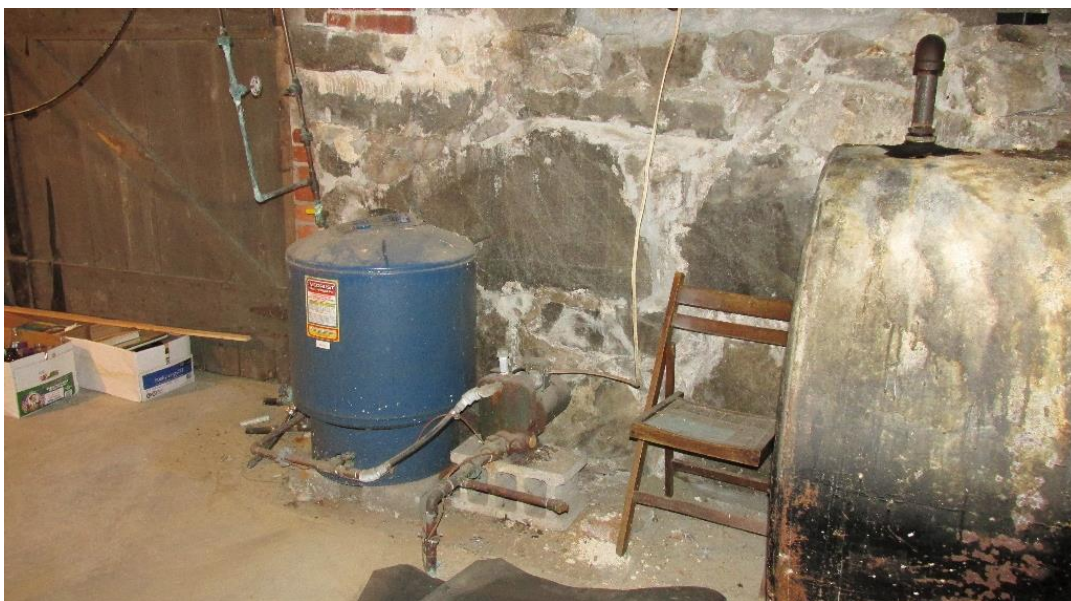
Town Hall Well Entrance Abandoned in Place

A vintage well pump, expansion tank, and piping is abandoned in place on the Depot Road-side of the basement. It is not known if this equipment is connected to the in-service domestic water system. In any event, this equipment must be disconnected and made safe, removed and disposed of properly, and the electrical removed all the way back to the distribution panel.

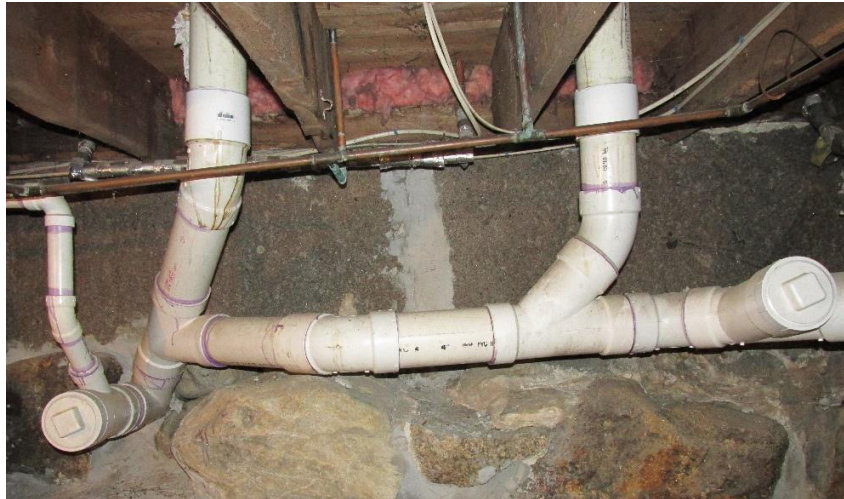
Town Hall Basement - Sanitary Main at Front

The 4" PVC sanitary drainage main exiting at the front foundation wall (Main Street side) terminates in an unknown location. Snow cover prevented locating the assumed septic tank during this visit. Two 4" PVC risers from the main go up through the ground floor along with a 2" drain serving the lavatory sink at the front of the building.

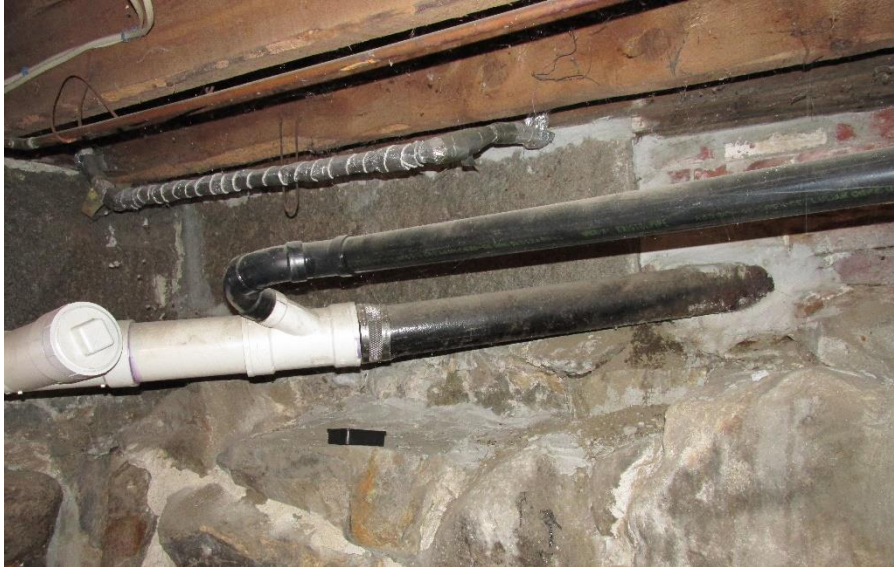
Town Hall Basement - Backward Sanitary Main Fitting

The PVC to Cast Iron joint is at a 4x2 wye fitting installed backwards. Also, the 2" branch pipe is ABS plastic, which is not compatible with PVC plastic. The joint may be glued, but it is not an acceptable joint. A transition coupling is required when joining two different plastics.

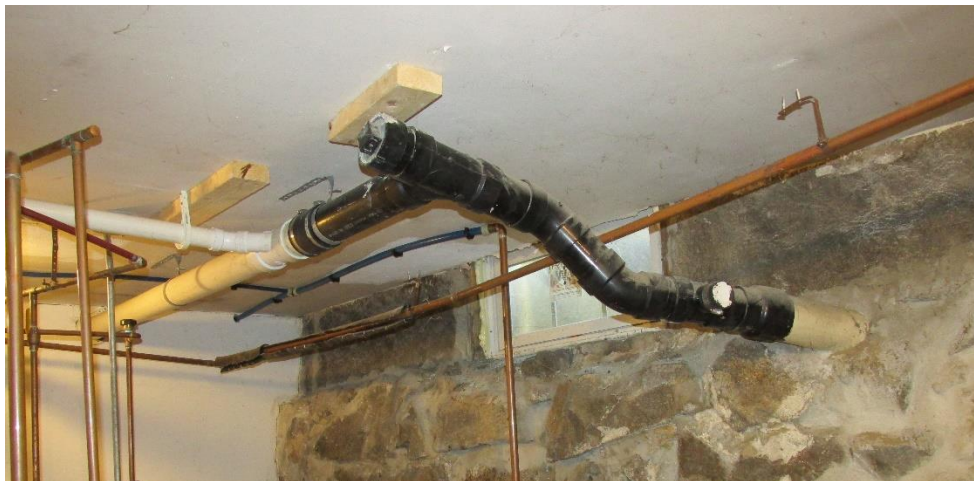
Town Hall Boiler Room - Sanitary Main Exit Rear

In the boiler room, a second 3" sanitary main exits the rear foundation wall. Again, ABS plastic is improperly joined to PVC plastic. The 4" PVC main through the foundation wall terminates in an unknown location.

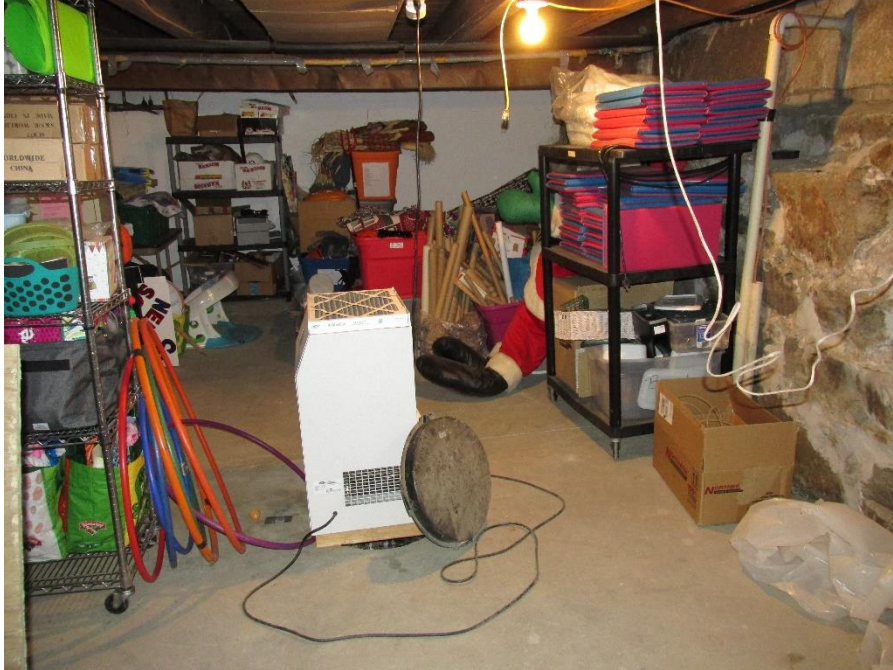
Town Hall Basement - Sump Pump West

Two sump pumps are located in the basement floor: one on the west side of the main basement space and the other in the boiler room. Discharge from the west side sump exits the foundation wall above grade on that side of the building. Discharge from the boiler room sump pump is through the foundation wall in the southwest corner of the building.

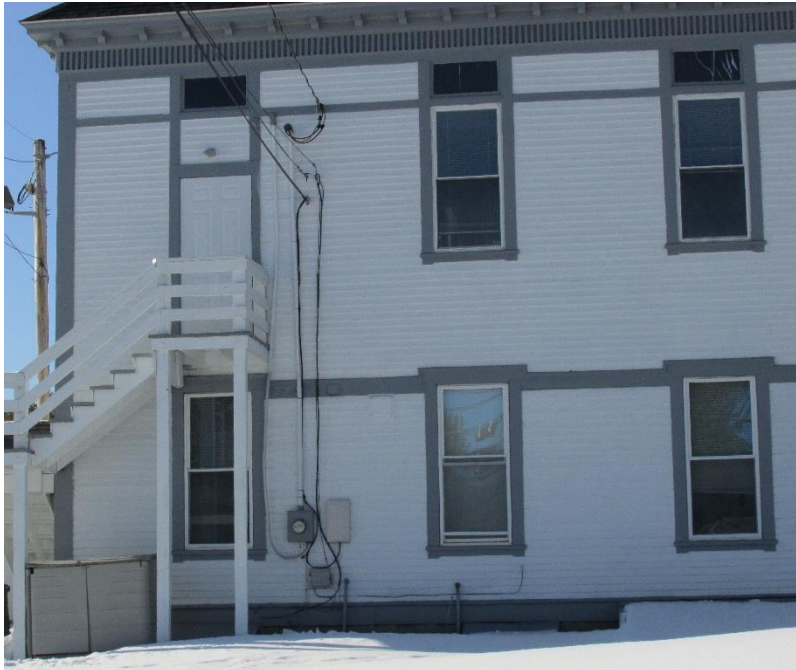
Town Hall Exterior - Electric Meter and Fuel Oil Fill & Vent

Electric power for the building is via overhead wires from a pole-mounted transformer on Depot Road to an electric meter on the outside of the building.

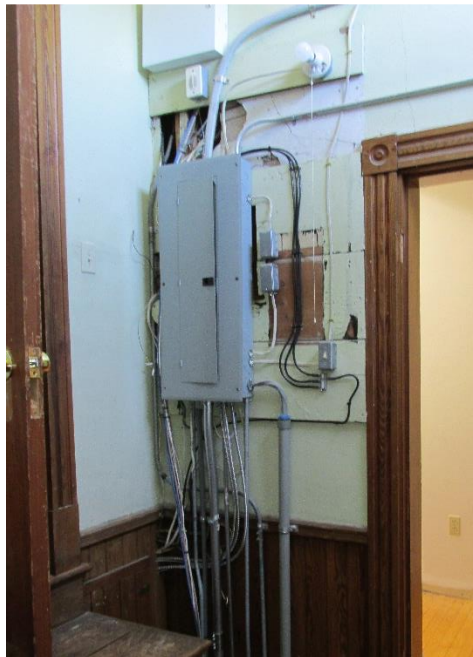
Town Hall Upstairs - MDP on Second Floor Landing, Rear

Power from the electric meter runs through an unsecured cable up the outside of the building to 200A Main Distribution Panel (MDP) on the second floor landing of the rear stair tower.

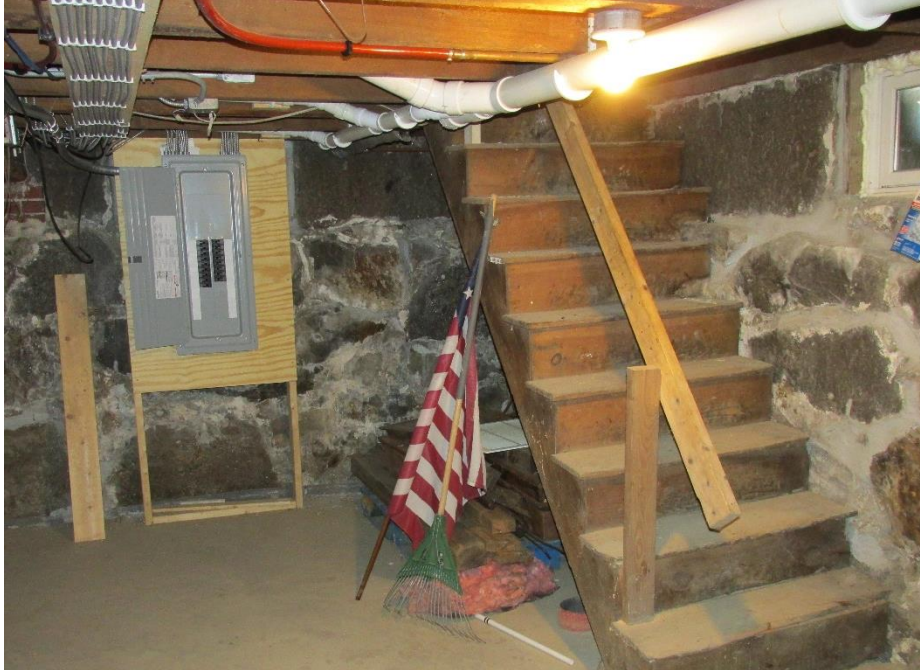
Town Hall Basement – Electrical Distribution Panel in Basement

From the MDP conduits and cables run down to the main floor and basement distribution panels, which are adjacent to or below the rear stair tower.

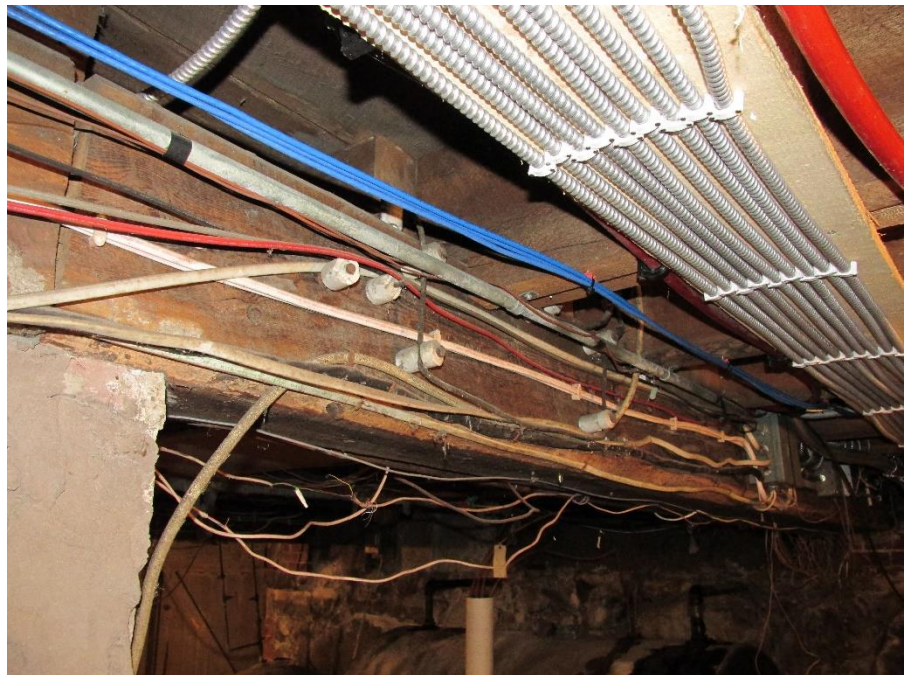
Town Hall Basement - Variety of Vintage Conductors

A variety of vintage electrical conductors are visible throughout the basement. It is not known if these circuits are live or abandoned in place.

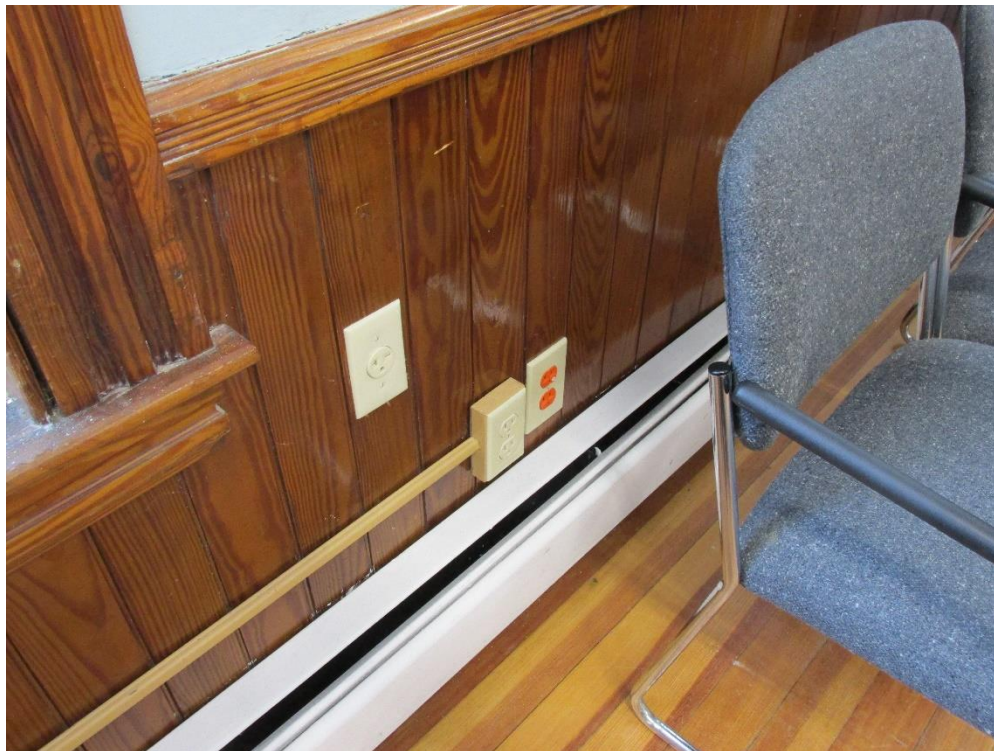
Town Hall Main Floor – Electrical Power Outlets

The central meeting room on the main floor exhibits three distinct but unlabeled electrical power outlets.

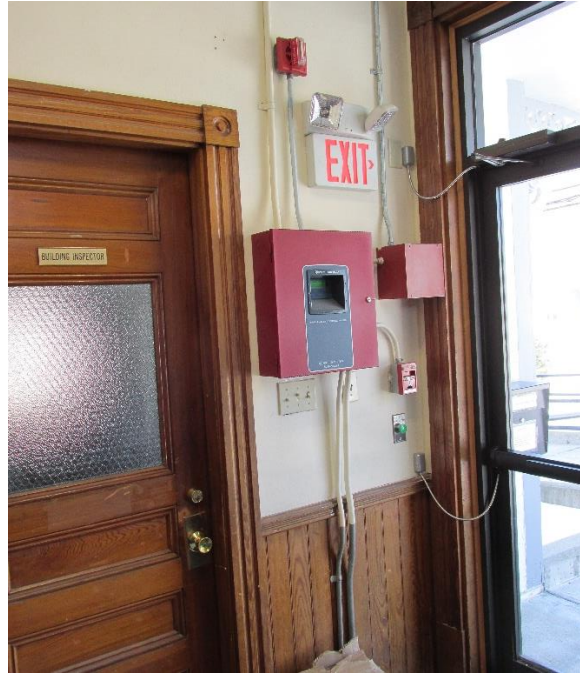
Town Hall - Fire Alarm Panel

A Honeywell fire alarm system is installed and reported as functional. The control panel is located in the main entrance foyer. There is no automatic fire protection/sprinkler system installed in the building.

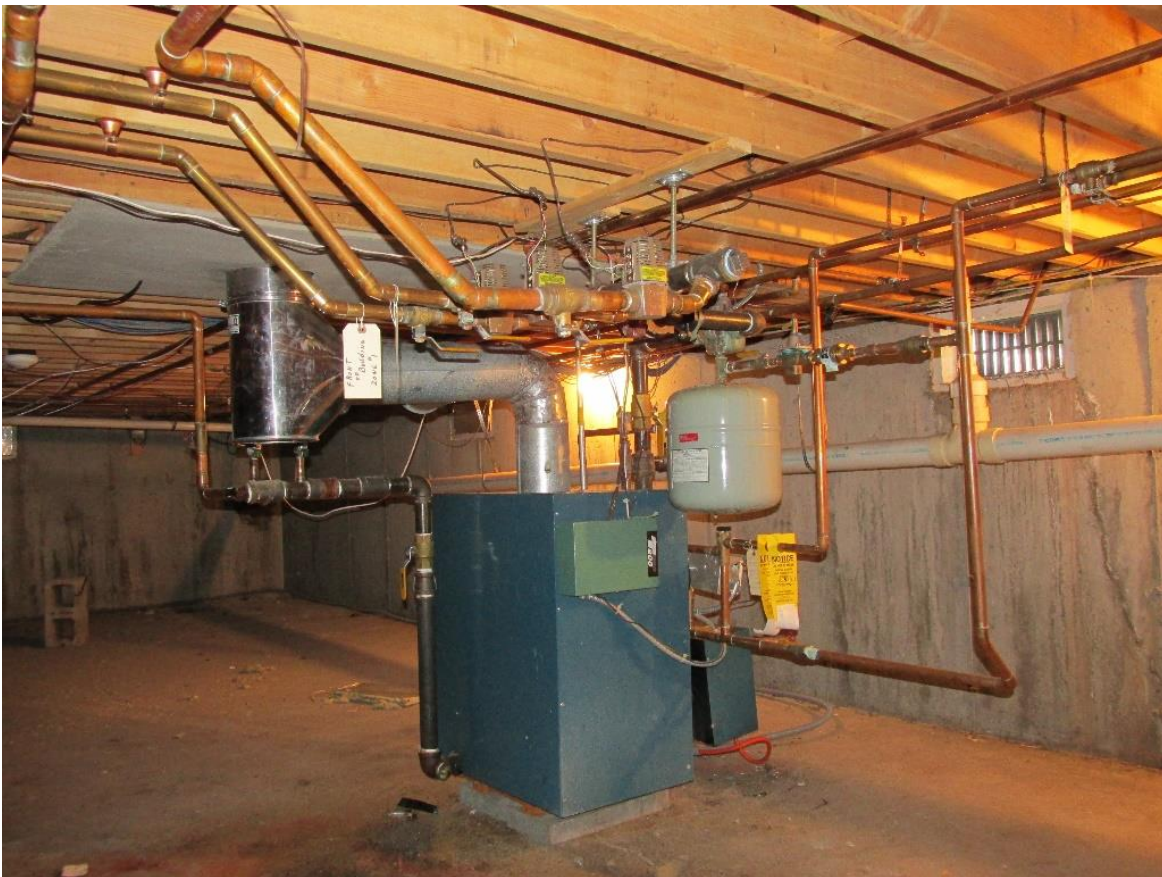
Police Dept Crawl Space - Oil Fired Hot Water Boiler

Building heat is sourced from an oil-fired cast iron of 109 MBH output manufactured by Burnham in October of 2000. System piping includes one circulator pump and three zone valves. The boiler and distribution piping are located in the basement boiler room. None of the heating system piping was insulated.

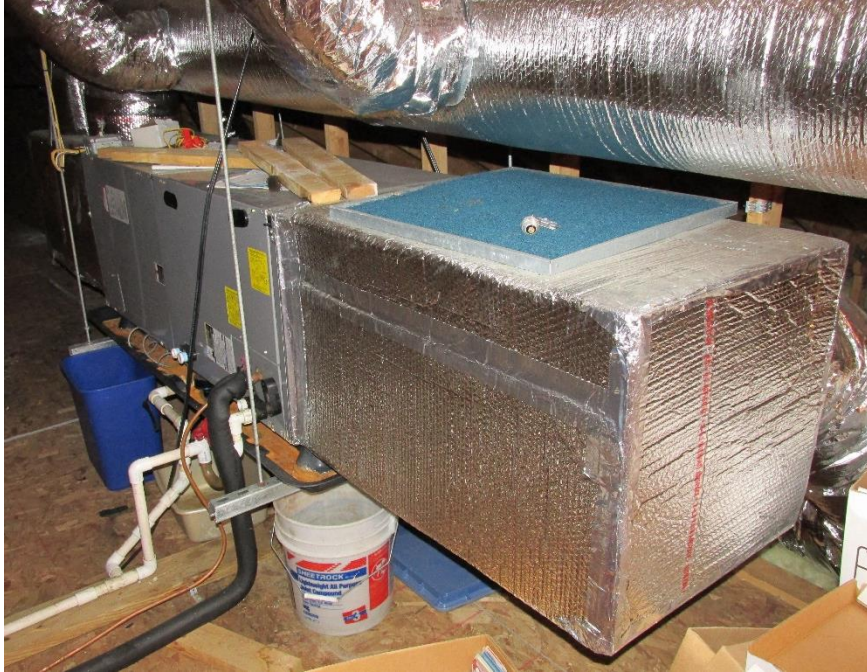
Police Dept HVAC - Air Handler in Attic Space

A split system air conditioner system is present with the air handler installed in the attic and condensing unit outside at ground level behind the building. This appears to be a nominal 4 Ton capacity system manufactured in June of 2008.

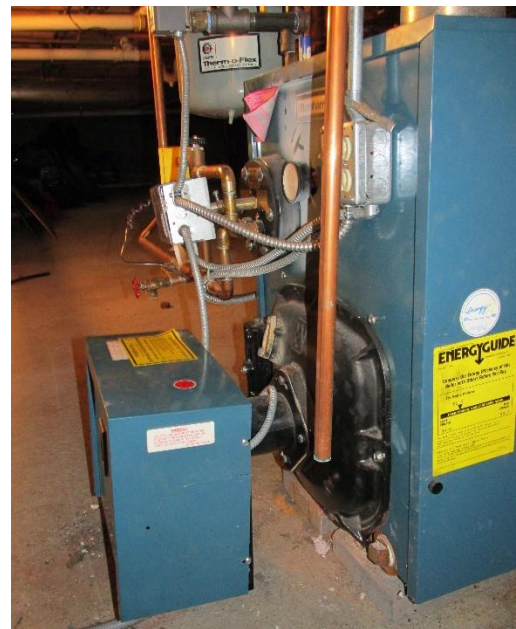
Police Dept Crawl Space - Boiler Front Showing Tankless Coil

Domestic hot water is sourced from an indirect coil mounted in the boiler.

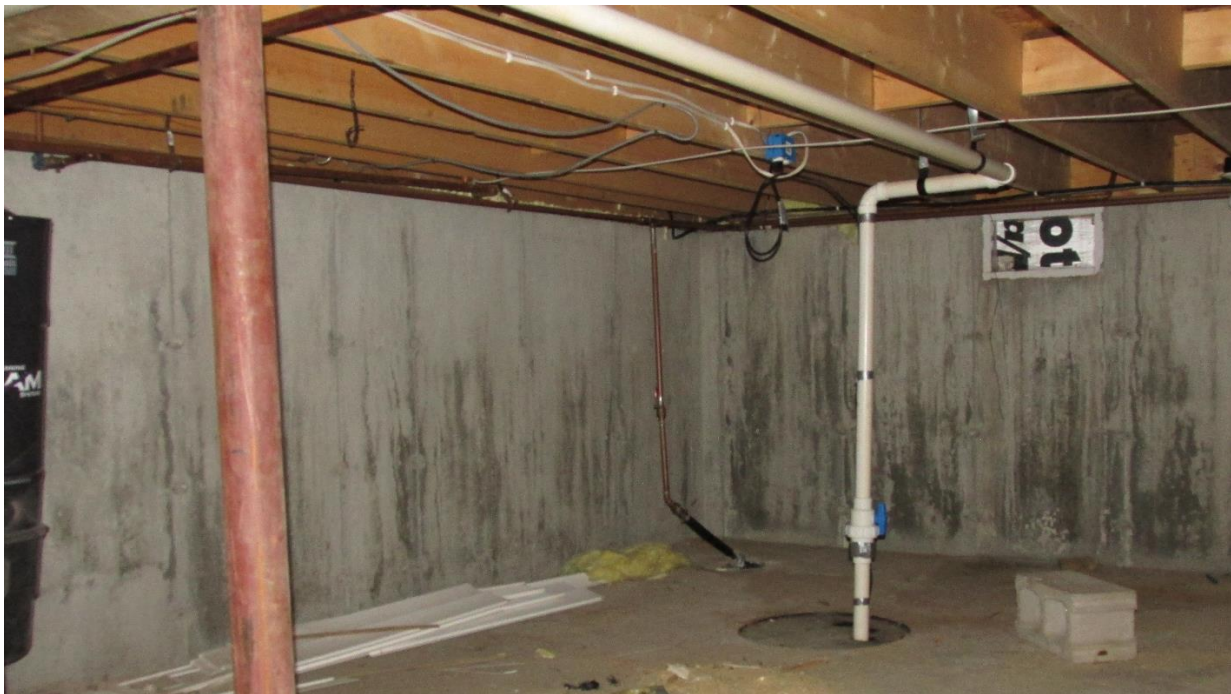
Police Dept Crawl Space - Domestic Water Entrance and Sump Pump

One sump pump basin is built into the basement floor.

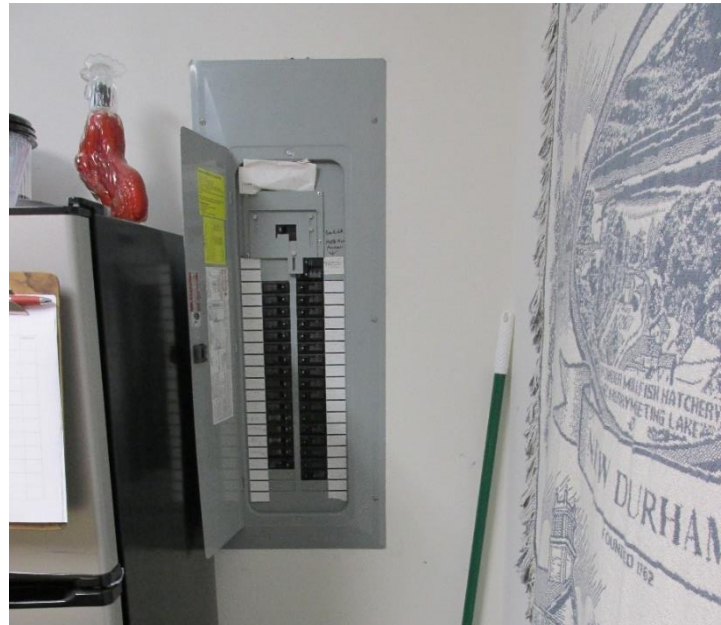
Police Department Electrical - 200A MDP

Electrical power to the building is via overhead wires from the street to an electric meter on the southwest corner of the building, then to the main distribution panel located on the other side of the wall in the kitchen. Emergency power is available from the fire station generator and is engaged via an interlocked circuit breaker in the Police Department MDP.

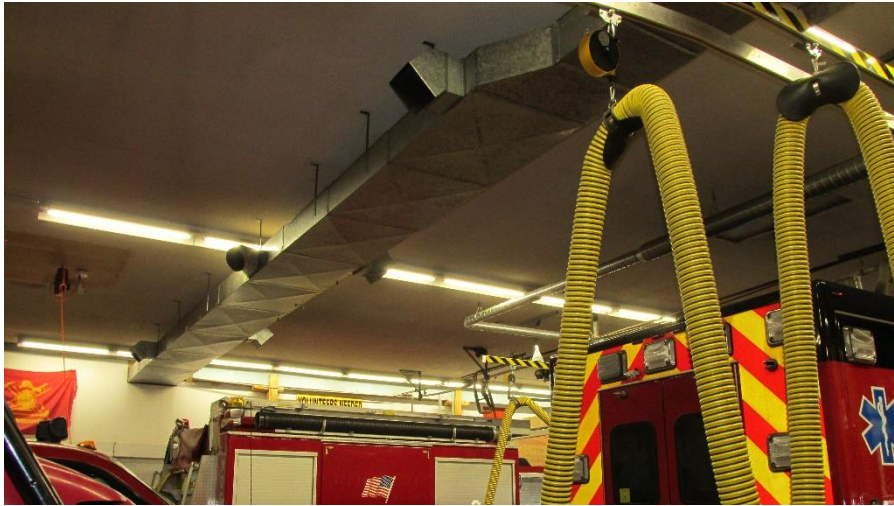
Fire Station Apparatus Room - Abandoned Ductwork

The previous heating system was comprised of an oil fired forced hot air furnace with distribution ductwork above the equipment bays. The furnace has been removed, but the ductwork remains in place.

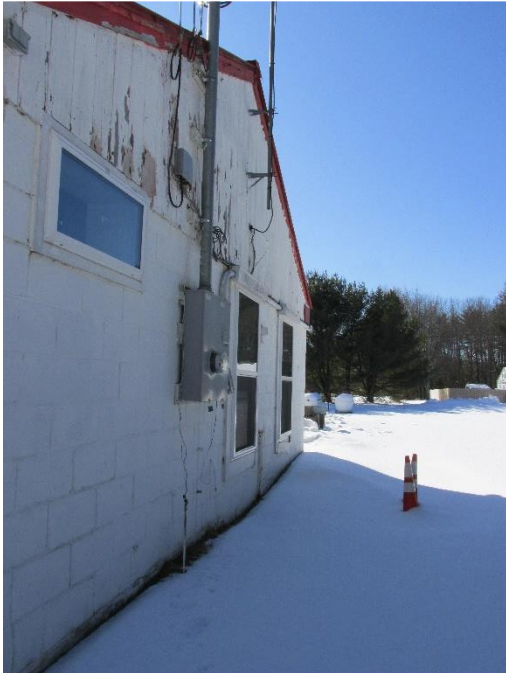
Fire Station - Electric Meter & Conduit to 2nd MDP

Electrical power to the building is via overhead wires from the street to an electric meter on the northwest corner of the building. The first of two MDP's is located on the other side of the wall from the meter. This panel is paired with a generator transfer (gentran) switch in a small closet without doors. The doorway framing does not allow the gentran panel door to be opened.

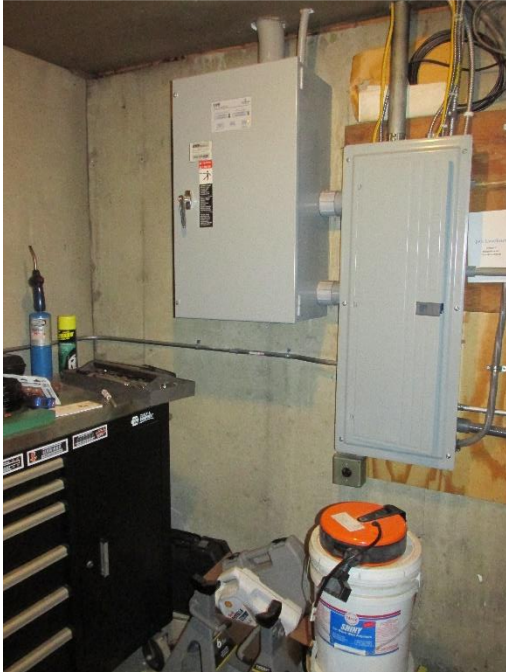
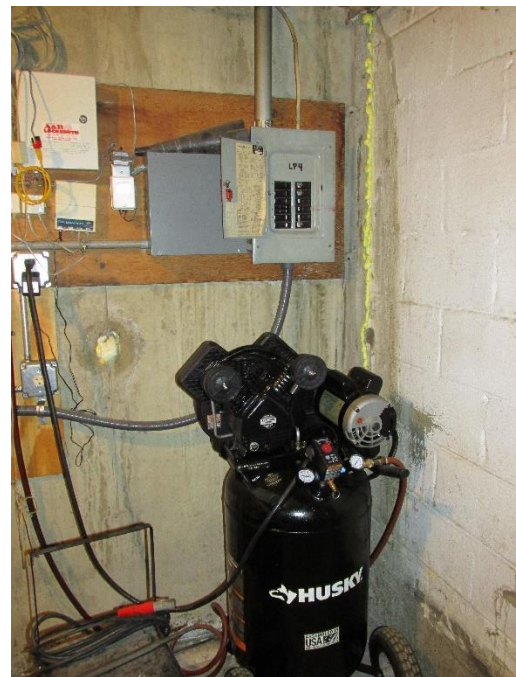
Fire Station - Distribution Panel in Old Boiler Room

A second distribution panel with gentran switch is located in the old boiler room.

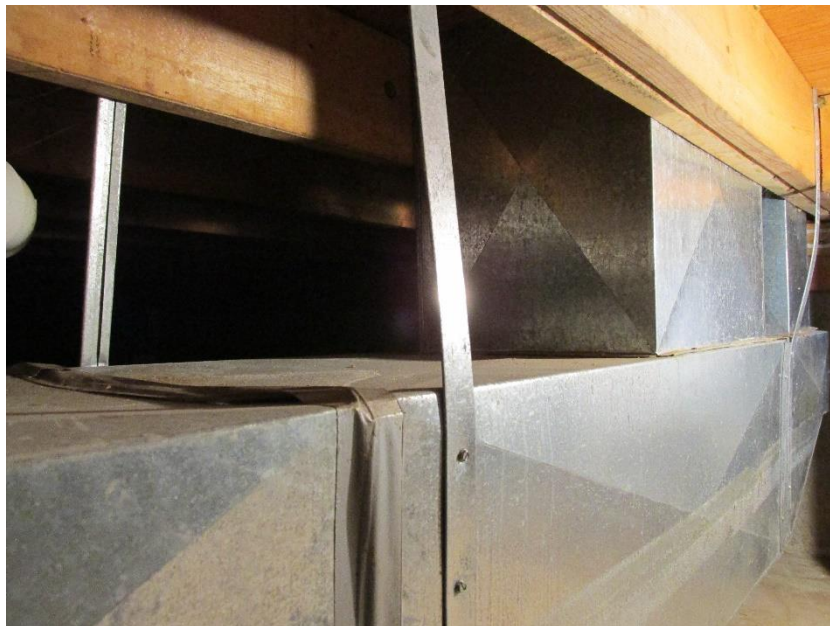
Library Crawl Space - Uninsulated Ductwork

- The ductwork from the oil-fired furnace is not properly sealed or insulated. This causes a loss of heat as warm air is distributed in the building.
- There are vents in the exterior soffits and a ridge vent at the roof peak. This means that the attic insulation is probably located at the bottom of the roof trusses, or possibly on top of the lay-in ceiling tiles, and the attic is a cold ventilated attic. The R-value of the attic insulation has not been confirmed, but given the age of the building it is probably R-25 or less.

5. Seal, insulate, and label supply and return ductwork.....Op Cost
6. Replace furnace flue pipe with insulated and welded one-piece assembly and seal tightly at connections to minimize chance of combustion gases being drawn into the adjacent return duct.....Safety

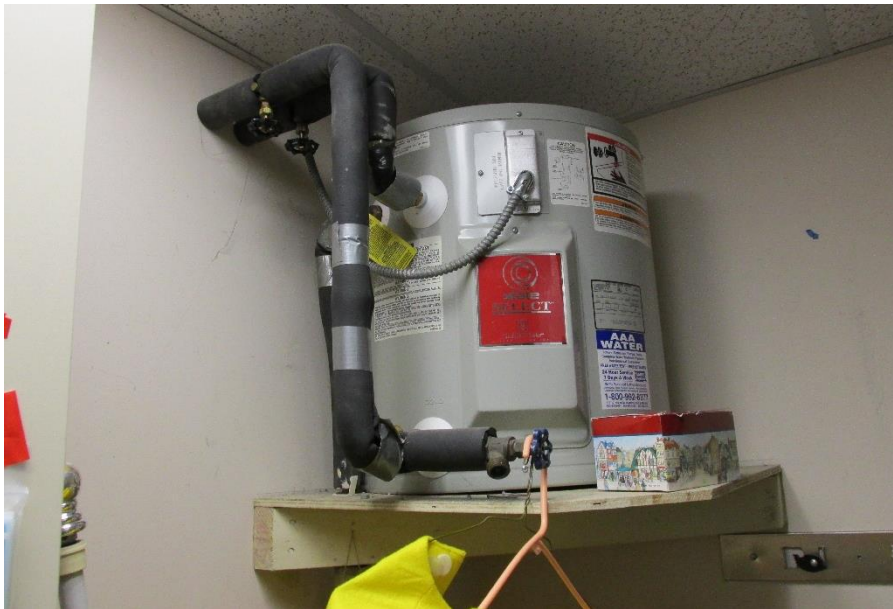
Library Furnace Room - Water Heater

Domestic hot water is sourced from a State electric water heater located on a shelf in the furnace room. The water heater is a 20-gallon unit manufactured in 1999.

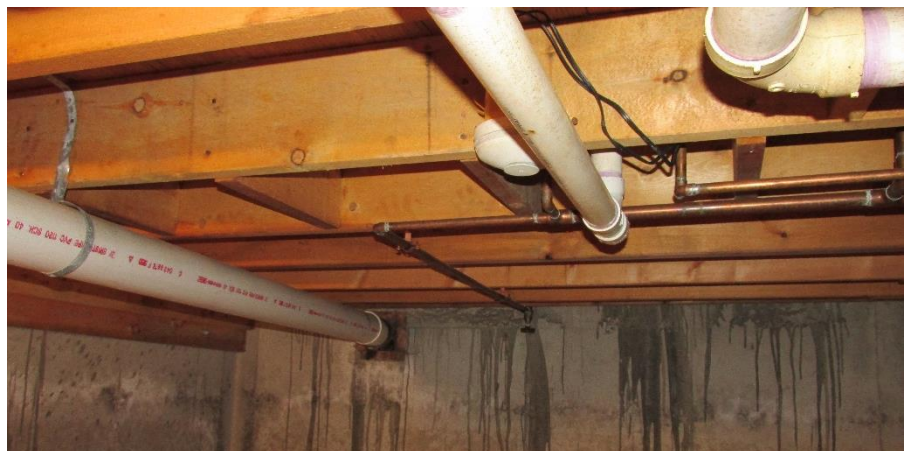
Library Crawl Space - Sanitary Drain

Sanitary drainage is piped to a septic tank.

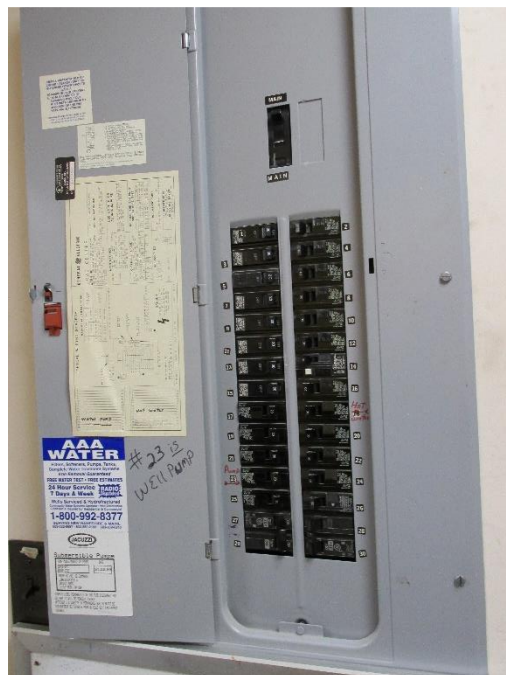
Library Furnace Room - MDP

Electrical power to the building is via underground wires from a pole in front of the building. The electric meter is mounted on the pole and the 150A main distribution panel is located in the furnace room.

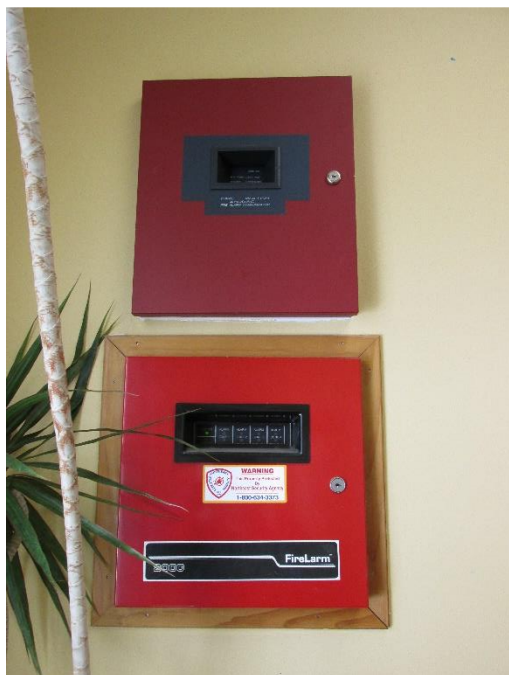
Library Fire Alarm - Fire Alarm Panels

A Honeywell Fire Alarm system is installed in the building. The control panels are located in the entrance foyer.

There is no fire protection sprinkler system in the building.
