Town Facilities Plan

Town of New Durham New Durham, New Hampshire

AGA Project No. 19-761
30 March 2021

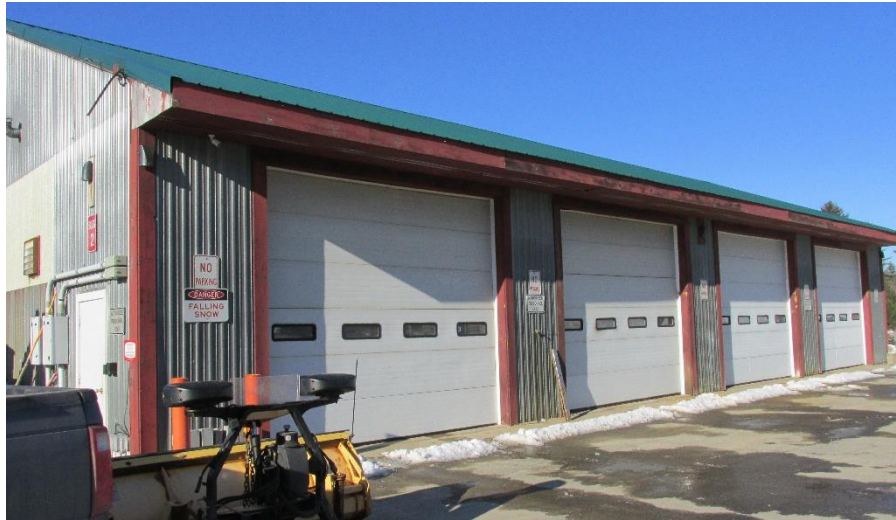
Public Works Garage Exterior

The building is a high bay, single-story wood framed structure sitting on a poured concrete slab on grade. The structure has four vehicle bays.

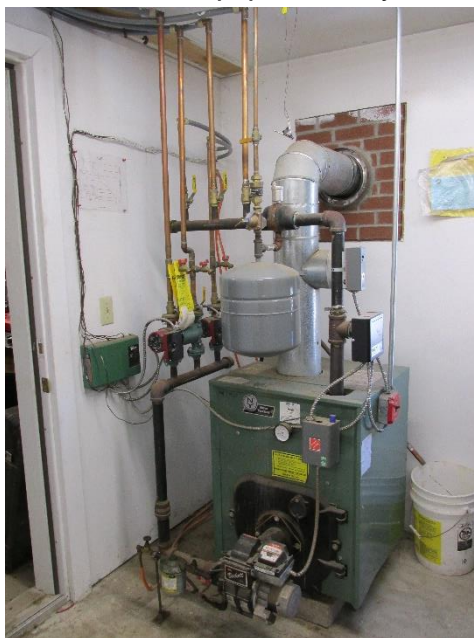
Space heating is provided by an oil-fired, hot water boiler with three zone pumps located in a utility space at the rear of the building. Two of the zones are the equipment bays each served by a ducted fan coil assembly. The third zone is fin tube baseboard serving the office area at the rear of the equipment bays. The boiler date of manufacture is August 2012.

Public Works Boiler Room - Oil-Fired Boiler

- A. Hot Water Boiler – New Yorker DOE Heating Capacity 179 MBH at 1.50 GPH firing rate from Beckett burner. Date of manufacture 08/2012.
- B. Domestic Water Heater – Kenmore Power Miser 5 1650W 10-gallon capacity. Date of manufacture is unknown.
- C. Fuel Oil Tank – manufacturer unknown – above ground double wall horizontal tank – unknown capacity.
- D. Well Tank & Pump Switch – Well-X-Trol pressure tank.
- E. Electrical Main Distribution Panel (MDP) – Equipment Bay – 600A.

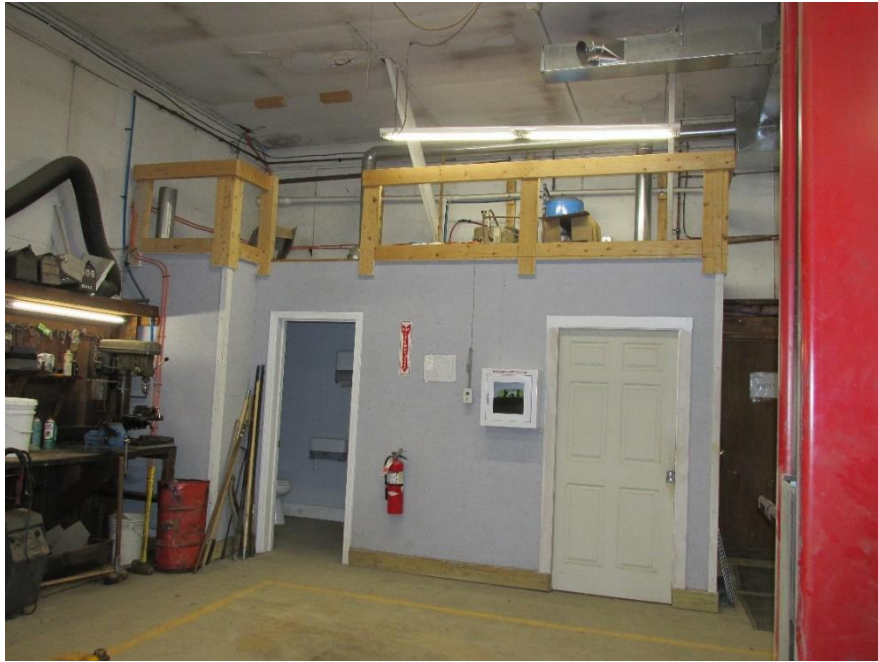
There are two Toilet Rooms in the equipment bays. Each toilet room includes a tank-type flush toilet and lavatory with cold and hot water. Toilet room on the left contains a shower currently used as storage.

Public Works Equipment Bays - Toilet Rooms

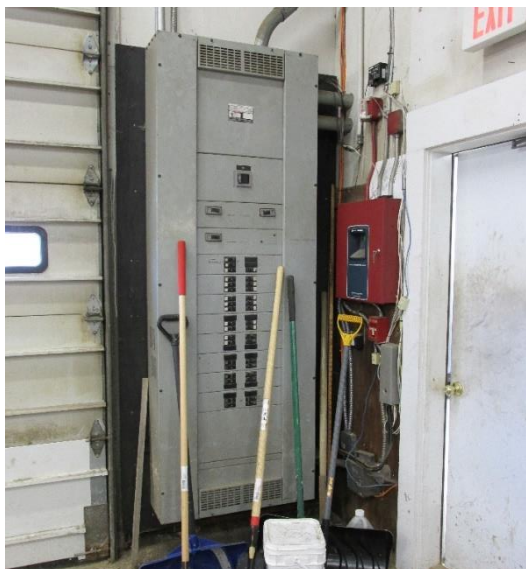
Building power is via overhead wires from street to an electric meter on the northwest corner of the building, then to main distribution panel located in equipment bay.

Public Works - Electrical Entrance

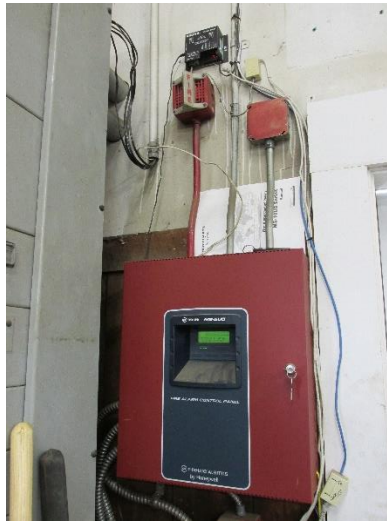
A Honeywell Fire Alarm system is installed in the building.

Public Works - Fire Alarm Panel

There is no fire protection sprinkler system in the building.

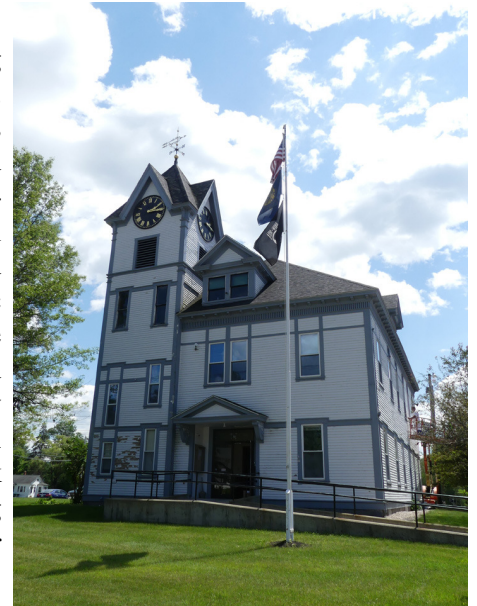
The New Durham Town Hall is a two-story wood framed building built in 1908. It has served since that time as the center of Town government, and originally with the second floor stage and auditorium open was considered a center for social affairs. The structure is 38' x 63' with painted wood clapboard siding, hip roof and granite foundation. A one-story hip-roofed addition on the rear built in 1970 contains Town records. The original building, designed by New Hampshire architect Alvah Ramsdell, was listed on the National Register of Historic Places in 1980. There are historic elements of the building that harken to the original 1908 construction, and are considered historically significant. This report identifies elements believed to be significant, but detailed analysis has not been completed to verify original components or dates of construction. It is recommended that an architectural historian be included as part of any subsequent phase of work to ascertain critical elements. Elements and components of the building considered significant that remain are quoted from the Nomination for historic designation as follows:

1. The exterior form of the building “...combines elements of the Italianate and the Colonial Revival architectural styles of the late nineteenth and early twentieth century.”

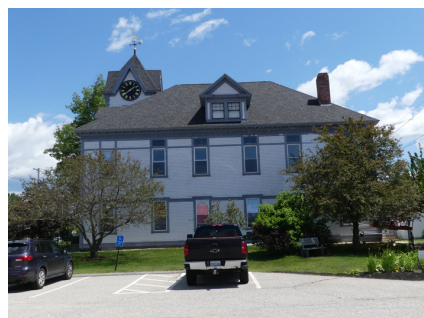
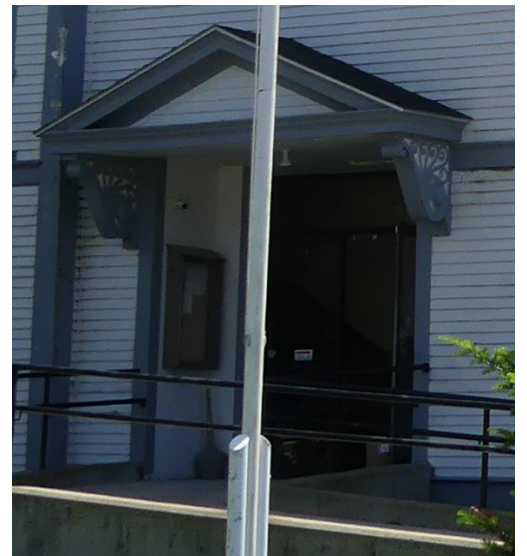
3. “The windows on the second story are topped by single-paned transom lights, and the lintels of the first-story windows are connected by a simple string course.” The double hung windows below the second floor transoms and on the first floor were replaced with vinyl windows 30+ years ago.

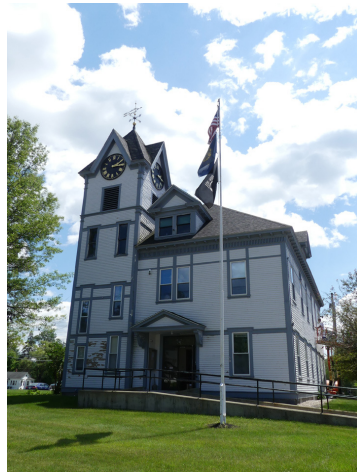
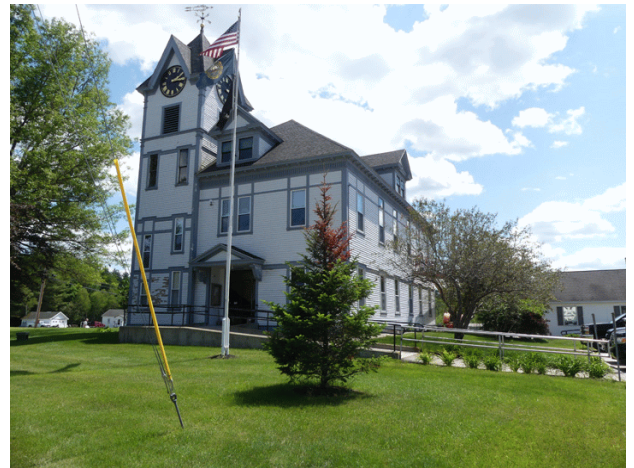
4. “The roofs of the North, East and West elevations each have a gable dormer with triangular pediment, bracketed eaves and paired windows.”

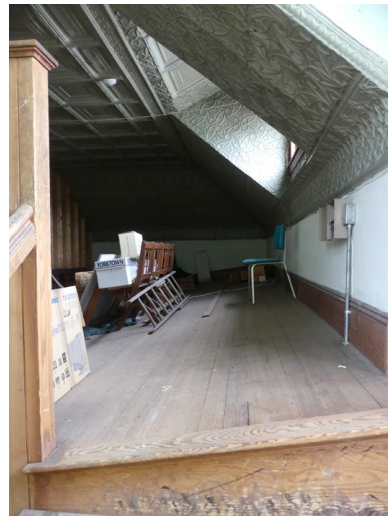
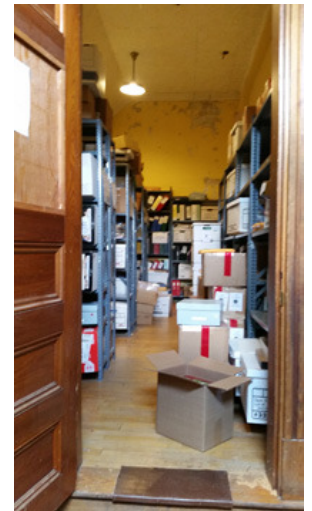
5. The front Northeast corner “...contains a 55', square, four-level clock and bell tower framed by pilasters rising to the top of the third level. The fourth level houses the bell, is louvered on all four sides and supports a hipped roof with two cross gables, each gable containing a circular clock face. The roof is topped by a 6' metal weathervane. The tower features tall, narrow windows on the three lower levels.”

6. “The second floor consists of an auditorium measuring 37' x 41' with an 18' x 20' stage.” Modifications to the interior have covered the majority of the stage with a storage room, and the original balcony and stamped metal ceiling are concealed by suspended acoustic ceiling tiles.

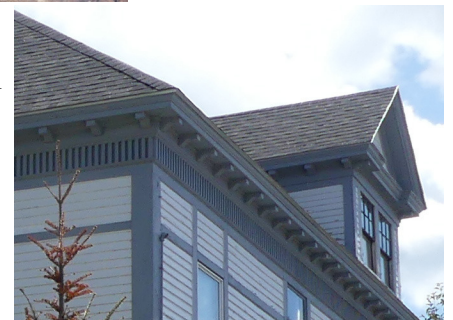
7. Below the hip roof are bracketed eaves with vertical denticular molding.

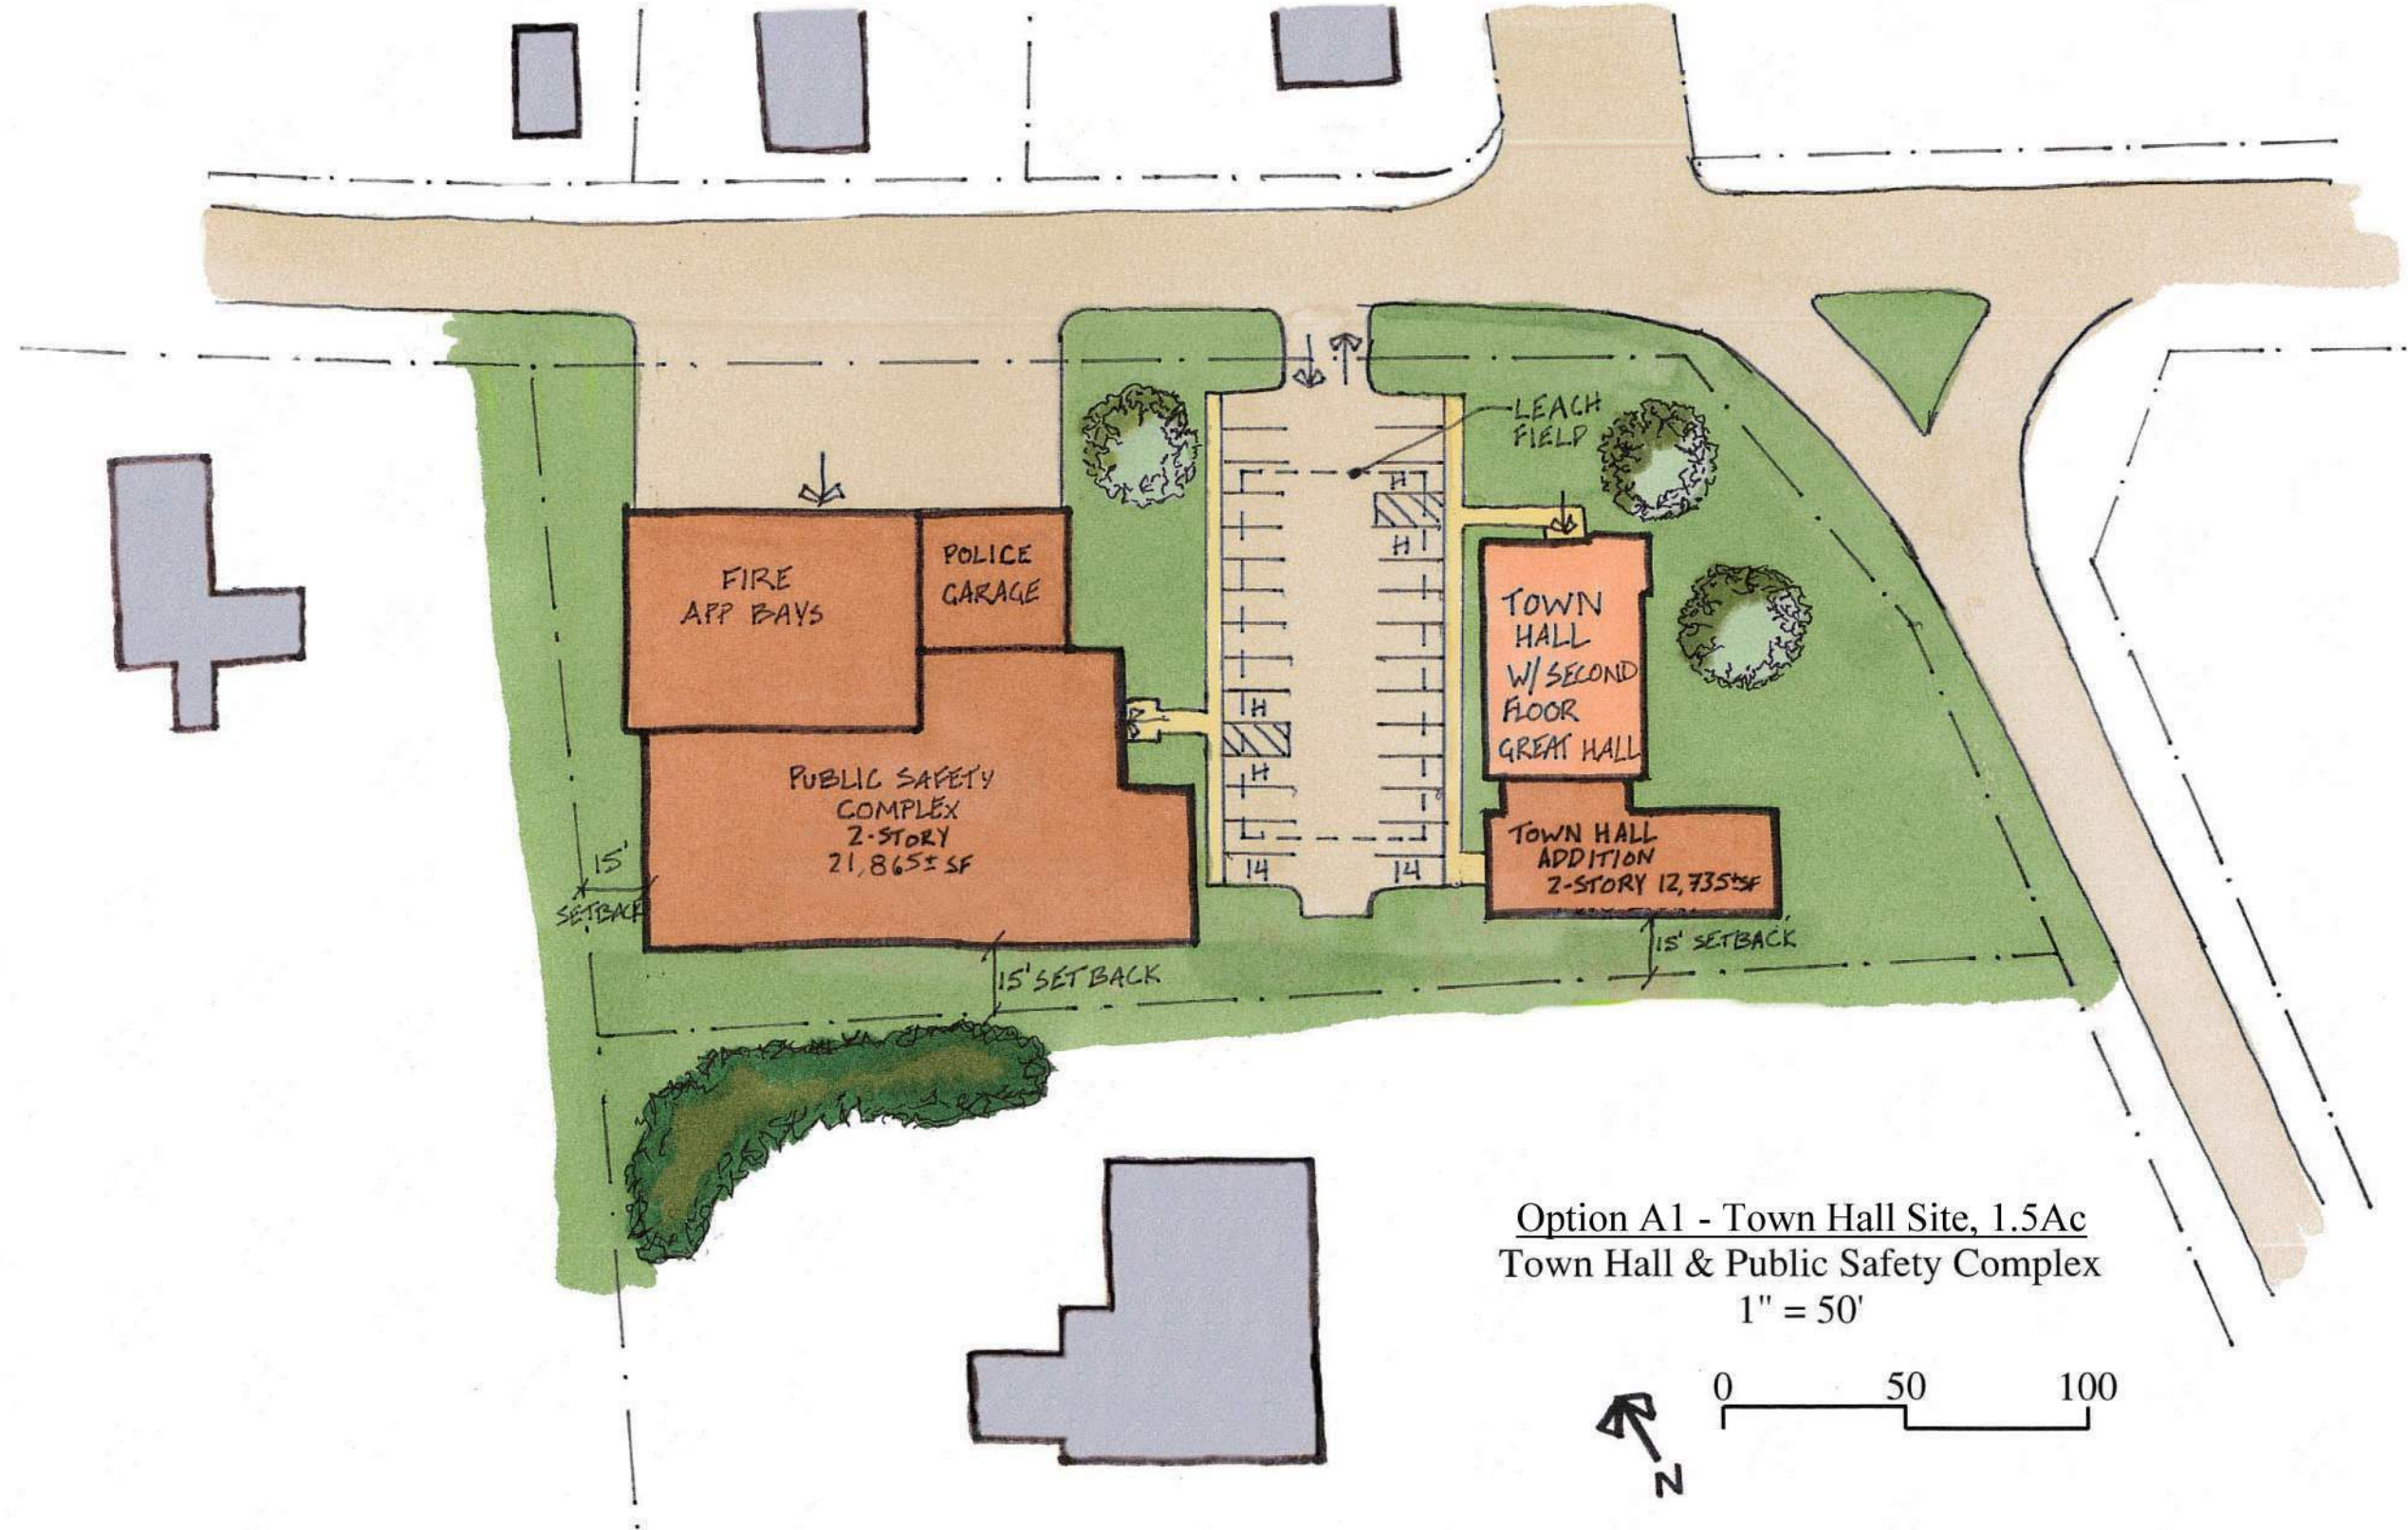
Option A1 - Town Hall Site, 1.5Ac
Town Hall & Public Safety Complex
1" = 50'

- 1A Remove Town Hall Records Room
- 1B Expand Town Hall with new construction to rear, 2-stories
- 1C Renovate Town Hall first floor offices and second floor Great Hall
- 2 Construct new bays at Public Works
- 3A Temporarily relocate Police and Fire Departments, utilize Public Works
- 3B Demolish and remove existing Police Station and Fire Station
- 3C Install new parking with septic system below; install new well
- 3D Construct new Public Safety Complex
- 4 Expand Library with new construction/renovation

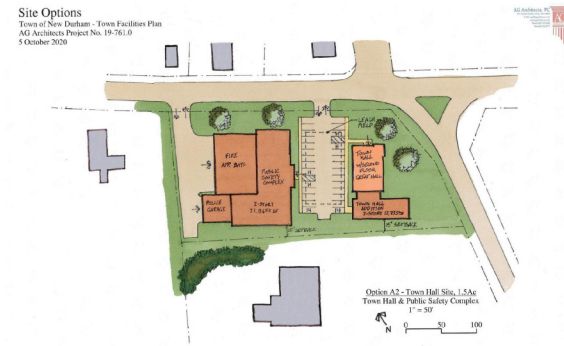
Phasing*:

- 1A Remove Town Hall Records Room
- 1B Expand Town Hall with new construction to rear, 2-stories
- 1C Renovate Town Hall first floor offices and second floor Great Hall
- 2 Construct new bays at Public Works
- 3A Temporarily relocate Police and Fire Departments, utilize Public Works
- 3B Demolish and remove existing Police Station and Fire Station
- 3C Install new parking with septic system below; install new well
- 3D Construct new Public Safety Complex
- 4 Expand Library with new construction/renovation

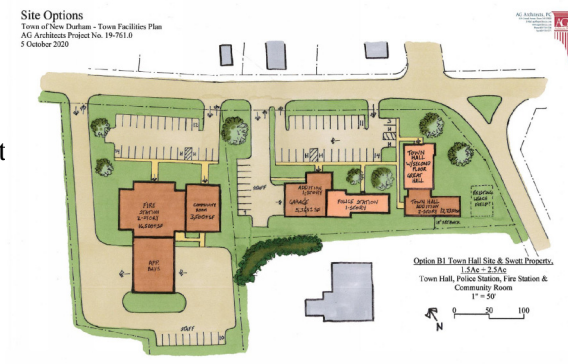
Phasing*:

- 1 Purchase Swett Property
- 2 Build New Fire Station/Community Center with Public and Staff Parking
- 3A Demolish and Remove Existing Fire Station/Community Center
- 3B Expand and Renovate Police Station with Staff Parking
- 3C Reconfigure Town Hall and Police Station Public Parking
- 4 Construct new bays at Public Works
- 5 Expand Library with new construction/renovation
- 6A Remove Town Hall Records Room
- 6B Expand Town Hall with new construction to rear, 2-stories
- 6C Renovate Town Hall first floor offices and second floor Great Hall
