New Durham Town Hall
New Durham, New Hampshire

Historic Building Assessment
with
Preservation Guidelines

Prepared by
Elizabeth Durfee Hengen
Preservation Consultant

May 2012

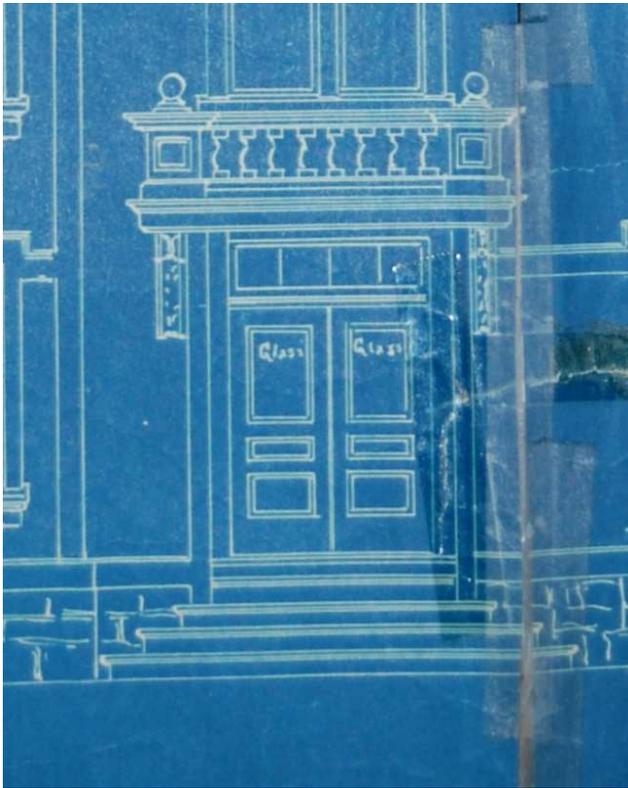
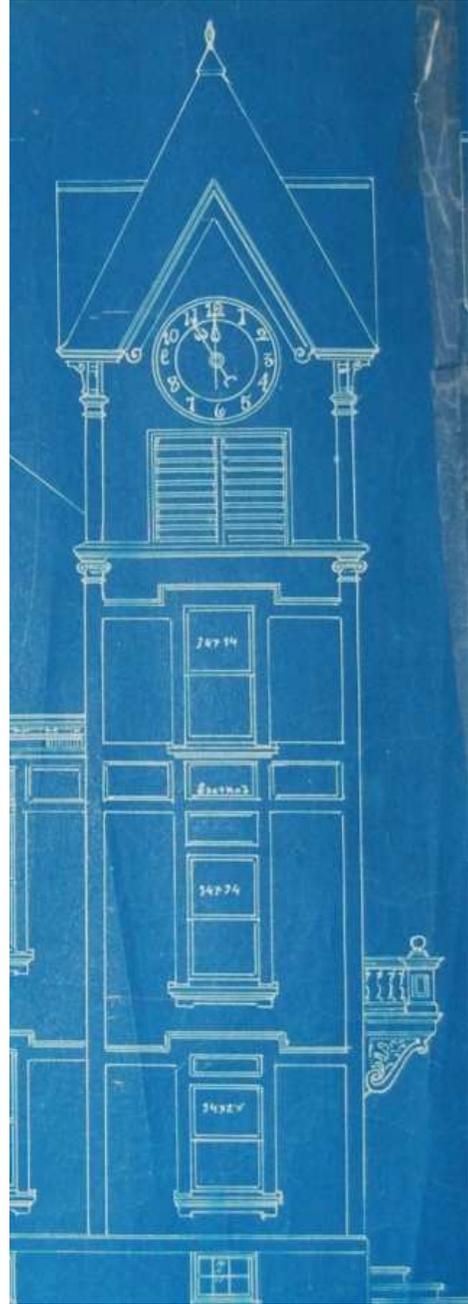
Architect drawings showing the original double doors, transom window and door hood at the front entrance

The original doors were replaced in the mid-1980s with bronze, single-light, double aluminum doors and a single-light transom above. The original doors were 2”-thick pine, double-leaf, with solid, molded panels in the lower half and a glazed molded panel in the upper half. The transom window had four panes. Unlike the replacement doors, the original doors filled the width of the entrance and, with the divided transom window above, complemented the overall architecture of the building.

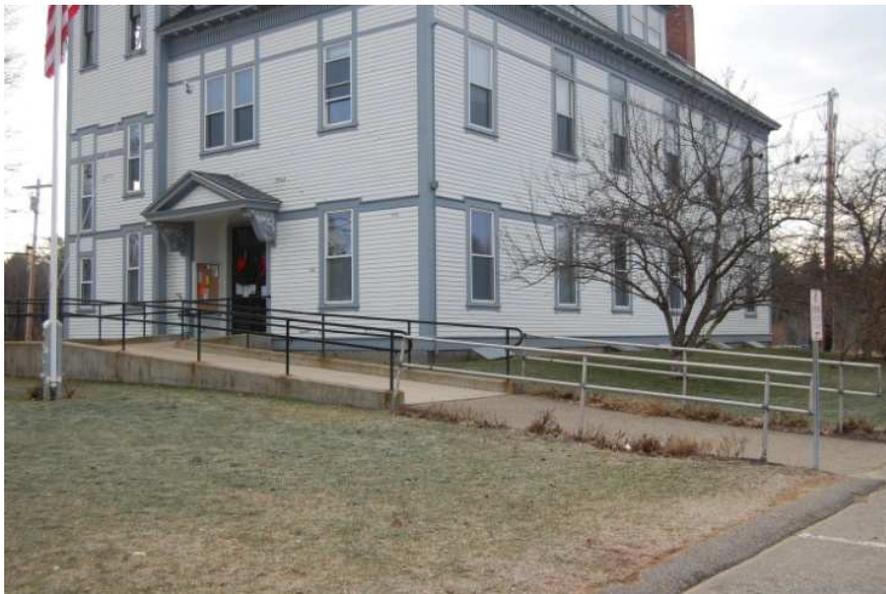
The ramp was added in 1987.

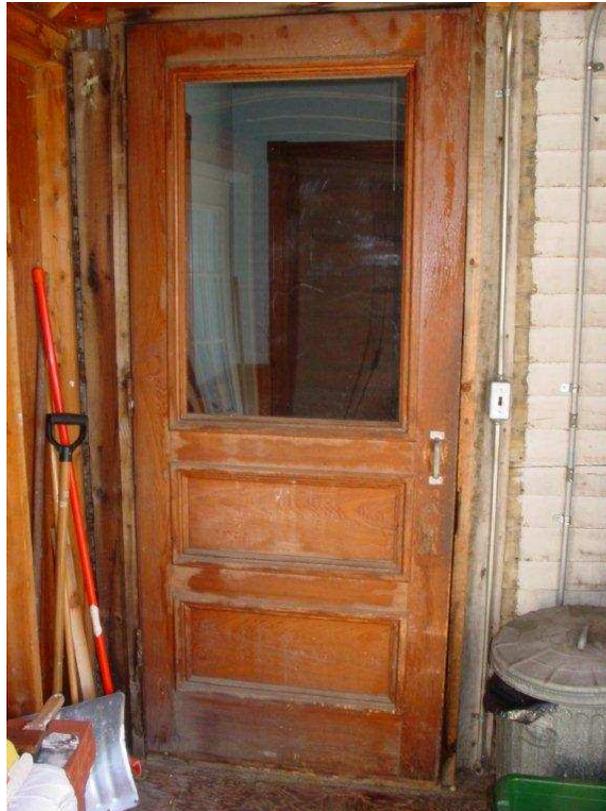
The rear entrance is located directly opposite the front entrance; the doorway, interior casing and the wood-and-glass paneled door, are original, though the door has been re-hung to swing outward. The entrance no longer leads directly outside, as it is within the connector that leads to the storage vault.

Rear entrance door, viewed from the exterior

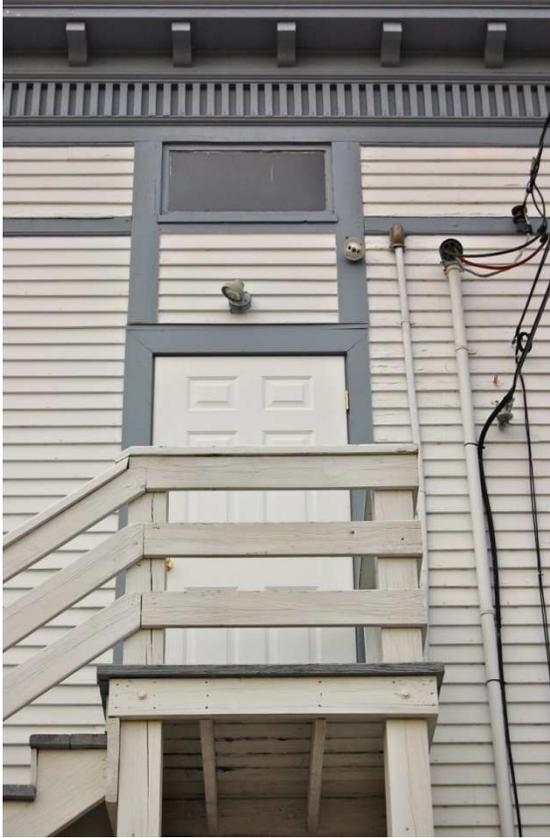
The second story entrance, located in the far left bay on the east elevation, was originally a window. At some point, likely in 1994 when the second story was renovated, the opening was elongated into a doorway leading to a wooden fire escape, thus providing a second means of egress from the second story.

When the town converted a second-story window opening into an emergency egress, it carefully worked within an existing opening and left the transom in place.

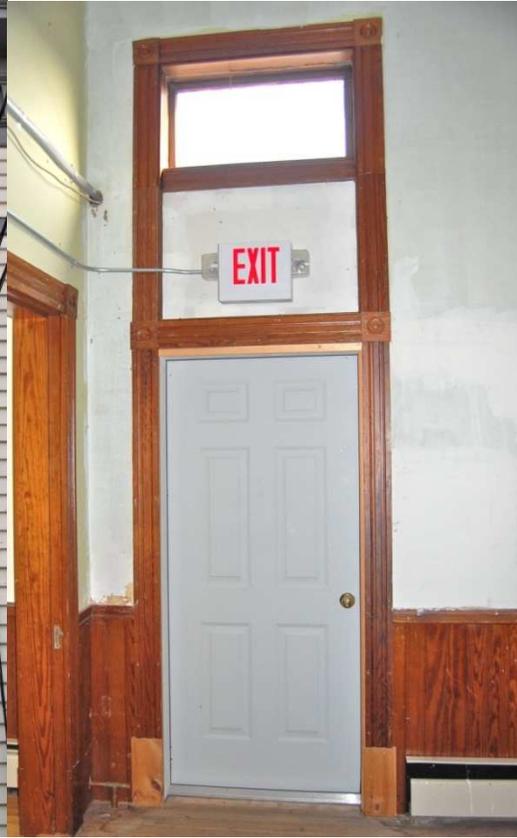
View of converted window opening for emergency egress, seen from the interior

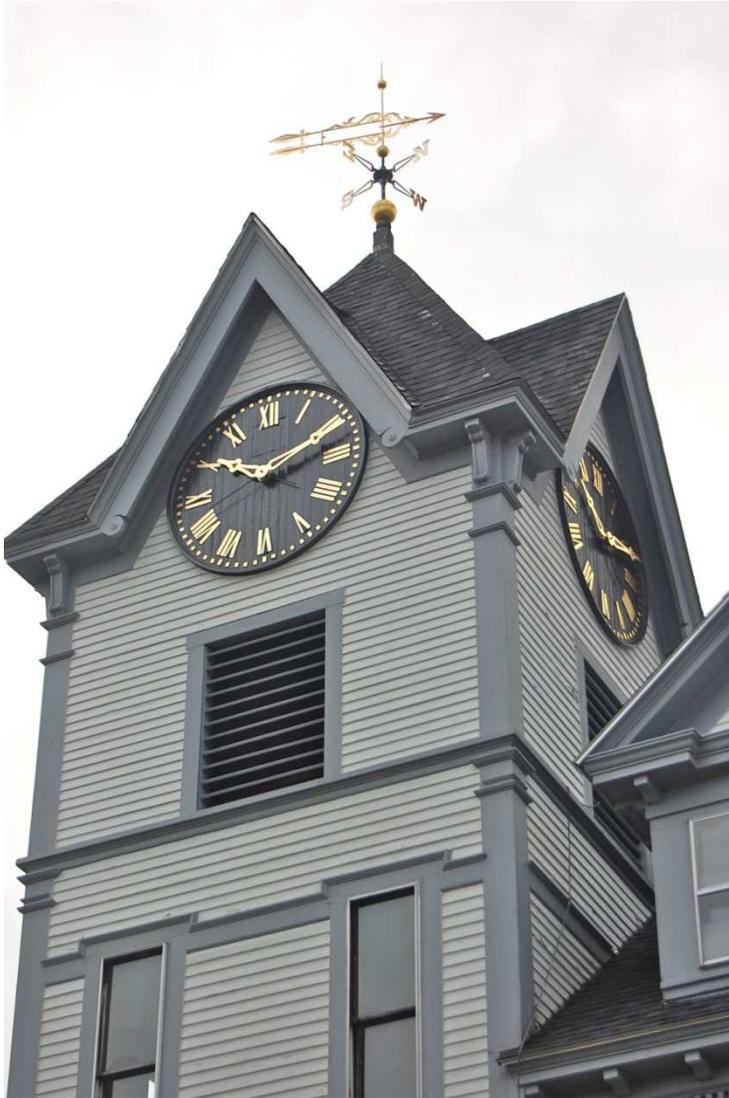
Each of Alvah Ramsdell's town halls has a clock-bell tower, but only New Durham and Alton's has steep gabled wall dormers on each face

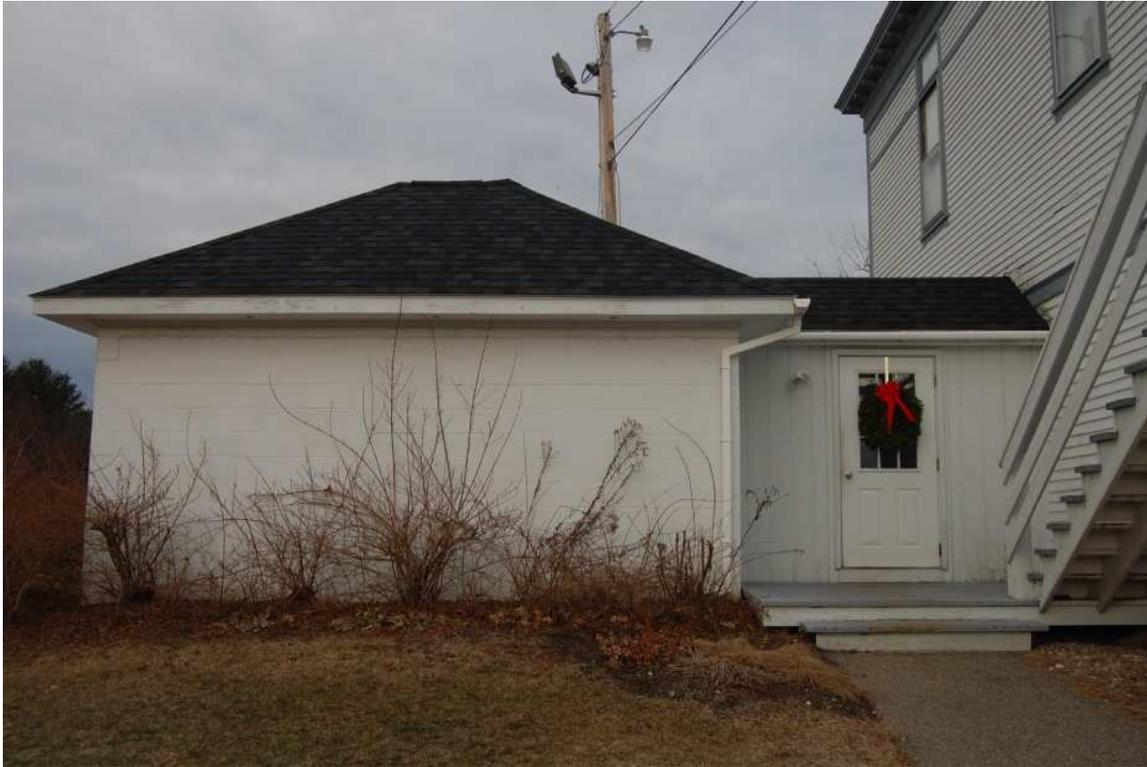
New Durham early on recognized the need for a secure storage spot for town records

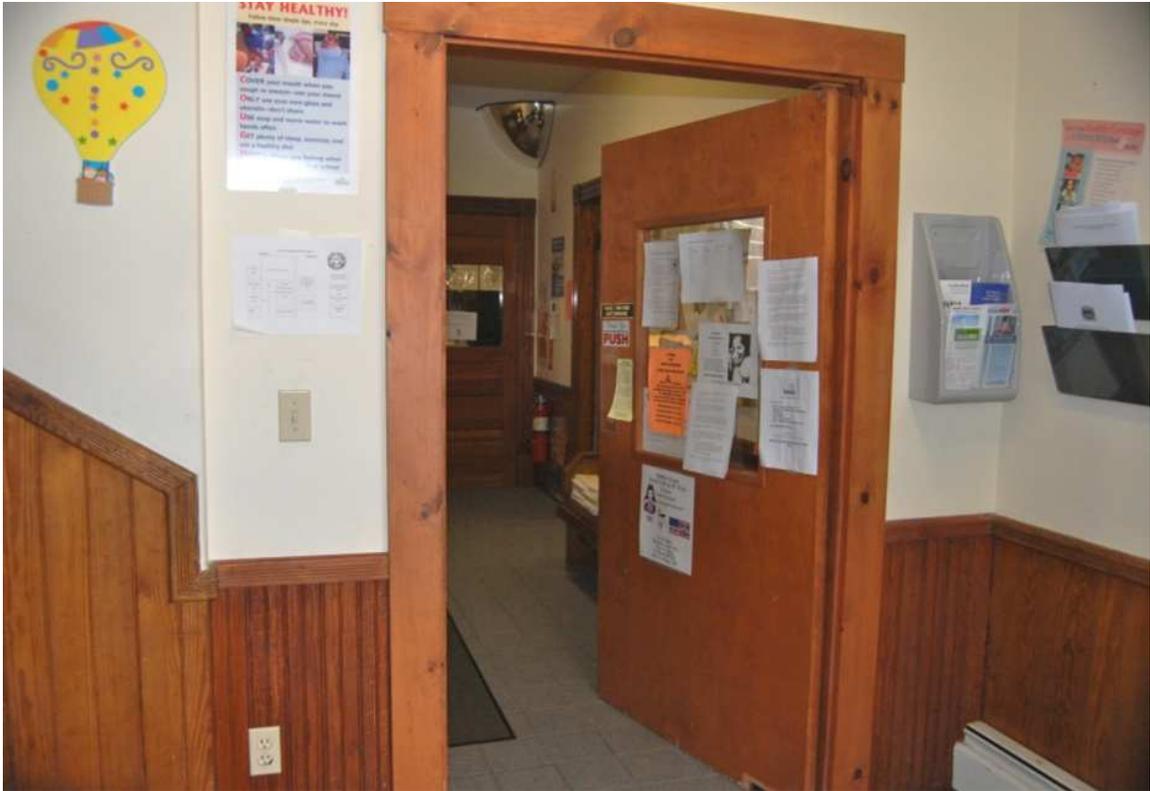
2. The doorway, including casing and door, from the vestibule into the main portion of the building was added in 1990 to conserve heat and prevent the spread of fire

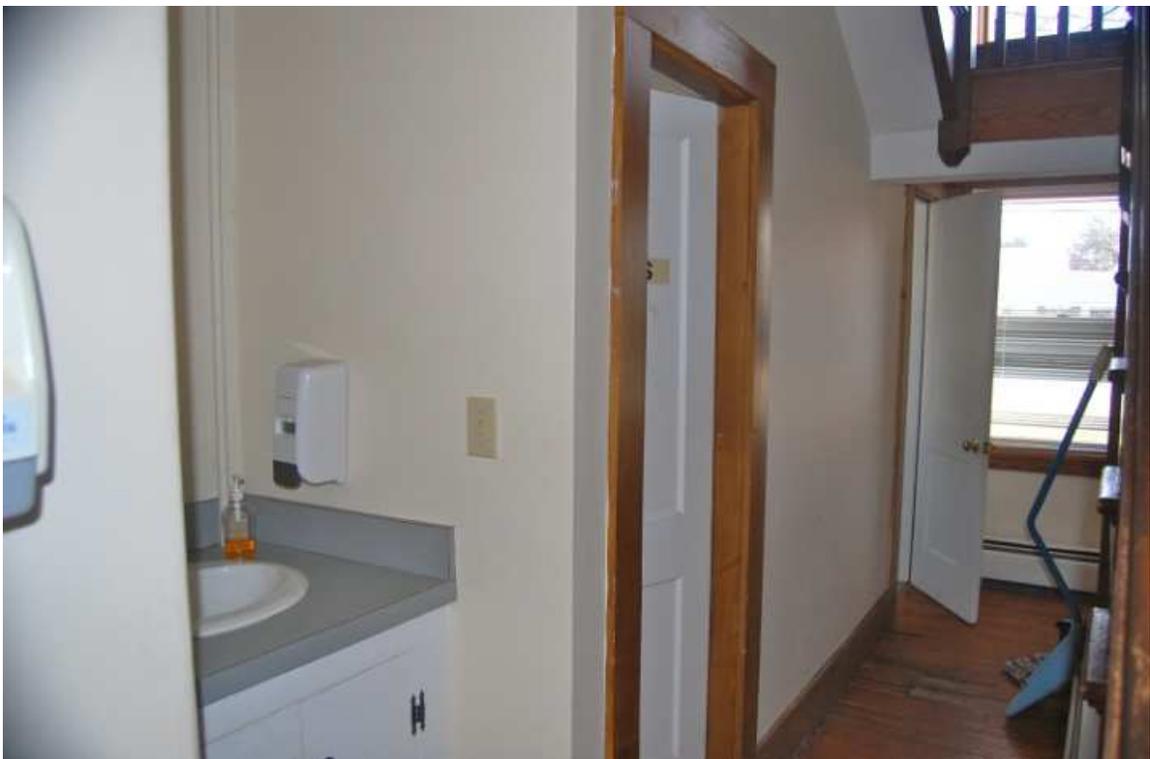
3. These two bathrooms off the front vestibule were added in 1951, replacing the ticket office for events in the second floor auditorium.

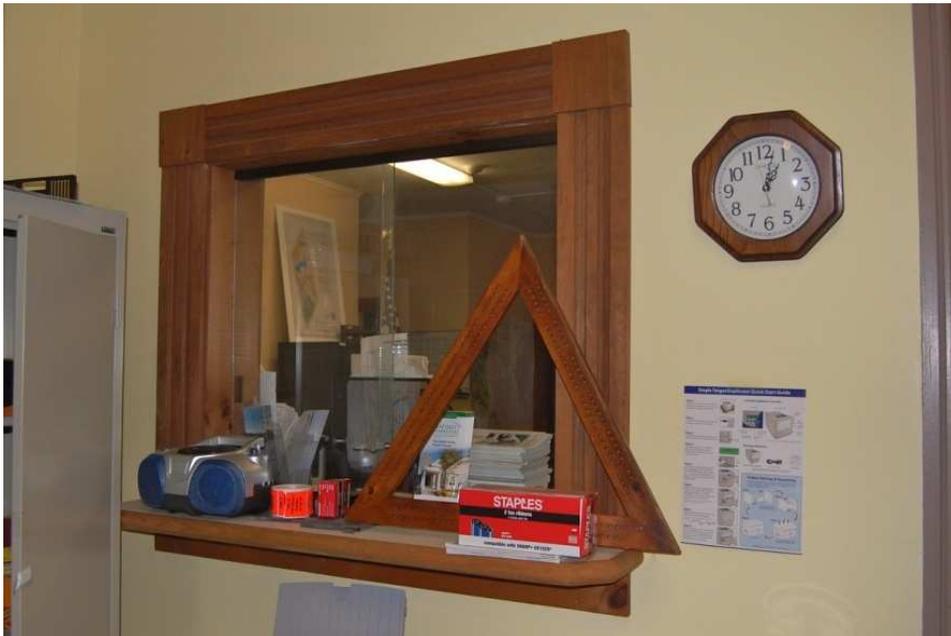
7. South wall of the west room; looking through the window into the court room. The window and counter, clearly a later alteration, are thought to have been installed within the past twenty-five years.

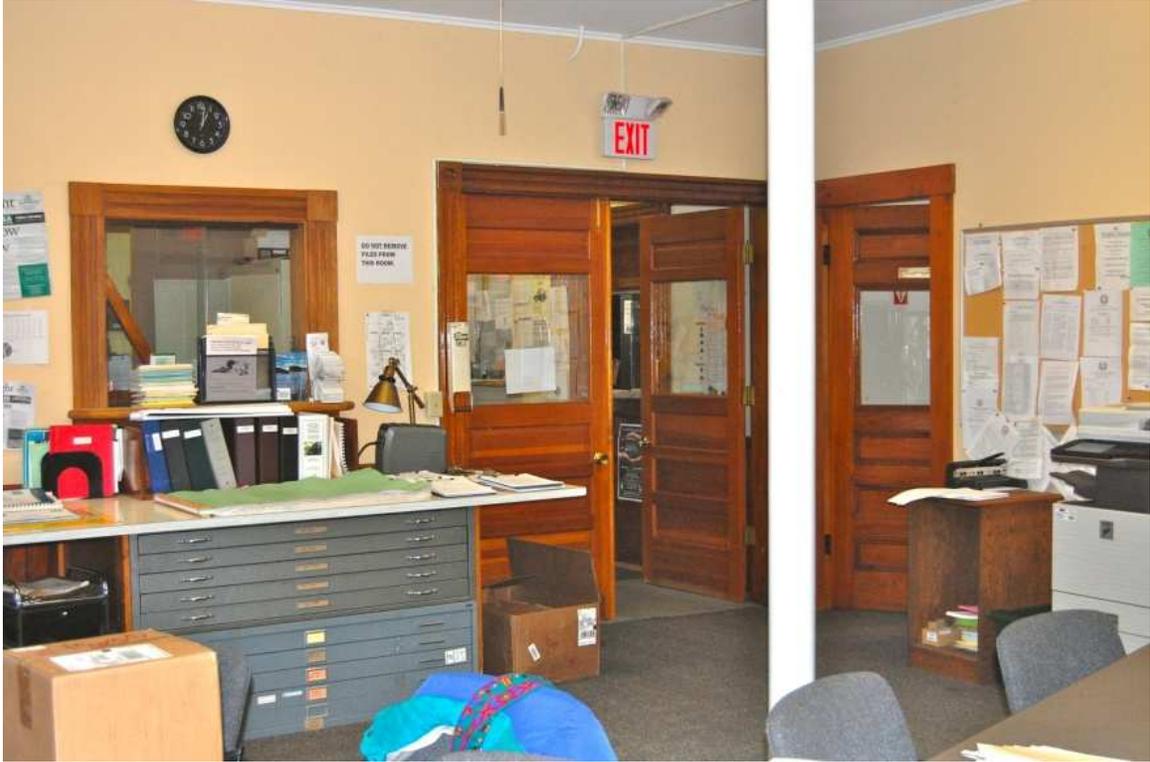
9. Looking northeast at ca. 1972 reproduction doors closing off court room from hallway. The window with counter at left was installed at date unknown. The doorway at right, which leads into east room B, was created in 1972 and reuses an original door.

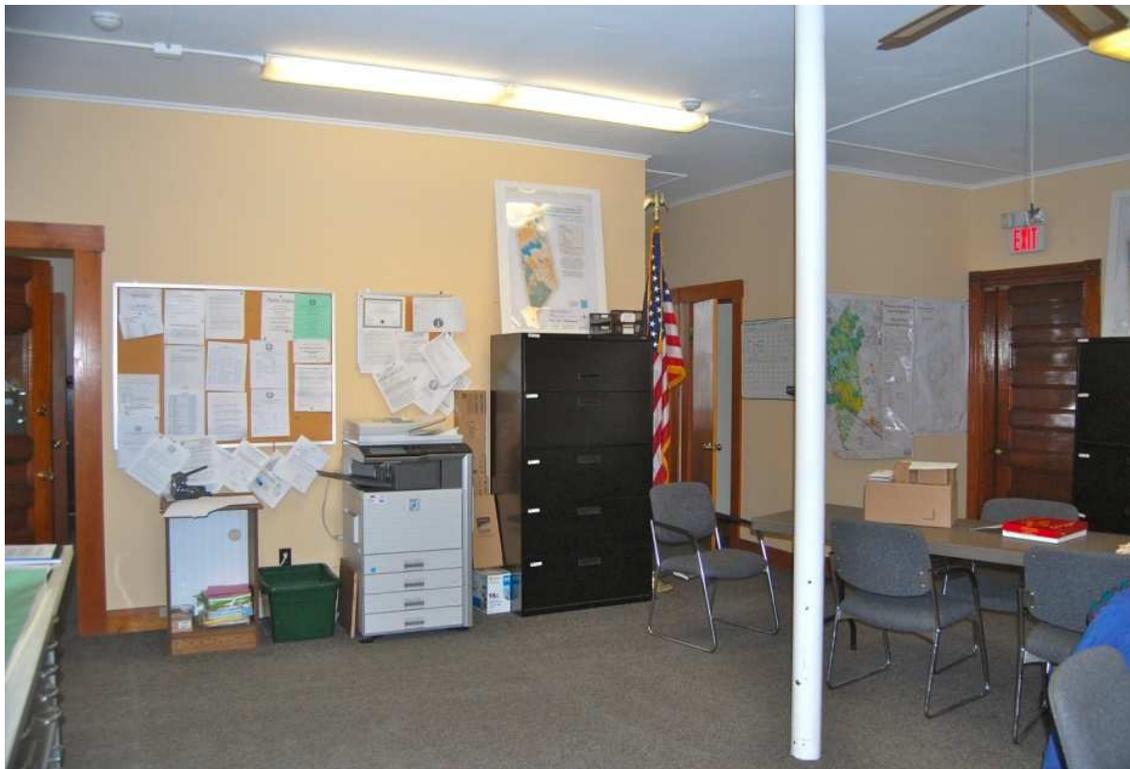
10. Court room, looking southeast, showing east room B (now used by finance officer and assessors' clerk), hall and bathrooms carved out of it in 1972. Door at far right is original and leads to back hall and vault.

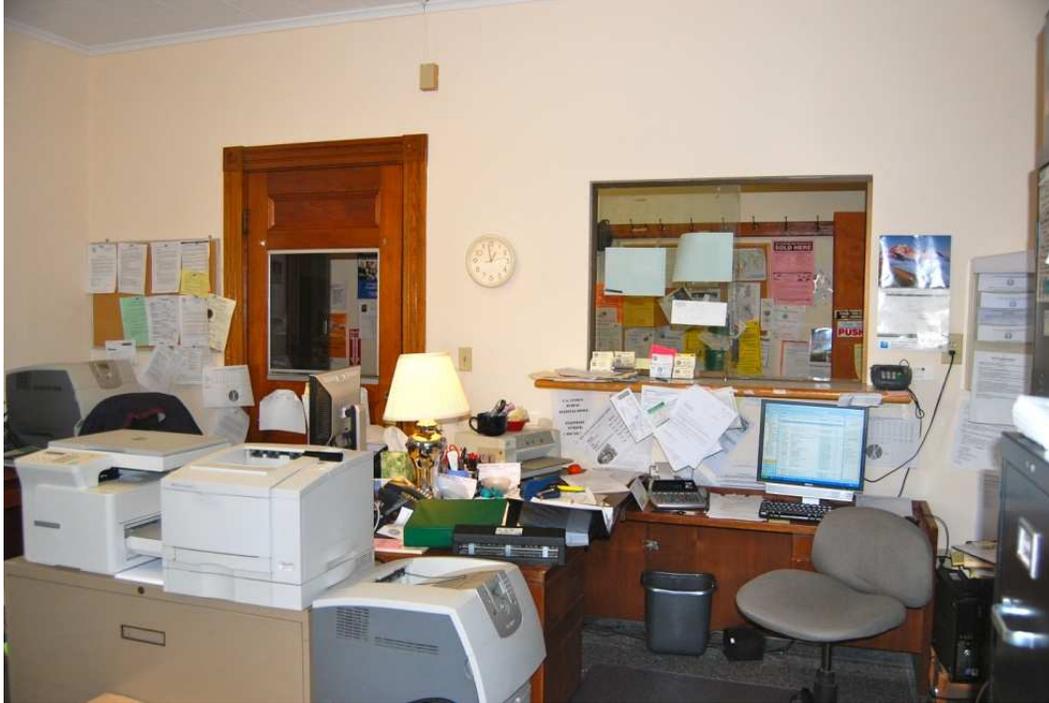
11. Looking west in east room A. The door and casing are original; the window with counter was added for the town clerk in 1987.

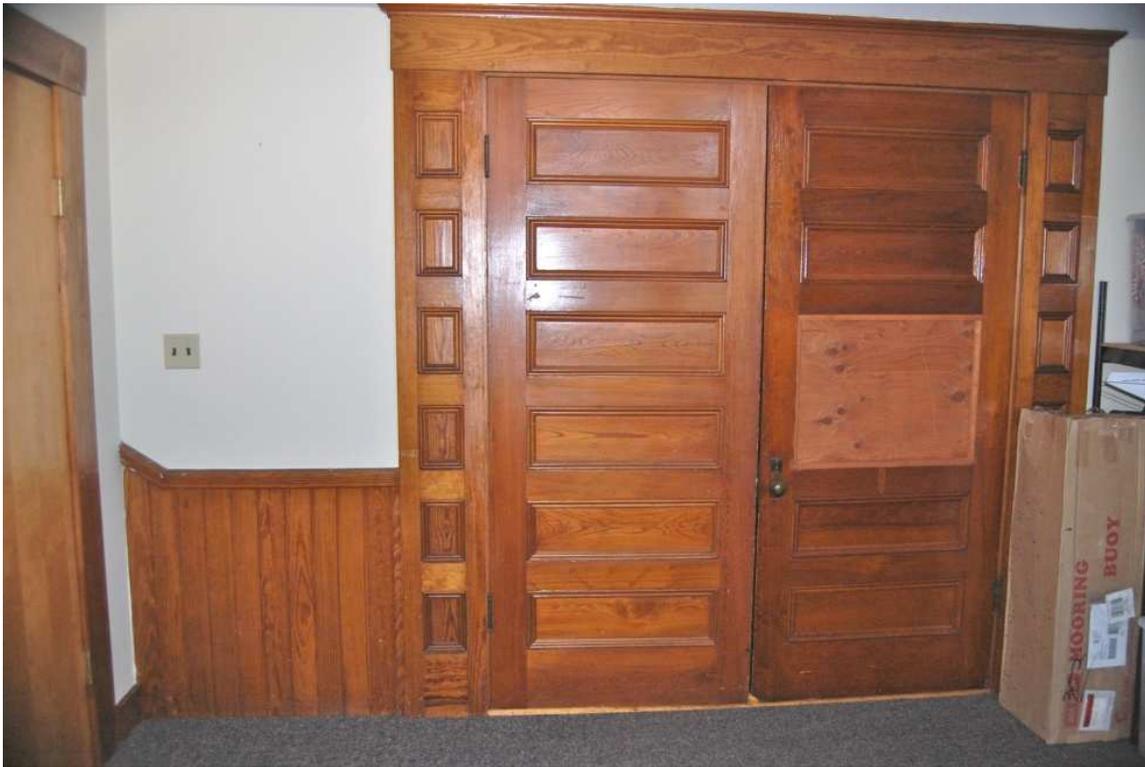
21. Looking south at double doors that led into auditorium; note the unusual paneled casing on either side. The right door had an opening or a glass panel at some point; the shadow line of a hinge suggests it also had a counter. The newer flush door at far left leads to the balcony stairway, which was originally fully open.

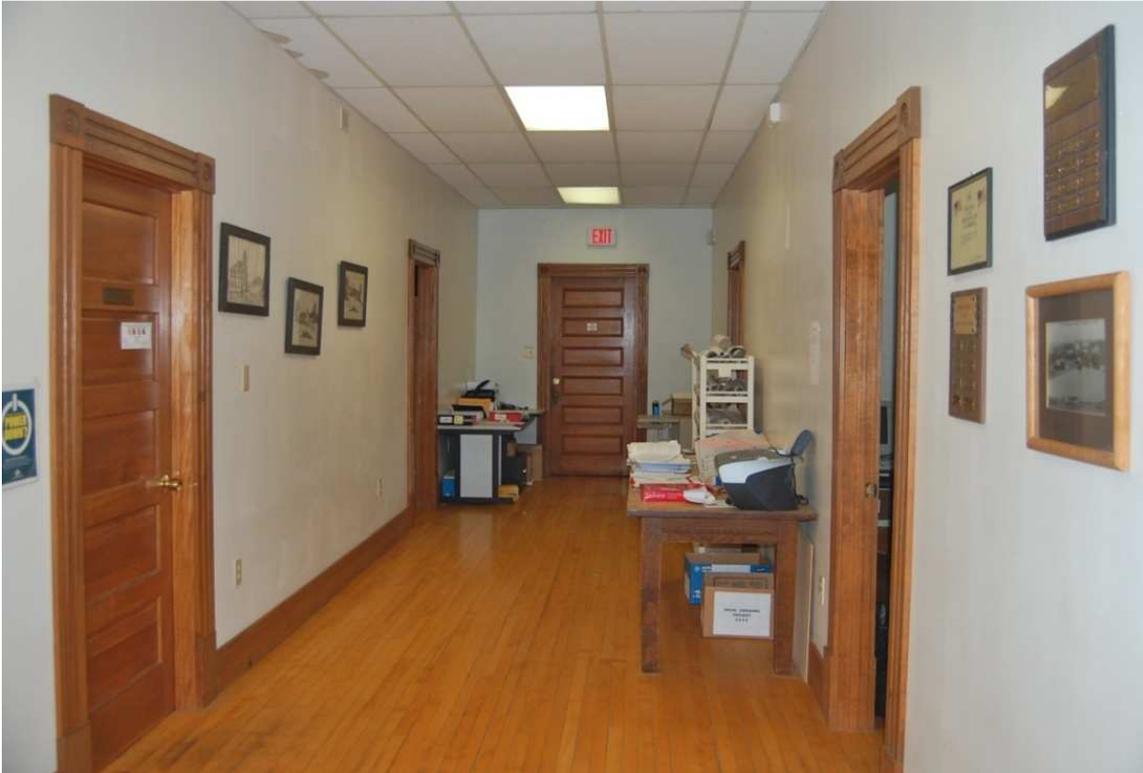
24. Hallway, looking south, showing new office partitions on either side. The wall at the end closes off the stage. The door was reused from within the building (location unknown).

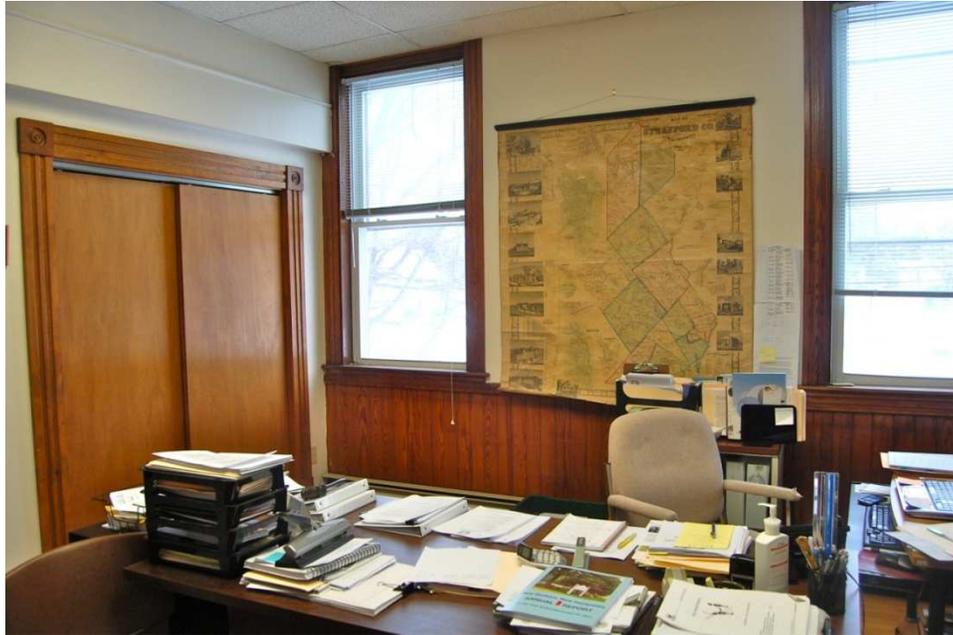
The dropped acoustical tile ceiling was added in 1972 to conserve heat, but it covers the original, handsome, pressed-metal ceiling that is still visible from the stage and the balcony. The ceiling also unfortunately covers the transom windows that are above each of the windows in the side walls.

27. Town Administrator's office, looking east. The original wainscot and window casings are visible within each of the offices, though the window transoms are concealed by the dropped ceiling. The casing used on the sliding closet doors dates from 1994, but reflects the original.

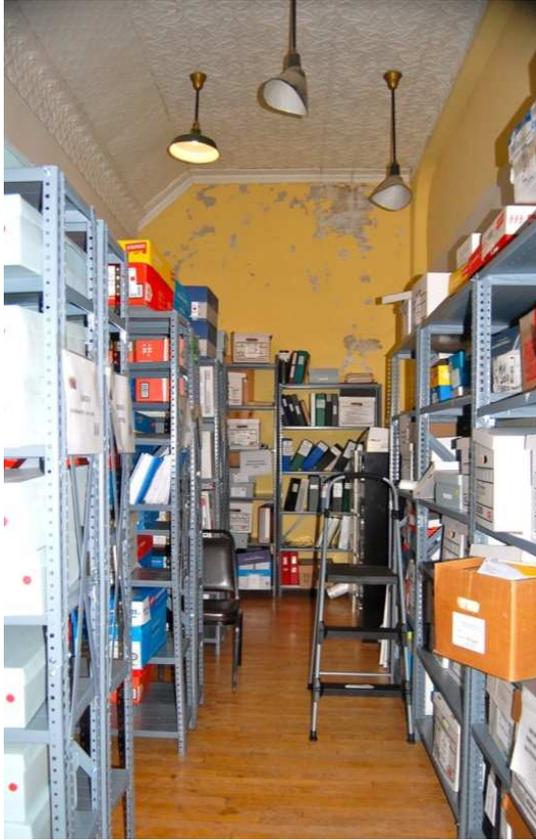
29. The stage, looking west. Note the original pressed-metal ceiling that survives throughout, above the dropped acoustical tile now in the offices and hallway.

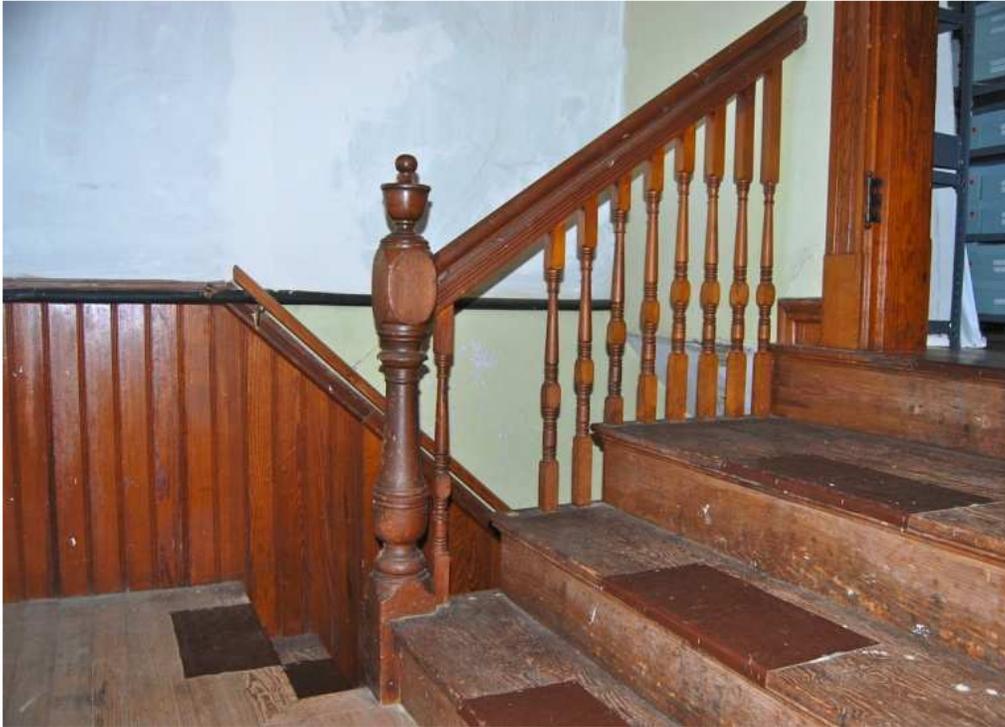
The balcony spans the width of the north end of the Town. It has a sloped floor that originally had rows of deacon benches for seating. Sections of the straight railing with turned balusters remain. The town closed off the balcony in 1972 due to fire code regulations.

31. Detail of staircase leading to balcony

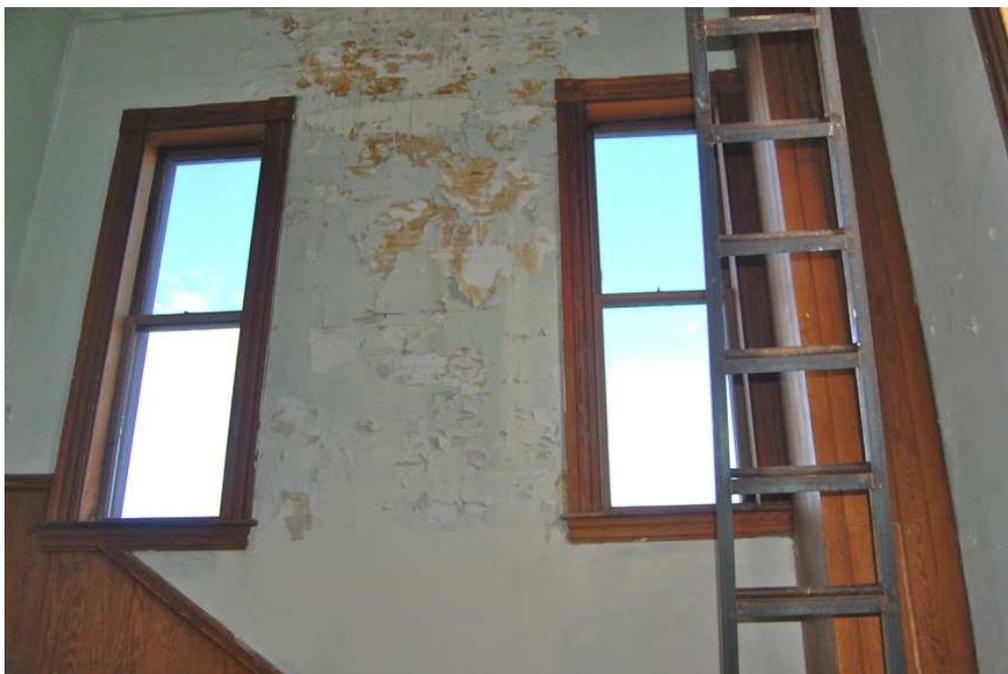
32. The window sash in the upper levels of the tower are some of the only surviving original sash

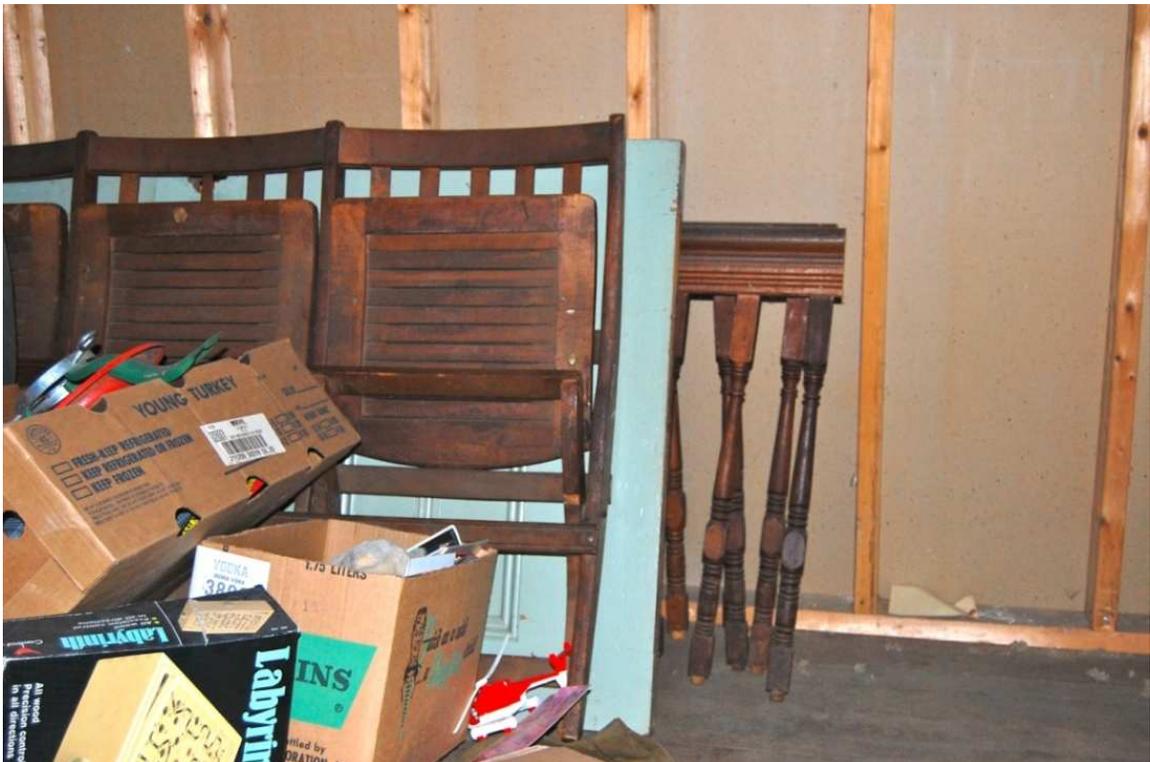
34. Some of the original wooden seats remain in the balcony, as well as remnants of the balcony railing.

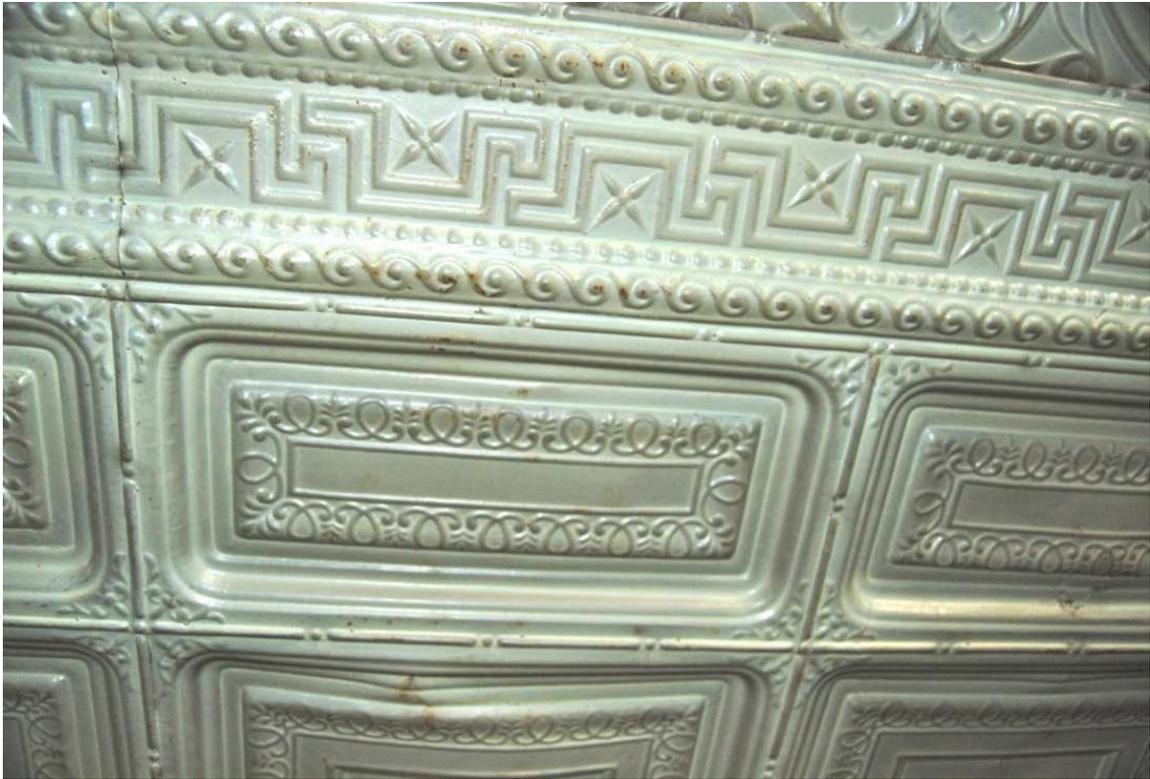
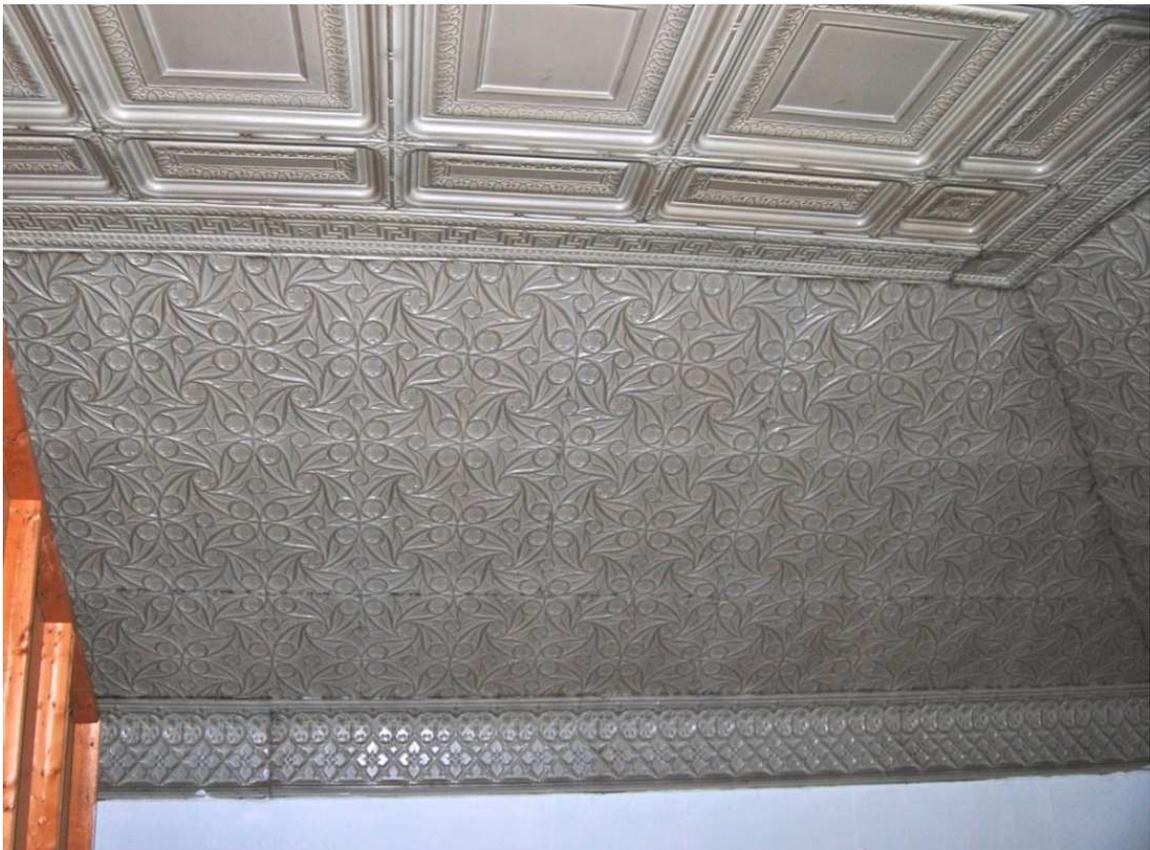
35 & 36. Details of pressed-metal ceiling in the balcony

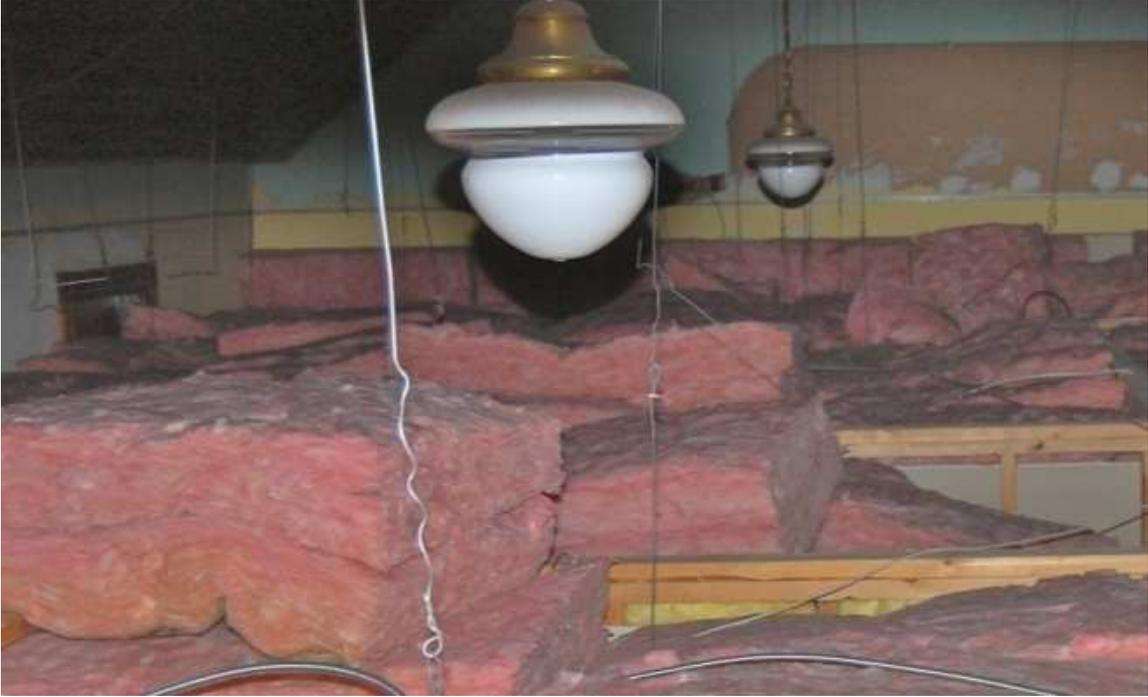
37. Original suspended lighting fixtures that lit the auditorium, still visible in the space between the acoustical tile and metal ceiling

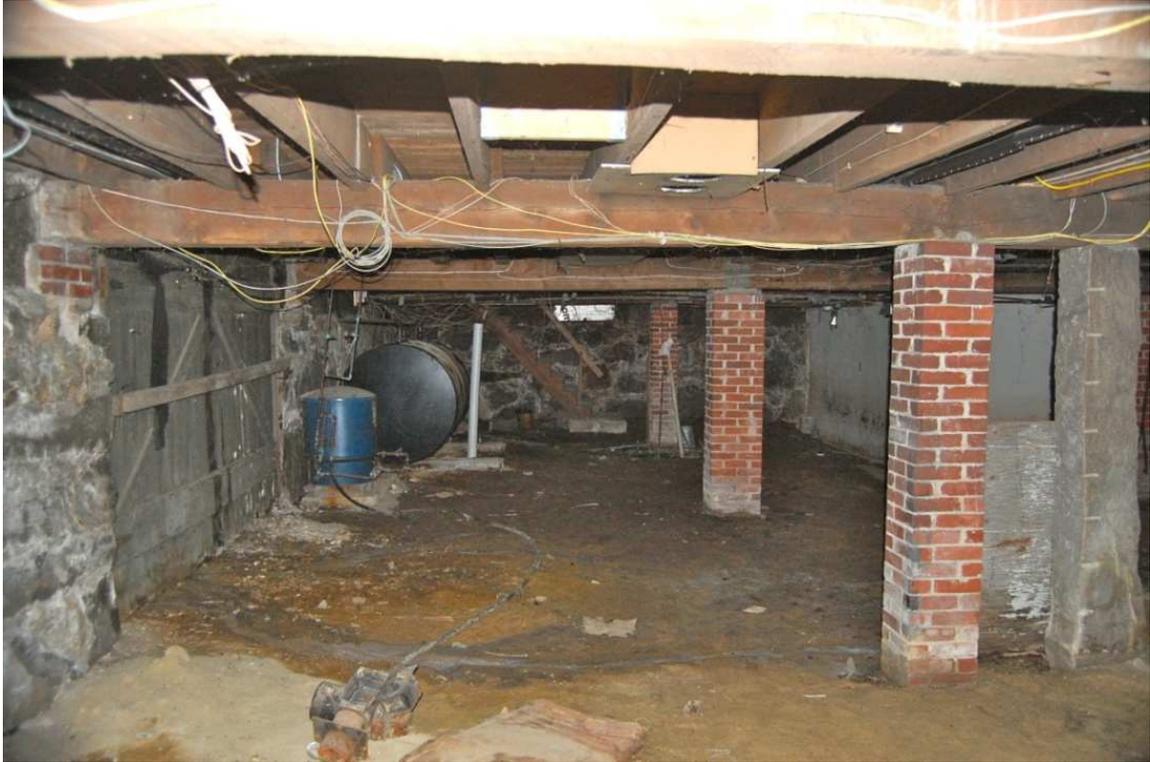
38. Both granite posts and brick piers support the carrying timbers.

The piers that support the major carriers in the cellar appear to be serviceable, with minimal deterioration, but do need some minor work. The foundation appears to be in reasonably serviceable condition.

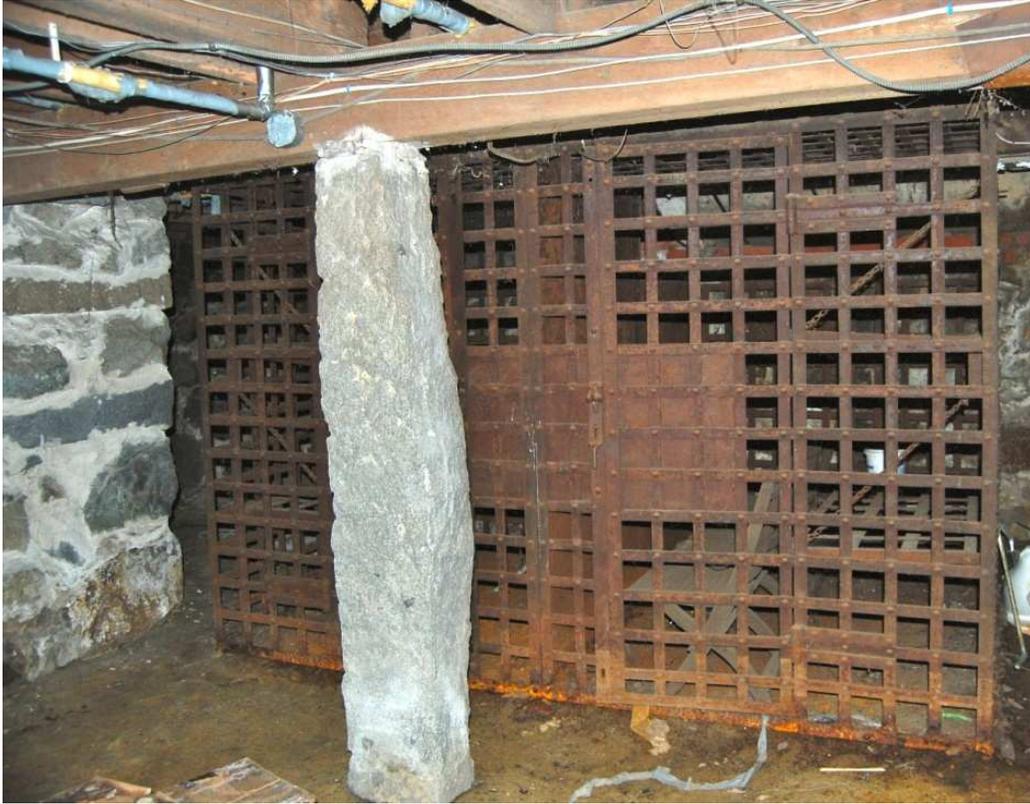
39. The two steel lattice-cage jail cells were installed during the first year the Town Hall was in use.

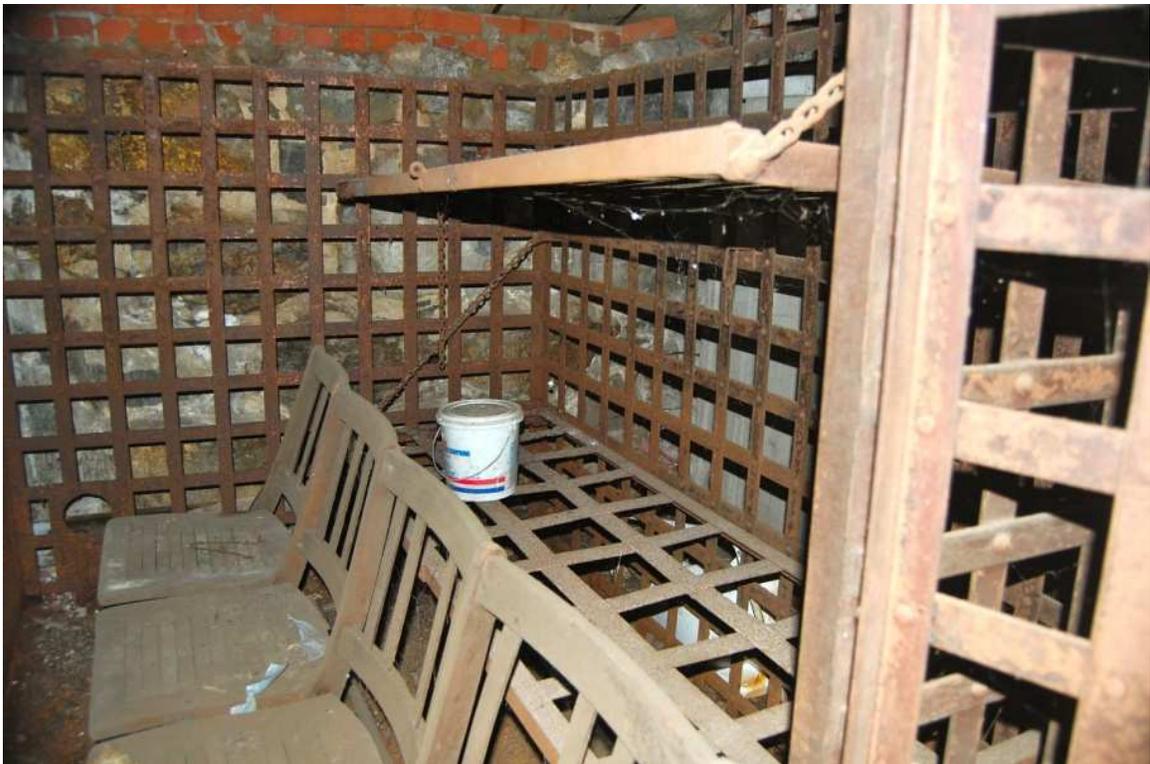
40. Each cell had two hinged sleeping benches. The cells have not been used at least since 1954.

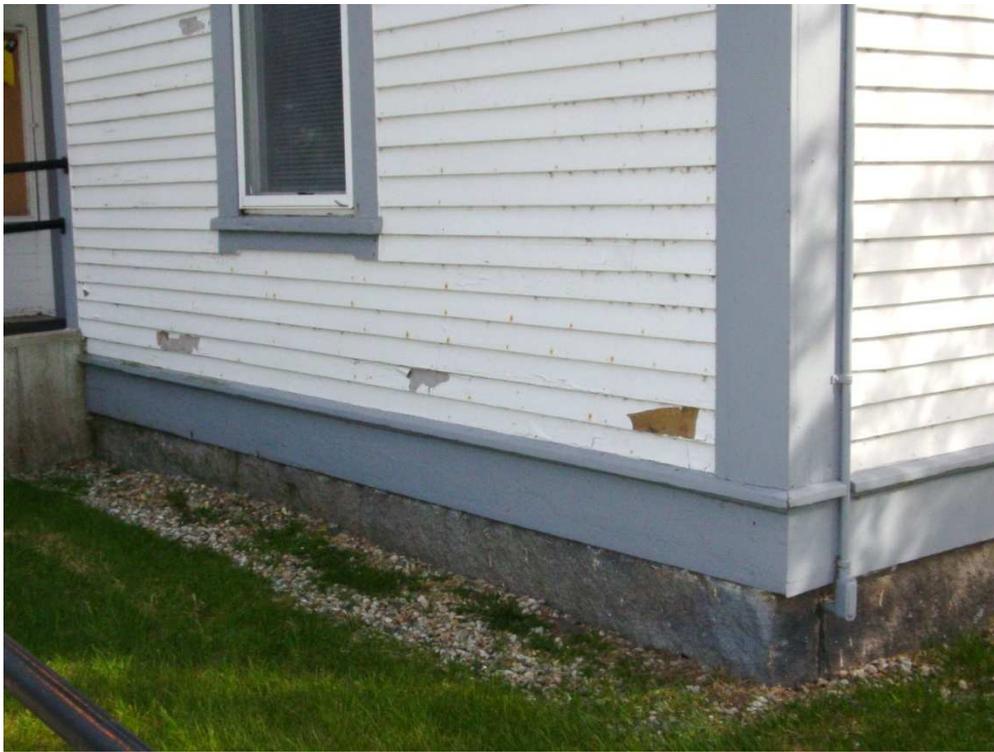
Walls on the east side of the connector and the south face of the main building are in need of repair and paint. This is likely due to a combination of water getting in and poor paint preparation.

Paint loss on the north elevation.

Where there are problems with peeling paint, and after any repairs/addition of new wood siding, it is very important that the new paint application follow careful preparation of the surface. After that, a good quality paint should be applied. It is possible some of the current paint issues were caused by substandard preparation work and/or paint product.

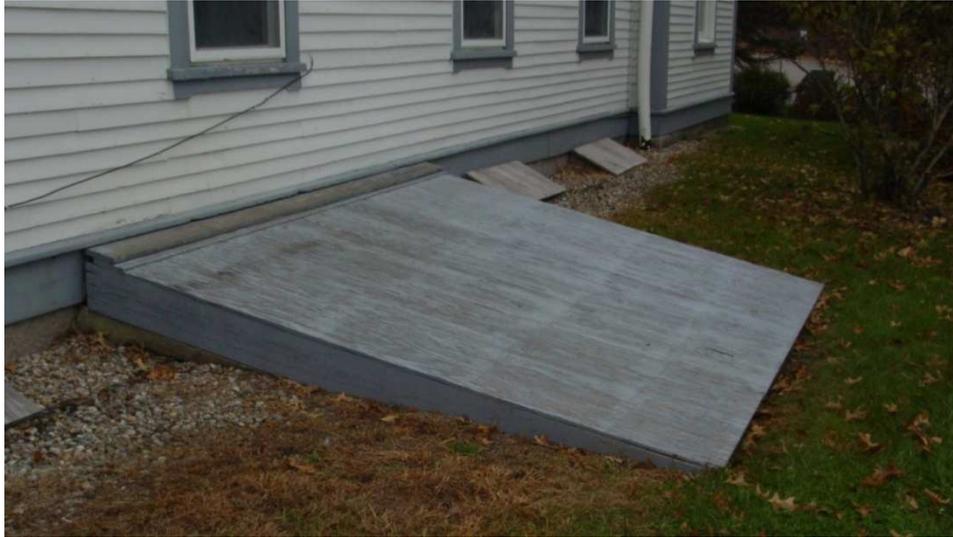
The bulkhead, while effectively shedding water, needs to be resealed/painted and should be insulated from the inside.

The bulkhead, on the east side of the building.
