New Durham Town Hall
New Durham, New Hampshire

Historic Building Assessment
with
Preservation Guidelines

Prepared by
Elizabeth Durfee Hengen
Preservation Consultant

May 2012

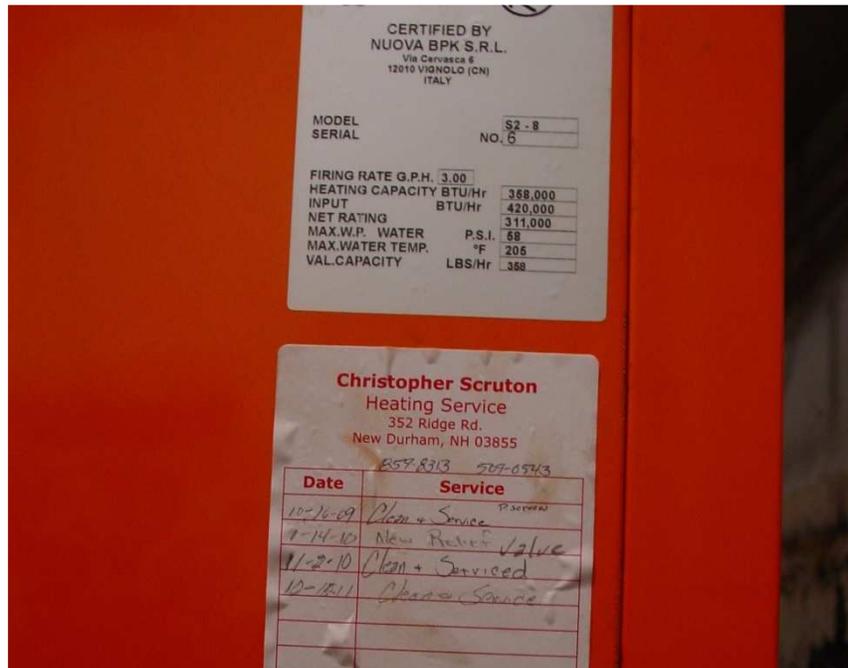
The area around the furnace is of major concern. Anyone working in the furnace room, above the furnace room and/or adjacent to the furnace is highly susceptible to exposure to mold and the physical problems that it can cause.

The boiler appears to be in good working order has been serviced regularly.

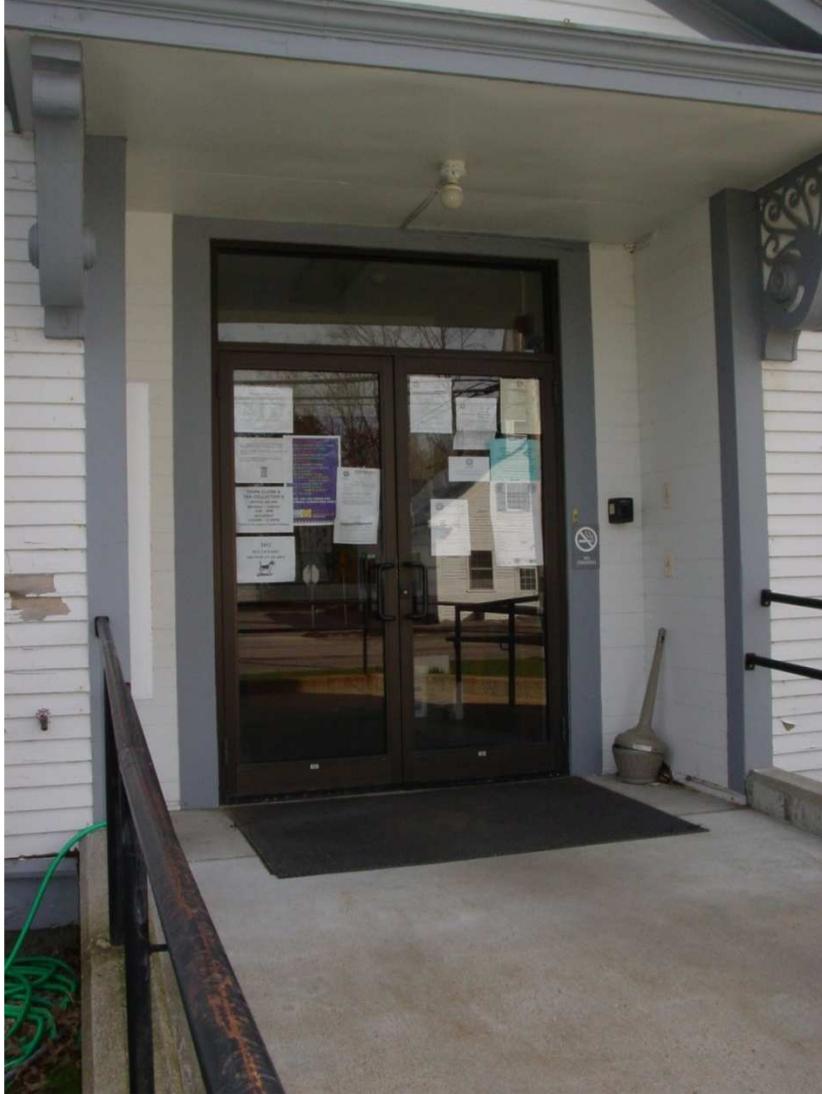
The ramp at the front entrance provides ADA access into the building. However, the existing replacement front doors lack automatic door openers.

The concrete ramp that provides ADA access for the front entrance

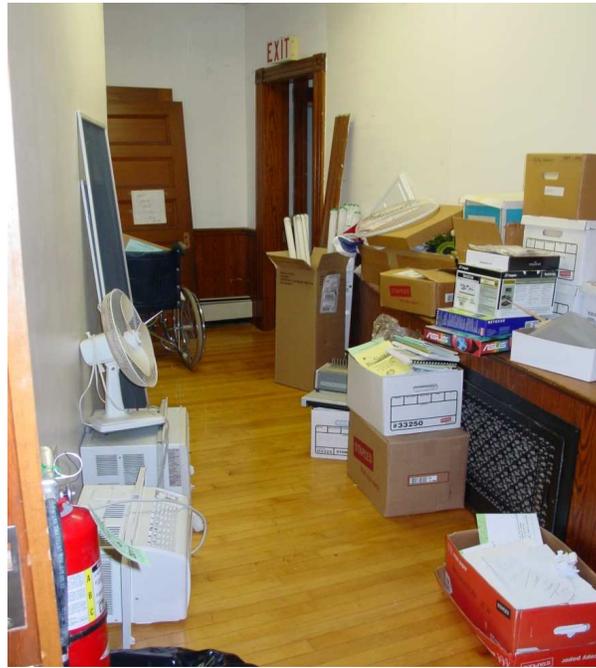
As illustrated in the photo below, the pathway to the emergency exit and fire escape on the second floor is being used for storage. All of these stored materials should be removed from the pathway to the fire escape. This is a *serious* safety issue that should be resolved immediately.

These items should be stored in designated storage areas and definitely not in an emergency egress hallway
